**Penn Hills #2 Passive Treatment System**  
**SRI O&M TAG Project #35 Request #1**  
**OSM PTS ID: PA-132**

Requesting Organization: Blacklick Creek Watershed Association  
Receiving Stream: Two Lick Reservoir  
Watershed: Blacklick Creek  
Municipality/County: Center Twp., Indiana Co.  
Latitude/Longitude: 40°38'15"N/ 79°2'16" W

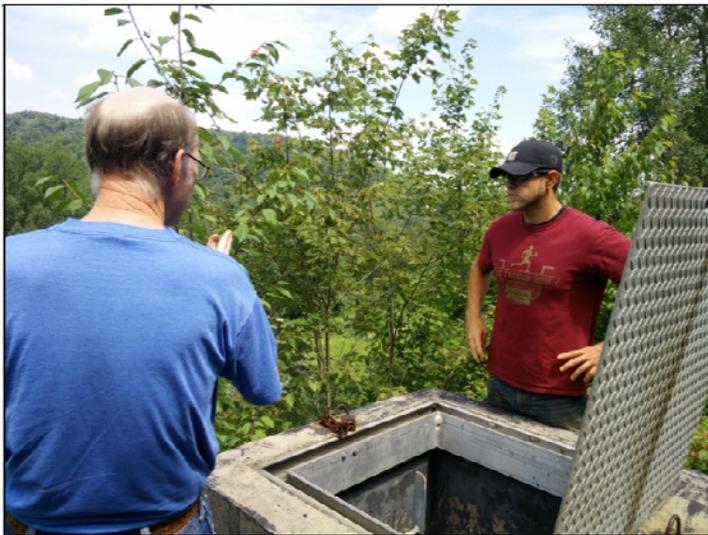
Dennis Remy of BCWA, and Dan Guy and Ryan Mahony of BioMost, Inc helped to remove the blockage at the splitter box and balance flow to the system (Left). Tim Danehy and Dan Guy of BioMost, Inc checked water quality while inspecting the site to ensure system components were performing properly (Right).

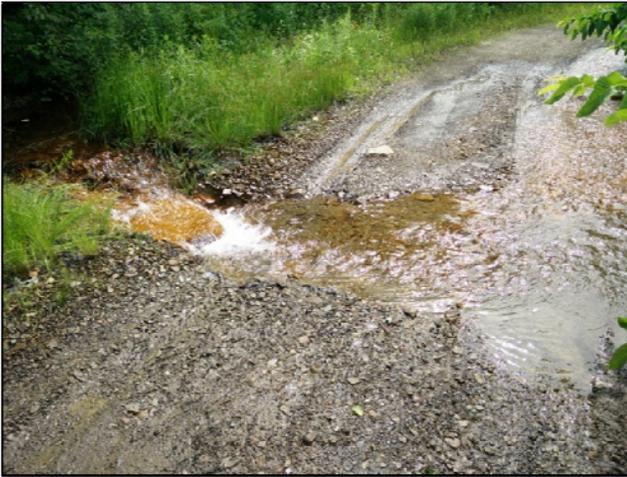
An untreated mine discharge was flowing across and eroding (Top Left) the long access road to the Penn Hills system. A culvert pipe was installed (Top Center) and stone was placed to repair the road where it had eroded (Top Right). An unknown pond structure which received AMD was overflowing and impacting the access road around the system (Bottom Left Right). Water was pumped from the pond. Once the water level of the pond near the treatment system was lowered, existing 12" and 4" outlet pipes could be accessed (Bottom Center) which were found to be capped. The pipes were uncapped to allow the water to flow. The outlet for the 4" pipe is located below a pile of rocks (Bottom Right). A culvert was also installed in case those pipes would become plugged in the future.
