Richards Passive Treatment System
SRI O&M TAG Project #36 Request #1
OSM PTS ID: PA-29

Requesting Organization: Blacklick Creek Watershed Association
Receiving Stream: South Branch Two Lick Creek
Watershed: Blacklick Creek
Municipality/County: Cherryhill Twp., Indiana Co.
Latitude/Longitude: 40° 39' 49" N/78° 58' 54" W

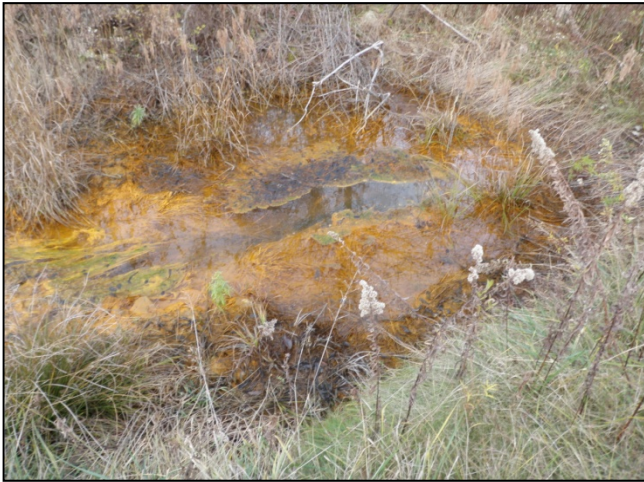
At the Richards Passive Treatment complex, the intake and conveyance pipe had become plugged (Top Left) causing most of the water to flow through a culvert and bypass the treatment system (Top Right). Additional plugged pipes from the flow splitter prevented water from getting to two of the VFR ponds (Center Left). An overgrowth of vegetation was causing difficulties for StreamTeam to sample, which needed to be removed (Center Right). After vegetation removal occurred, valve boxes were able to be located (Bottom Left).

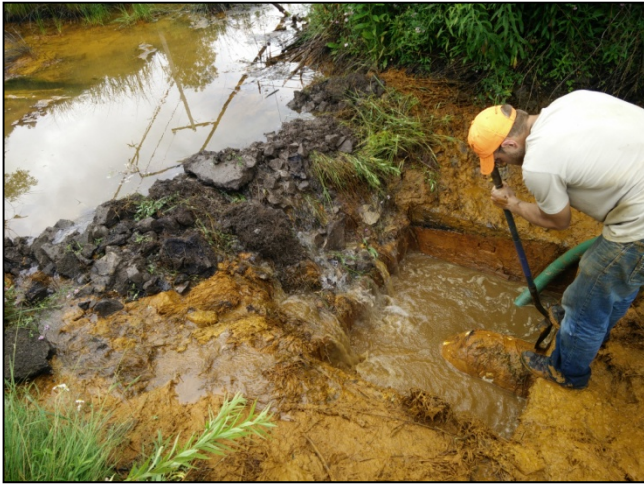
Water within the drop inlet box had to be pumped in order to access and clean the box (Top Left). The conveyance pipe to the treatment system was plugged (Top Right) as well as the piping from the flow splitter box to two of the VFRs. These were cleaned out using a power snake (Center Left). Debris that had accumulated with the mine discharge pipe was also removed (Center Right). Seeps from the leaking Settling Pond and potential other sources flow into South Branch Two Lick Creek (Bottom Left).
