Richards Passive Treatment System
SRI O&M TAG Project #36 Request #2
OSM PTS ID: PA-29

Requesting Organization: Blacklick Creek Watershed Association
Receiving Stream: South Branch Two Lick Creek
Watershed: Blacklick Creek
Municipality/County: Cherryhill Twp., Indiana Co.
Latitude/Longitude: 40°39' 49"N / 78° 58' 5"W

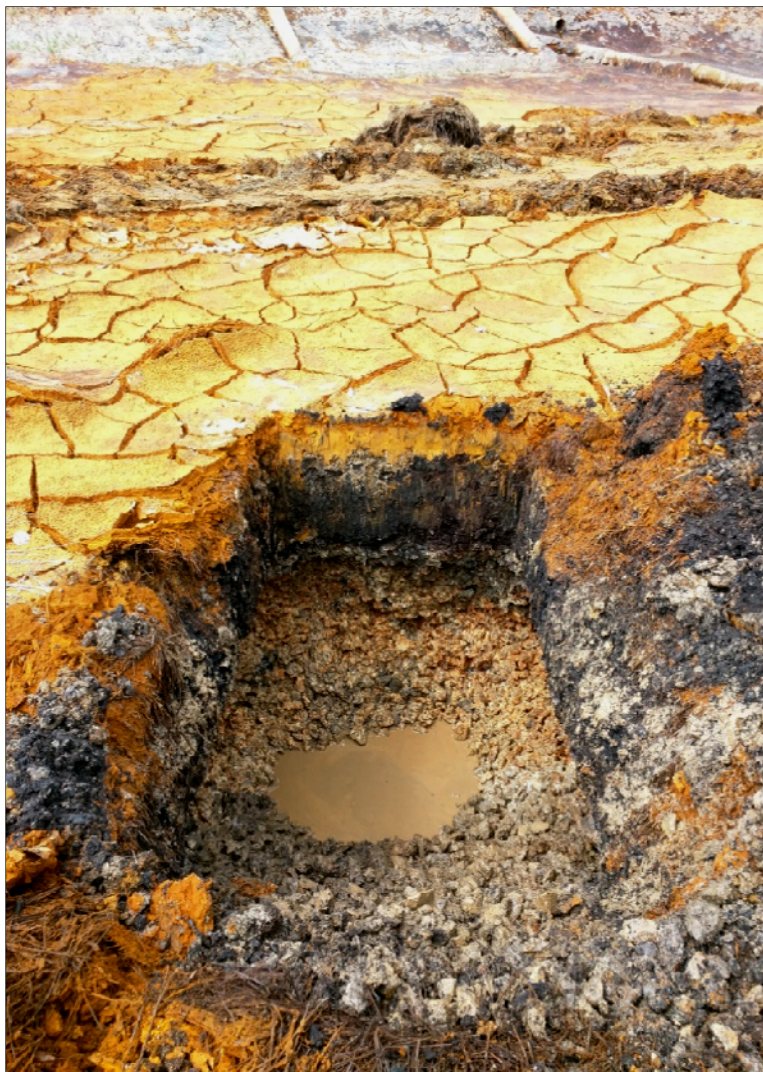
In May 2017, BioMost Inc. (BMI) returned to the site to conduct maintenance. VFR1 was allowing very little flow through the media, and VFR2A and 2B were at a much higher water elevation than designed. The flush valves for 2A and 2B were opened to allow the ponds to drain. Once drained, the ponds were stirred using a mini excavator to improve permeability of the media. It was discovered that there was a relatively uneven mixture of compost and limestone within each pond, with pond 2B having a higher limestone content than pond 2A. Both ponds appeared to have a layered media design with a compost mixture on top of a limestone layer.

Left: VFR 2A and 2B had layered media which benefitted from the top layer being stirred to improve permeability.
Top Right: VFR 2A after being stirred.
Bottom Right: VFR 1 media was very compacted, shallow and had no observable limestone.

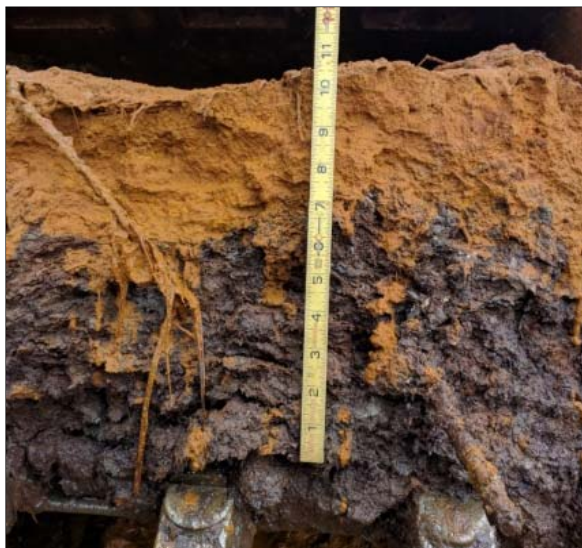
VFR1 was also drained with the intention of stirring the media. The treatment media only had approximately 6-12 inches of compost with no observable limestone. In conjunction with the iron precipitates on top of the media, it was not possible to effectively stir the media without causing damage to the liner or the piping system presumed to be underneath the media. Due to the lack of permeability of the media in pond 1, the inlet pipe was temporarily capped until a more permanent solution could be found to utilize the pond. Flow which would normally enter VFR 1 is now diverted to VFR2A and 2B.

As the passive system is nearly 20 years old and the media within VFP1 appears to be spent, the BCWA should consider obtaining funding for a system redesign in the near future especially if water quality does not improve after recent maintenance. When the system is rehabilitated, Settling Pond #1 should be lined.

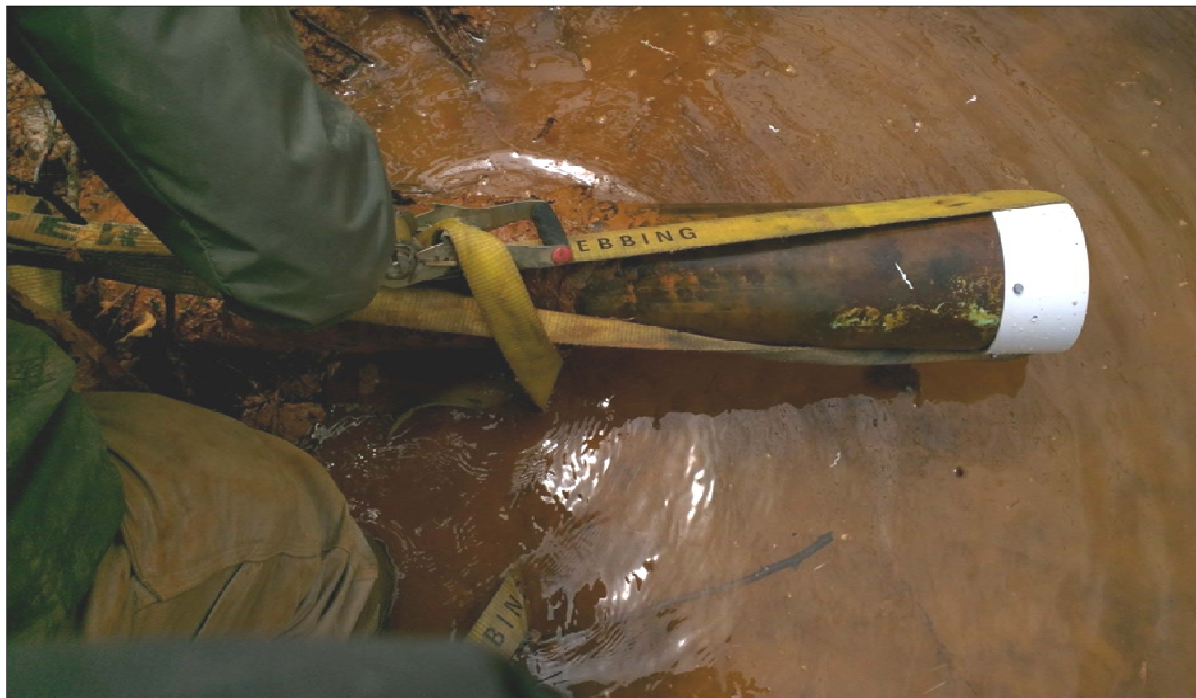
Above: VFR1 was capped to divert all flow to VFR2A and 2B.

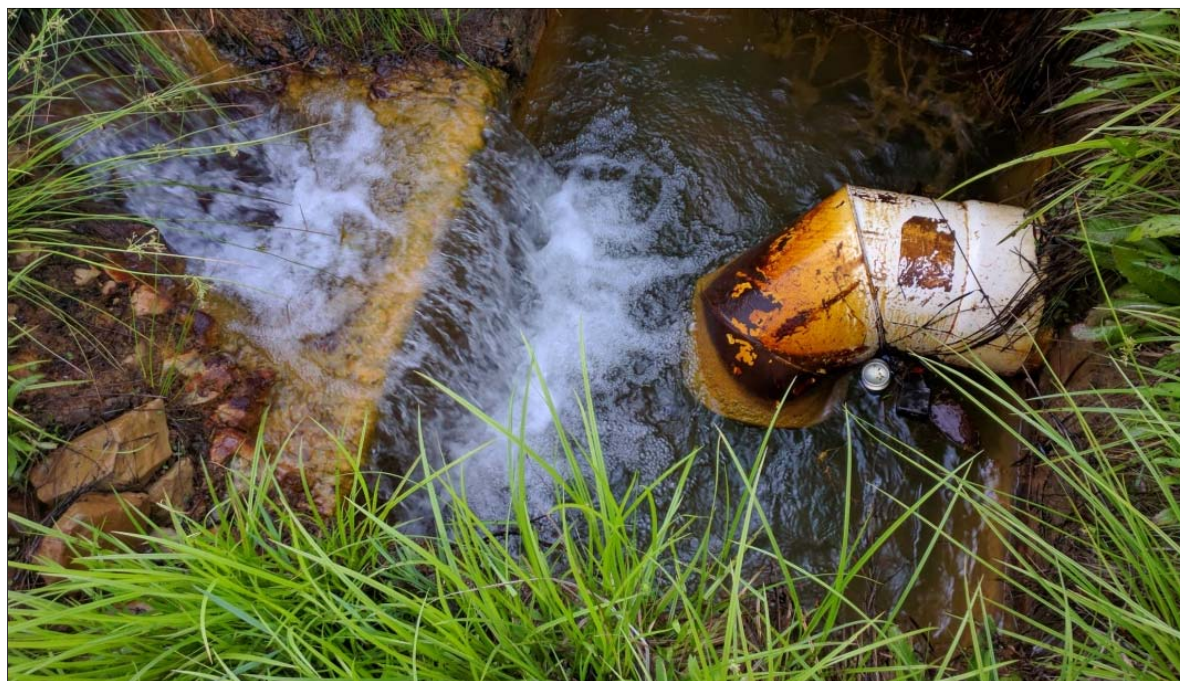
After stirring the ponds, it was found that some sort of blockage existed within the raw water conveyance pipe. After exercising the valves for both VFR2A and 2B and attempting to snake the pipes manually, the clog within the piping appeared to let loose and allow free flow from the inlet. To

Below: Due to debris entering the concrete inlet structure, a bar guard was installed to help prevent blockages in the system inlet pipe.

reduce the chance of plugging in the future, a bar guard was installed at the concrete box inlet structure pipe elbow.
