Hamilton Passive System and Potato Garden Run Evaluation Report

December 2018

**Prepared by
Stream Restoration Incorporated & BioMost, Inc.**

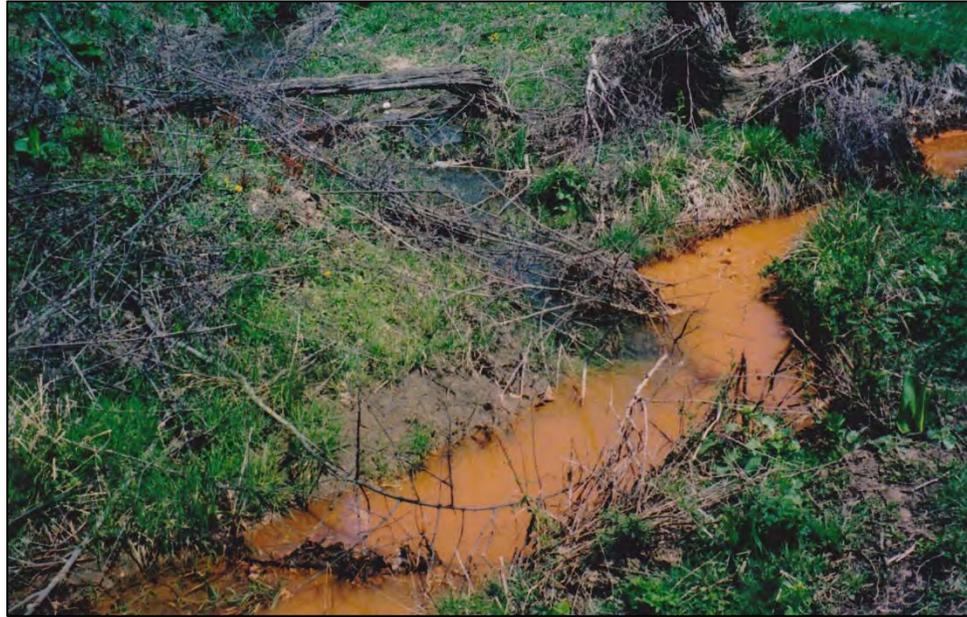
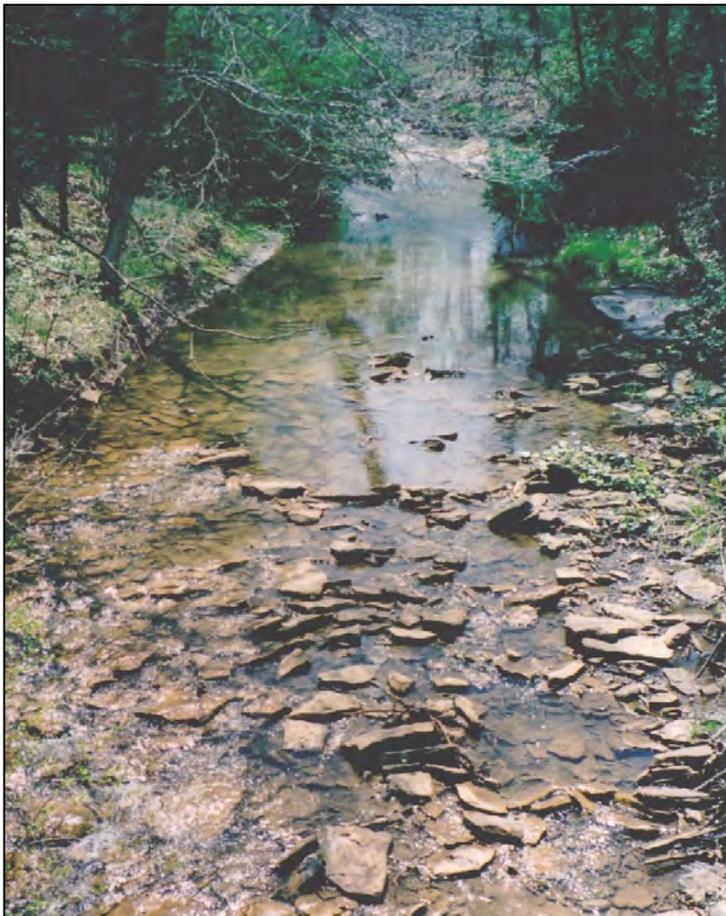
The Hamilton Discharge (H3) emanates from an abandoned underground coal mine. The discharge was reportedly created, when the operator of the Mazzaro landfill accidentally broke into the mine. Prior to construction of the Hamilton Passive Treatment System, the Hamilton discharge impacted both an unnamed tributary (Top) and Potato Garden Run. The impact to Potato Garden Run was visibly noticeable by comparing the upstream (Bottom Left) and downstream (Bottom Right) of confluence with the unnamed tributary.

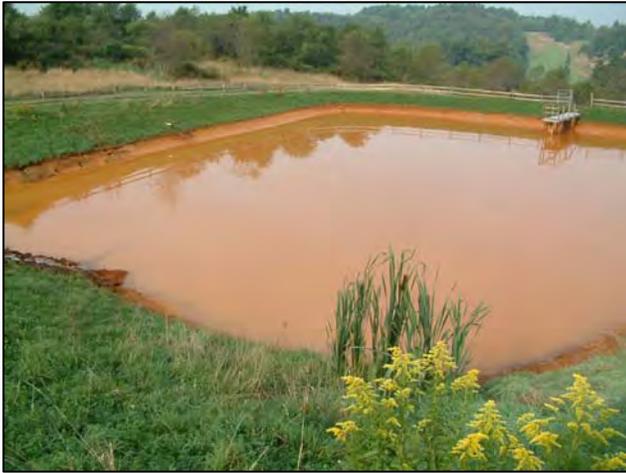
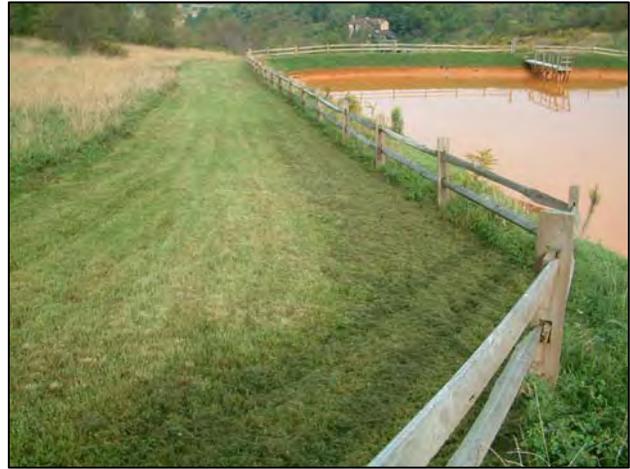
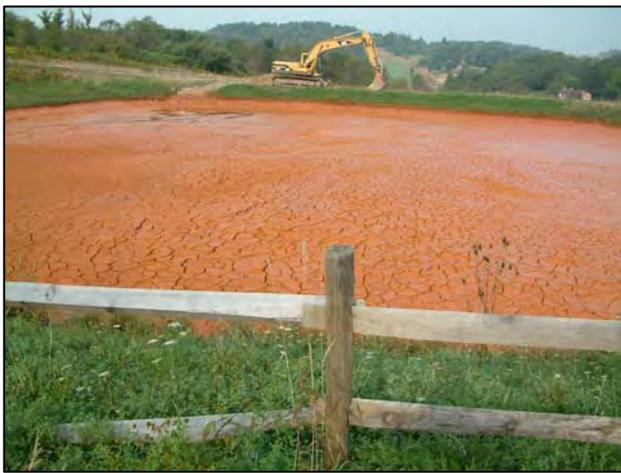
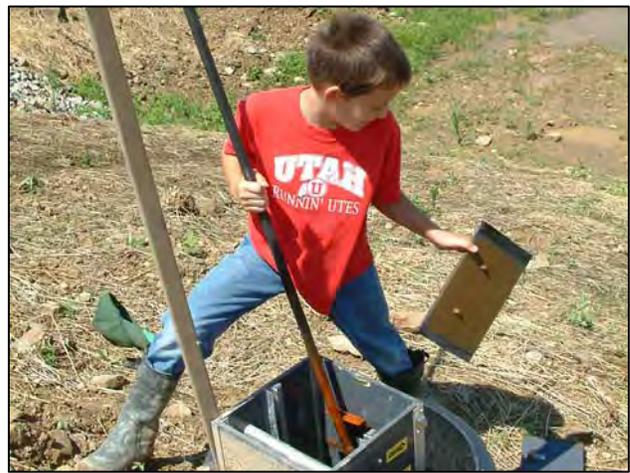
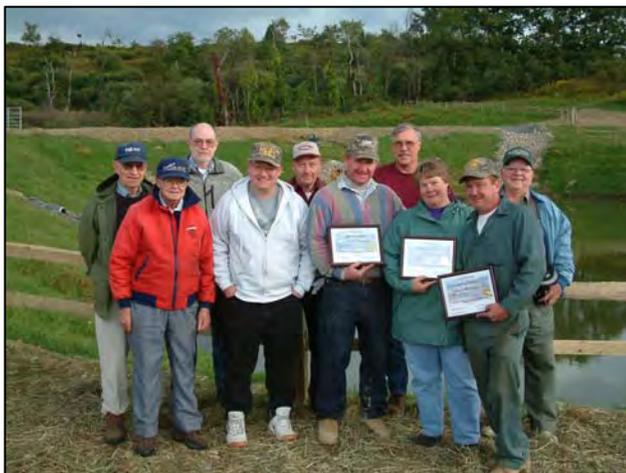
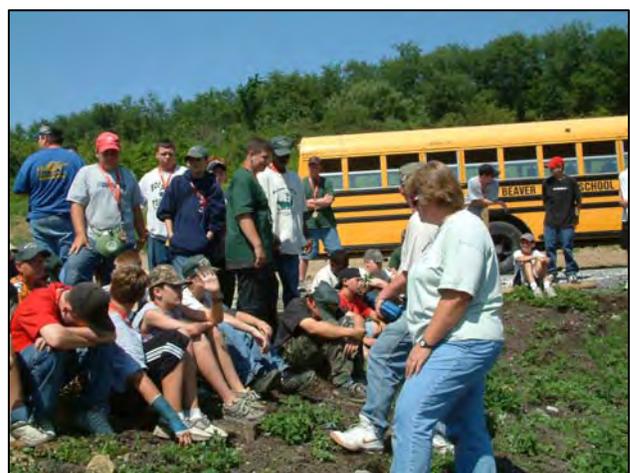
The Hamilton Passive Treatment System was installed in 2003. As can be seen from the photos above, the system was meticulously maintained and was effective at removing large quantities of iron from the discharge. The site was the pride and joy of the Raccoon Creek Watershed Association and was used as a “show piece” for providing education programs related to AMD, passive treatment, and watershed protection/restoration and careers in conservation.

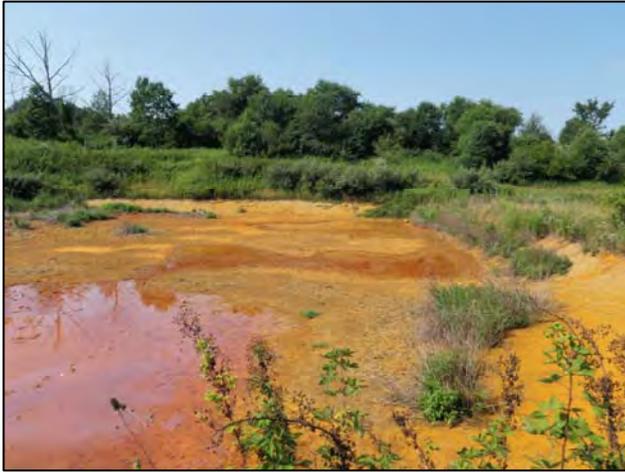
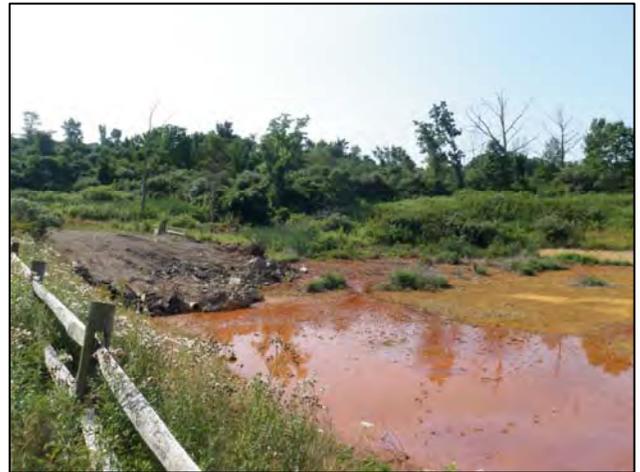
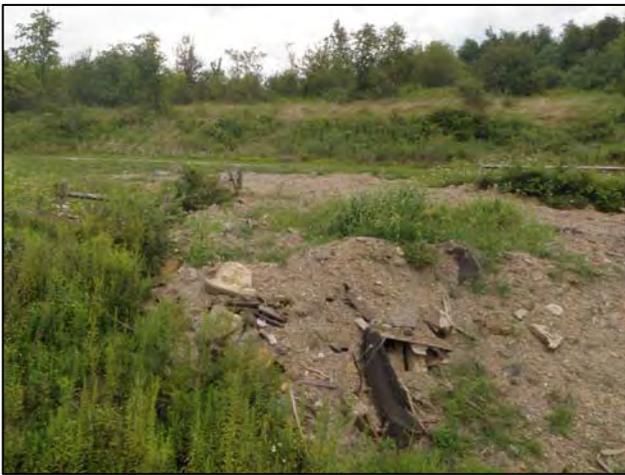
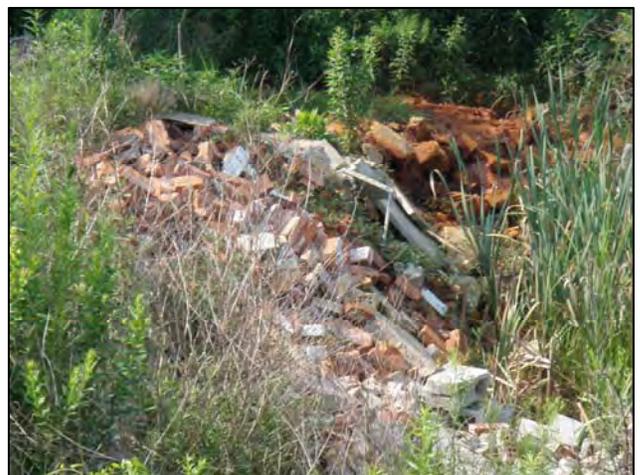
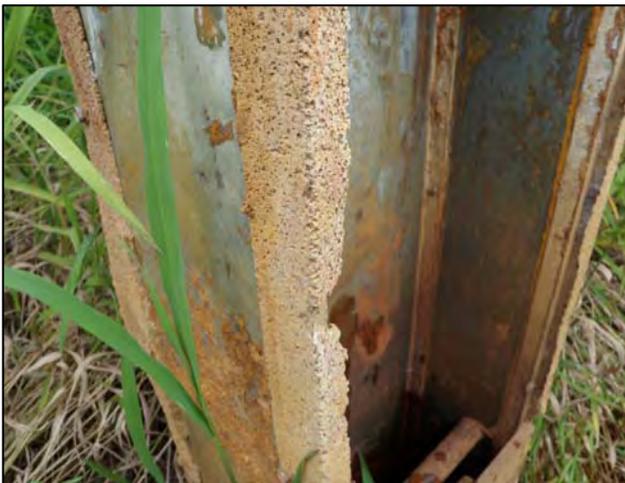
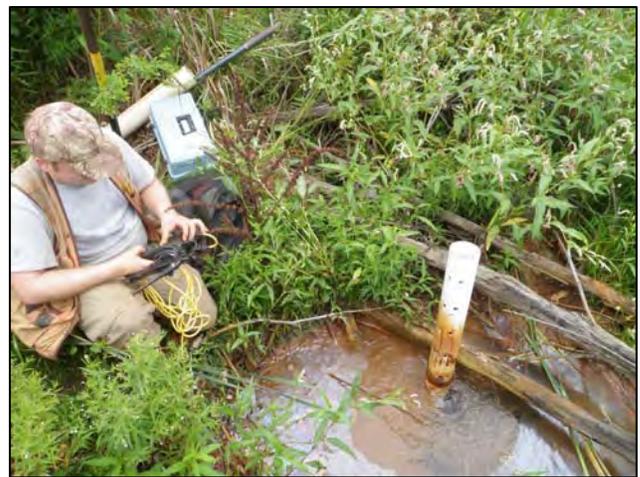
In 2008, a new landowner purchased the property who then prevented the RCWA from accessing the site to conduct maintenance. The system was vandalized and fell into disrepair. After the property was sold again, SRI was contacted in 2012 to address maintenance issues. A field investigation was conducted in which a variety of needs were determined. For instance, debris including bricks and furniture were dumped into system components and portions of the split-rail fence were either broken or stolen. The Agri Drain water level control structures have also corroded and need to be replaced with either stainless steel or plastic devices. In addition, available water monitoring of the treatment system indicated that the system needed to be expanded to increase treatment performance.

- The existing outlet structures of the VFP and SP need to be replaced.
- The sampling dock at the existing SP needs to be replaced or removed.
- Construction/misc. debris dumped into the VFP and SP needs to be removed.
- Iron sludge on top of the VFP will need to be removed in the future.
- Sections of the split-rail fence and gates needs repaired/replaced.
- Large brush and trees along the fence line needs to be cleared.
- Existing access road is in need of repair including placement of additional stone.

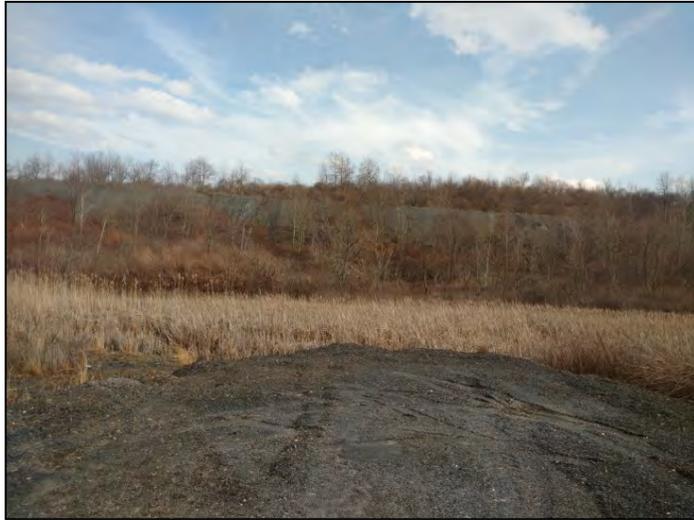
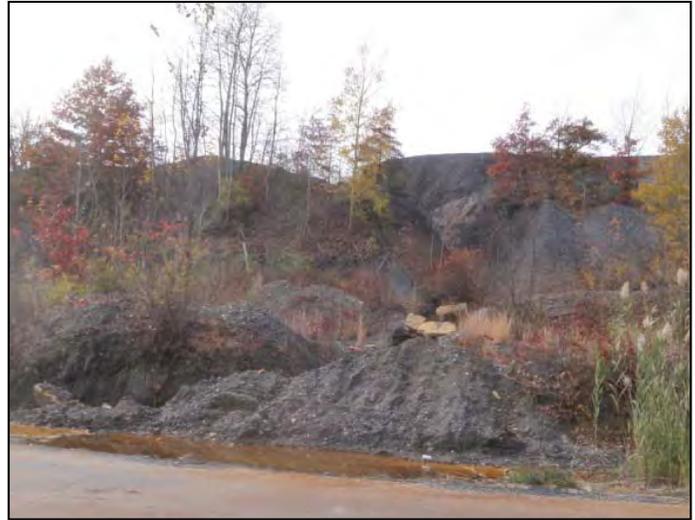
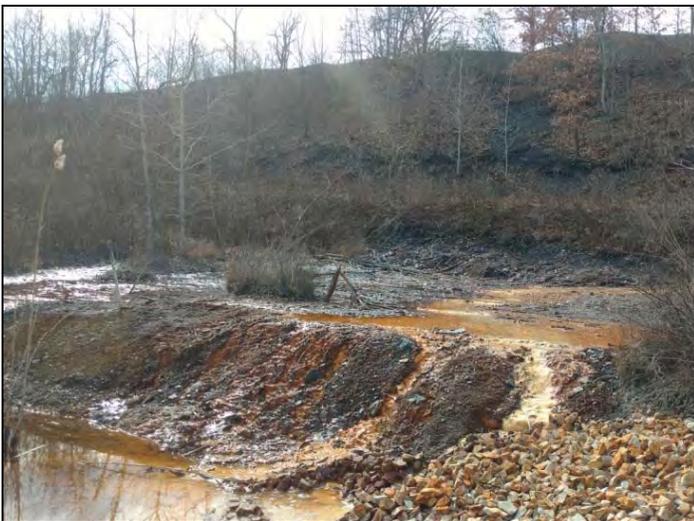
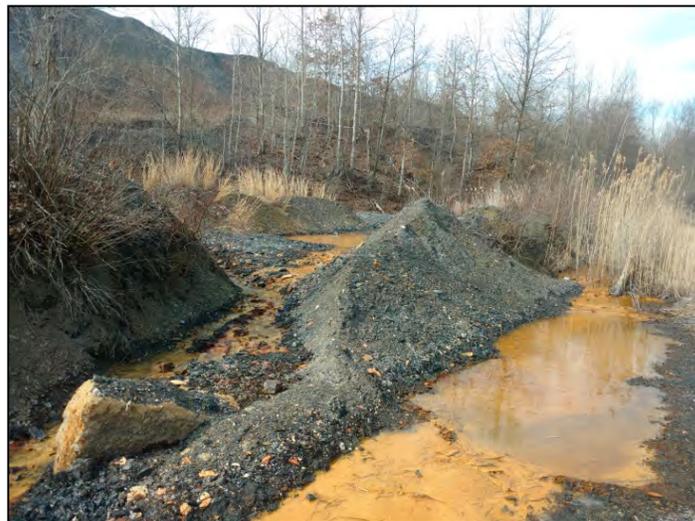
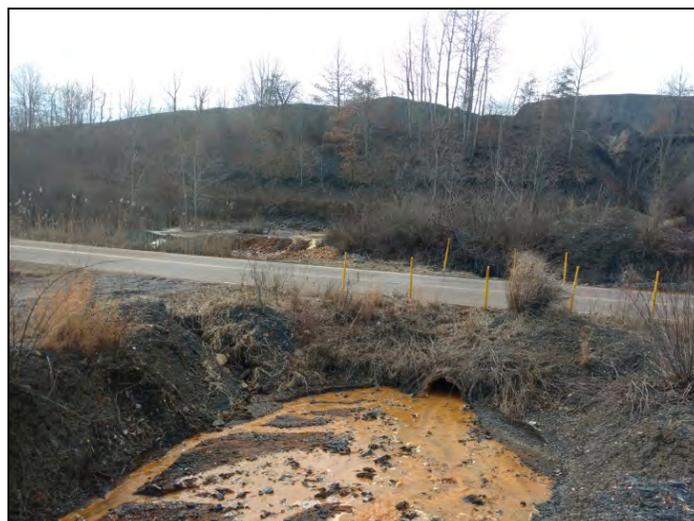
Massive coal refuse piles containing an estimated 1-2 million cubic yards of material line both sides of the valley in the headwaters of Potato Garden Run, which flows through a large wetland complex. The coal refuse is the source of various acidic metal-laden seeps and discharges that flow into the stream and at times degrades most of the length of Potato Garden Run, exceeding the TMDL goals. In addition, at times, the culverts carrying the AMD become plugged with iron and flow across the road creating hazardous driving conditions.

While there are likely other sources of mine drainage within the watershed, no other major sources were identified and most of the tributaries entering Potato Garden Run were visually observed and tested for pH at a minimum. Based on the limited site investigations, the two primary sources of mine drainage identified within the watershed are the Hamilton discharge which is being treated and the pollution emanating from the coal refuse piles. Therefore, the water quality data obtained during this project indicates that almost the entire length of Potato Garden Run is being polluted by the coal refuse piles located in the headwaters of the stream. The coal refuse piles are identified by the PA DEP BAMR as Priority Area 0638. While no official publicly available reports were found to document the quantity and quality of the material, an estimate of at least 1-2 million cubic yards of material is believed to be present. The ideal solution to addressing this source of pollution would be to excavate the coal refuse and transport to a Circulating Fluidized Bed (CFB) electric power plant. This of course assumes that the material is of suitable quality to be burned. Alkaline CFB ash could then be brought back to the site and utilized to properly reclaim the site, which would significantly improve, if not eliminate, the major sources of AMD to the headwaters of Potato Garden Run. Unfortunately, the proposed Beech Hollow plant that was to be built in the area could not be constructed due to permitting issues and the project has since been abandoned. The material would now need to be trucked to another plant located far away, which may prove to be economically prohibitive. There may be a need to conduct a short study to drill and collect a number of samples of the pile to determine quantity and quality. Grant funding would likely be needed. Another option would be to regrade the pile while adding alkaline materials, capping, and then revegetating the site.

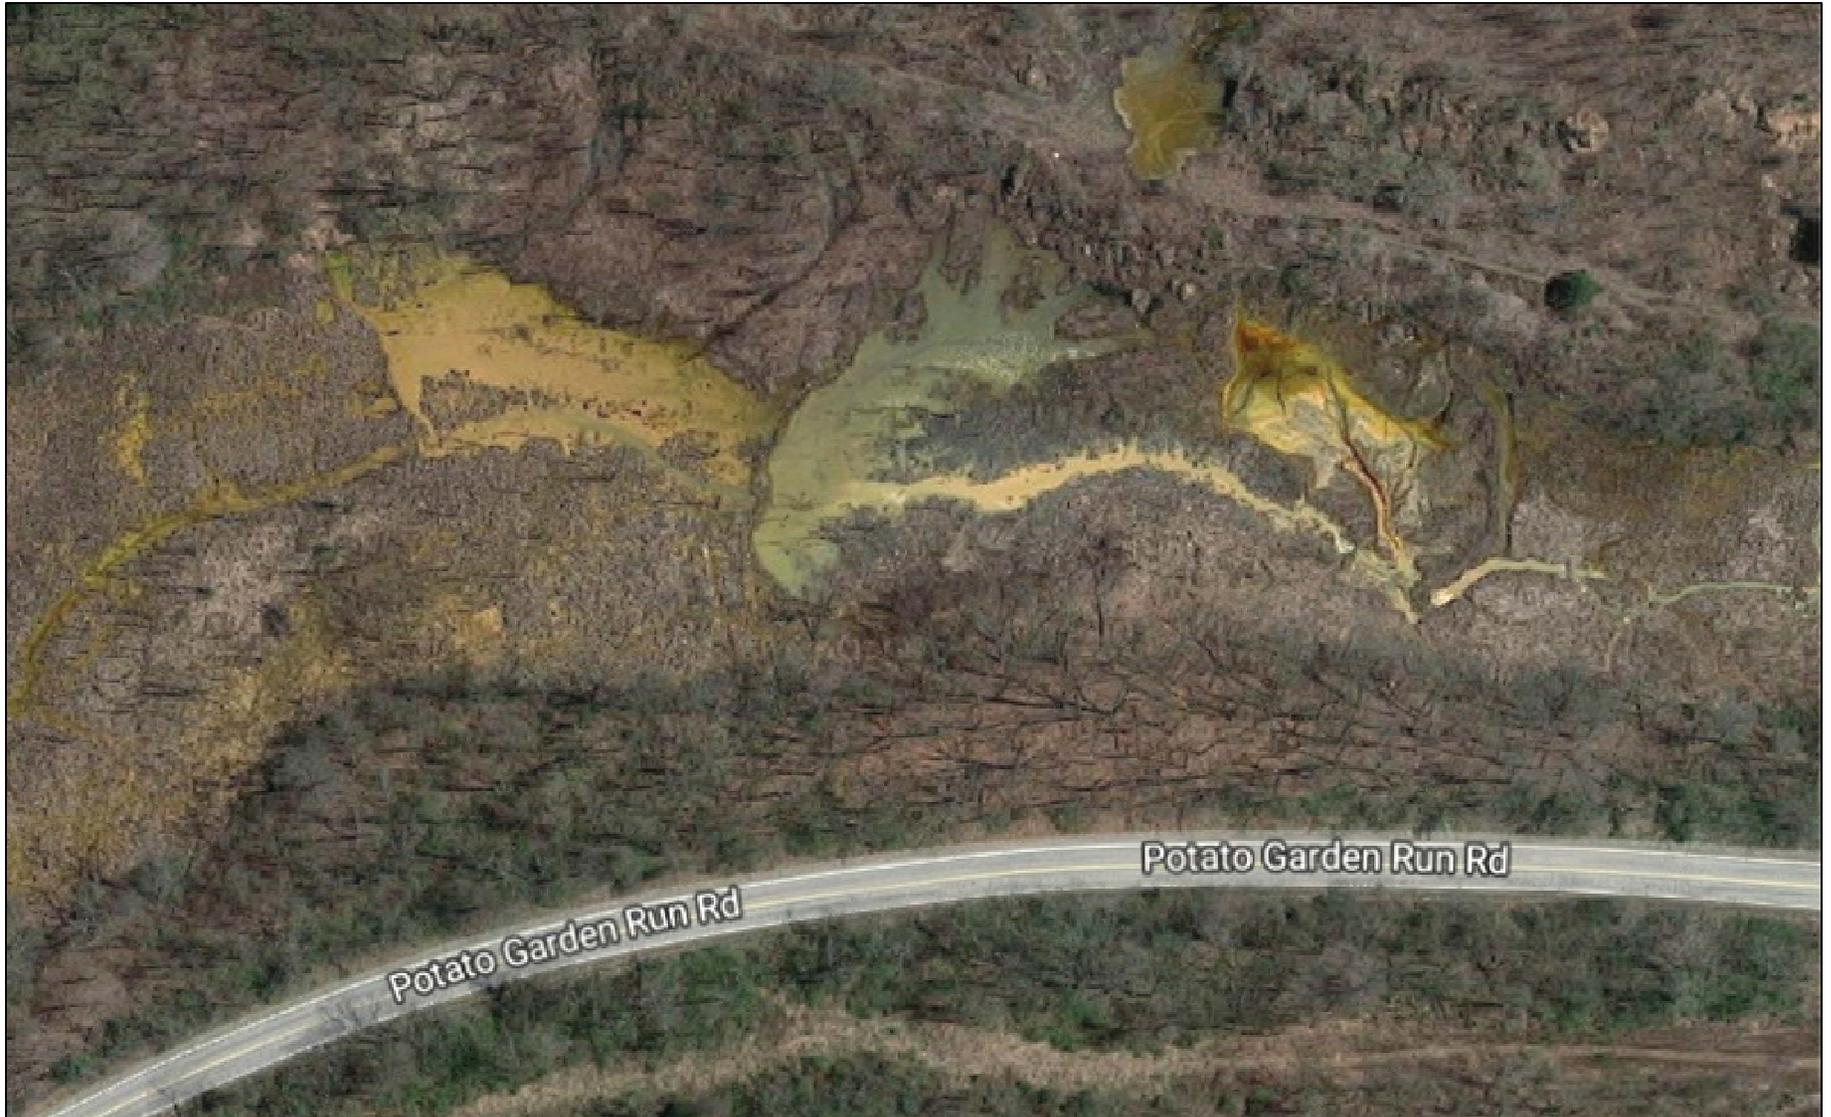
"Zoomed-in" aerial view of the Potato Garden Run and associated wetlands that are severely degraded by acid mine drainage flowing from the coal refuse piles.

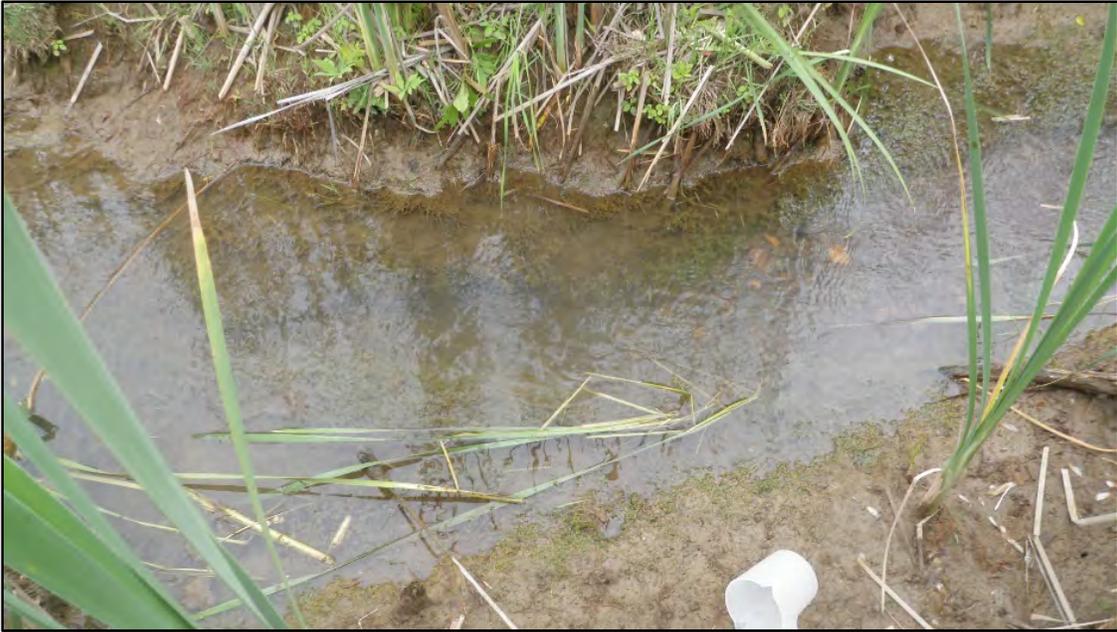
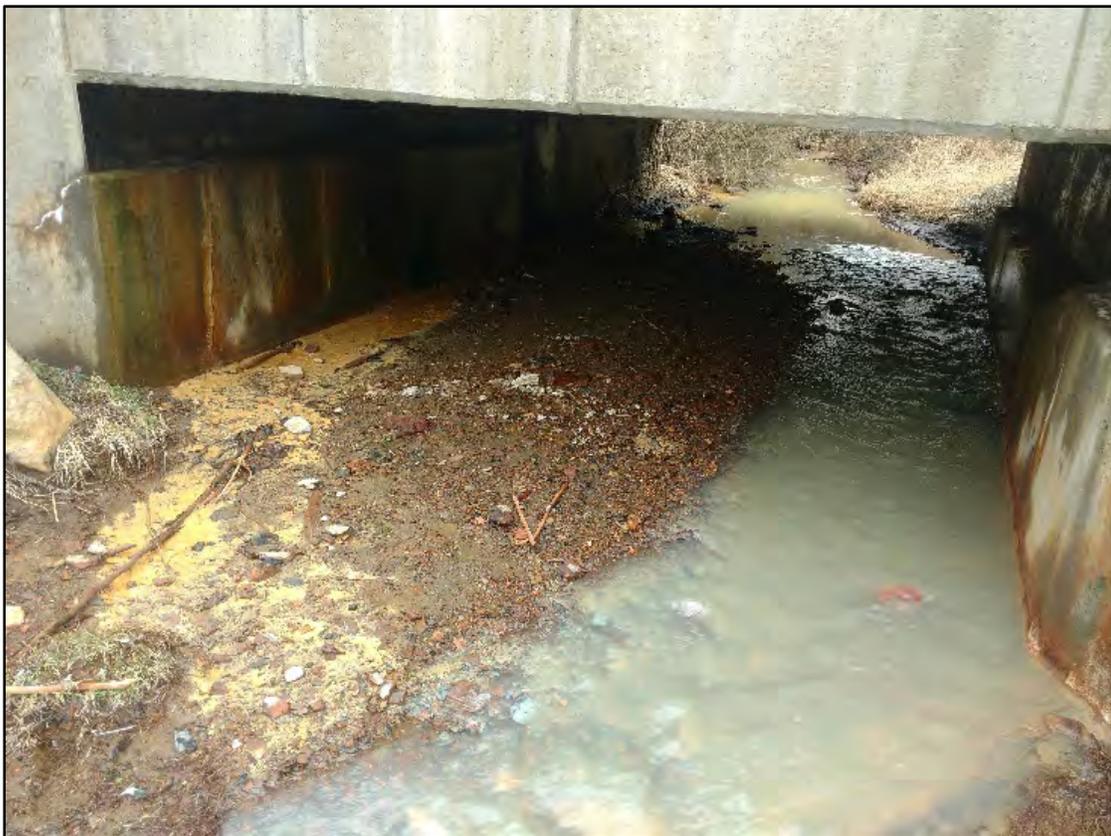
Directly upstream (Top) of the main coal refuse discharges, at sample point 247-12 Potato Garden Run is alkaline and only slightly impacted; however downstream the stream is highly impacted. At sample point 247-10 (Bottom) at Burgettstown Road next to the Westport Area Booster Station, aluminum solids are visible in the water as is iron staining on the bank and bridge deposited during higher flow events.

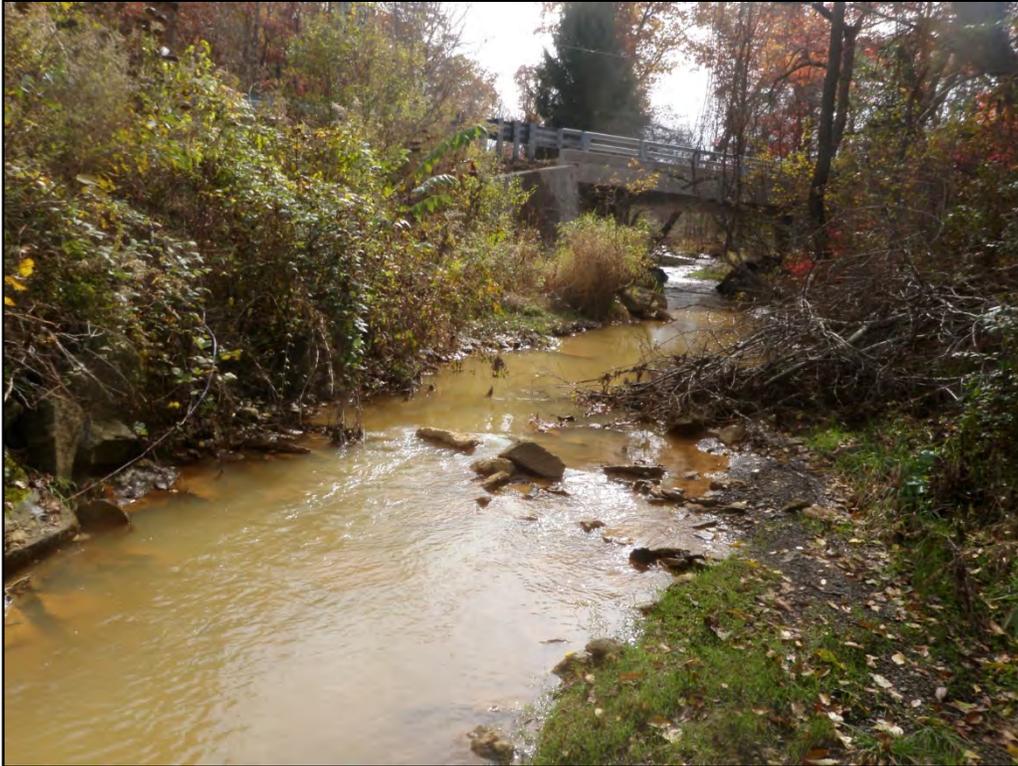
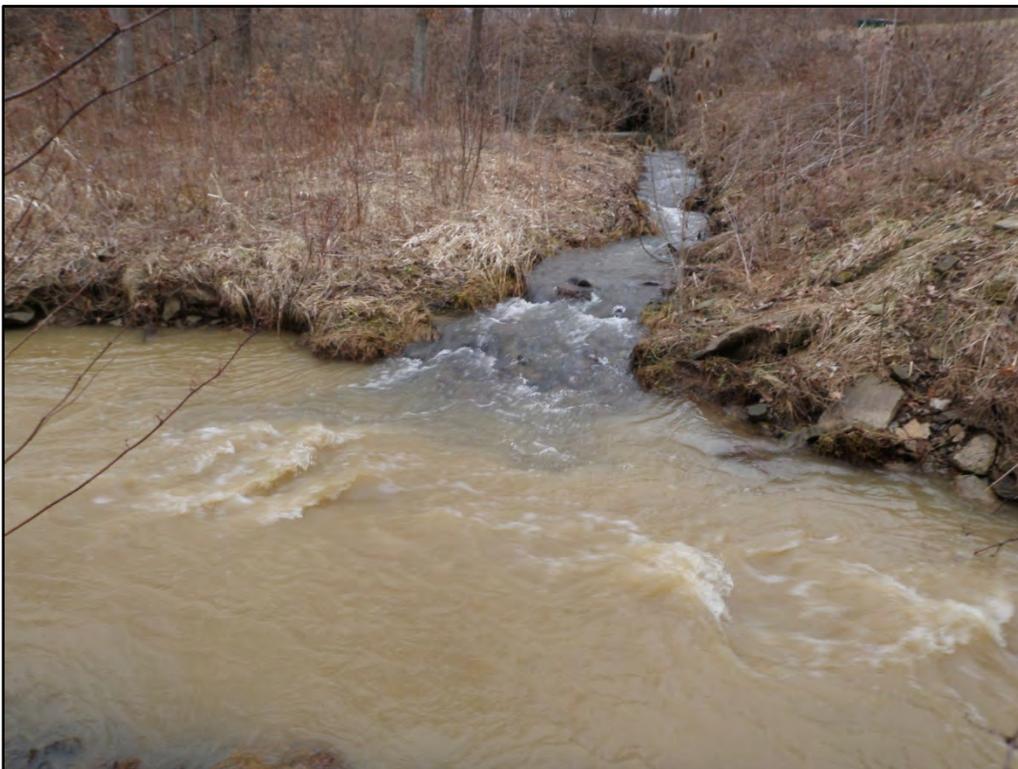
The impact to the stream from the coal refuse is visually observable for miles. At sample point 247-3 (Top), just upstream of the “Hamilton” tributary, iron solids tend to be more dominantly visible than aluminum. When the “Hamilton” tributary enters Potato Garden Run (Bottom), the water quality is so improved by the treatment system that it now improves Potato Garden Run and sometimes a “clean plume” can be observed.

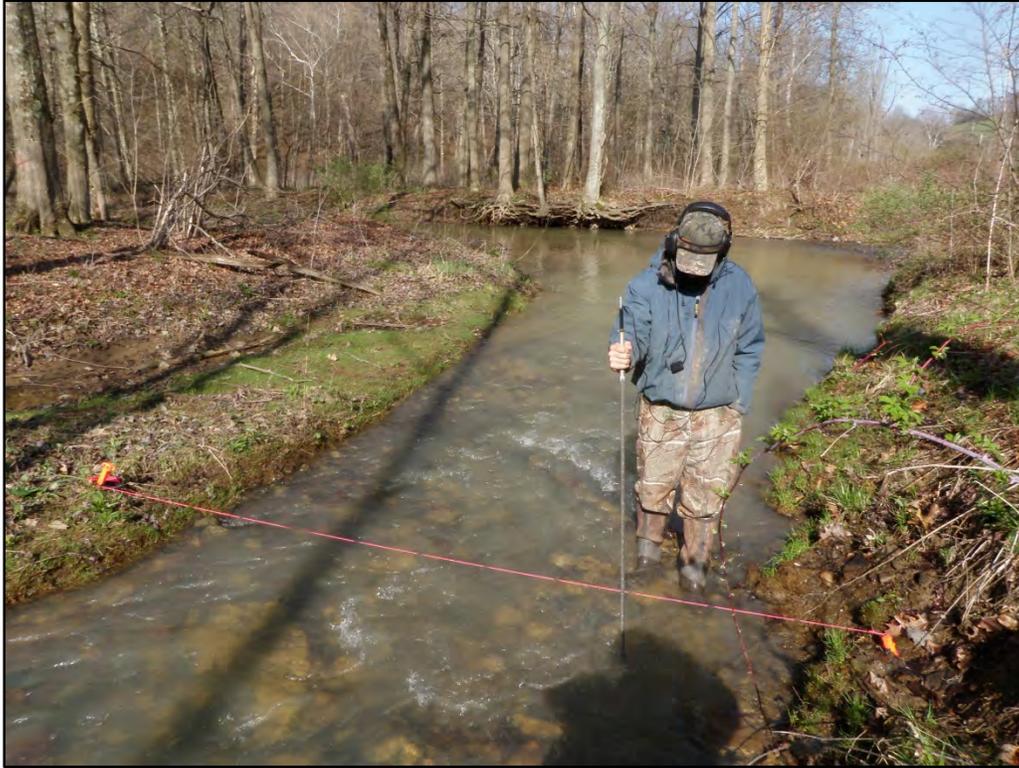
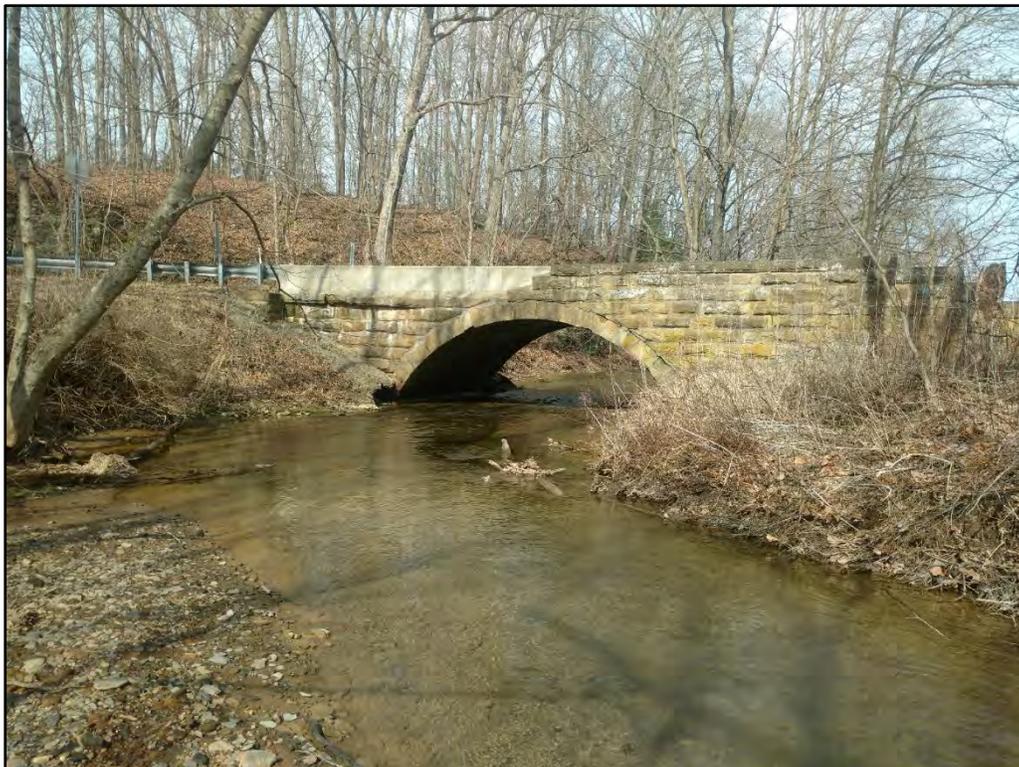
As better quality sources of water enter the stream and metal precipitates settle on the bottom, Potato Garden Run begins to improve (Top). By the time the stream reaches sample point 247-8 (below) near the mouth and confluence with Raccoon Creek, the stream is in general much better quality with a good pH and meeting TMDL goals.
