Re: **Final Report with Attachments**

McIntire Passive Treatment System

Project #2832E/2915; Document #: 4100049700

Marion Township, Butler County

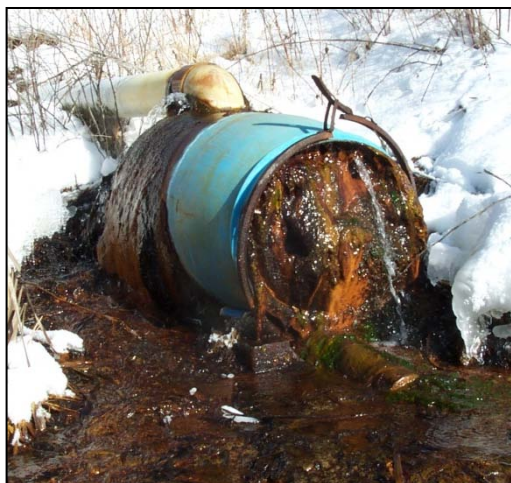
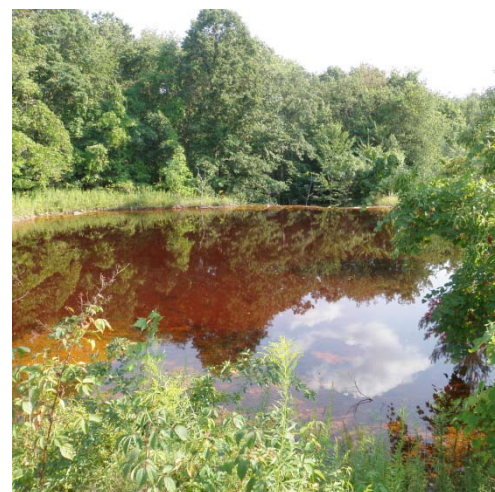
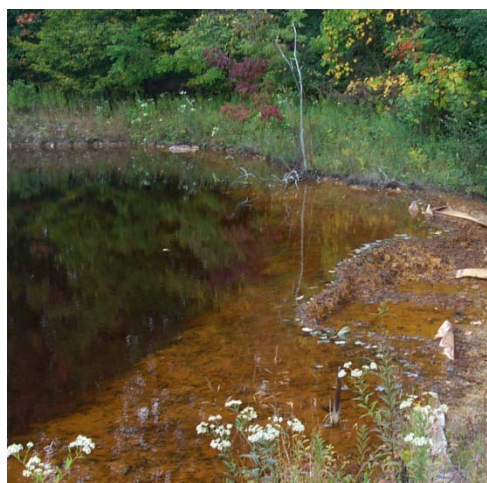
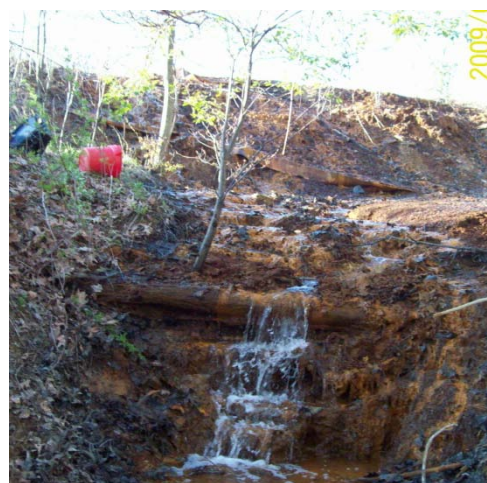
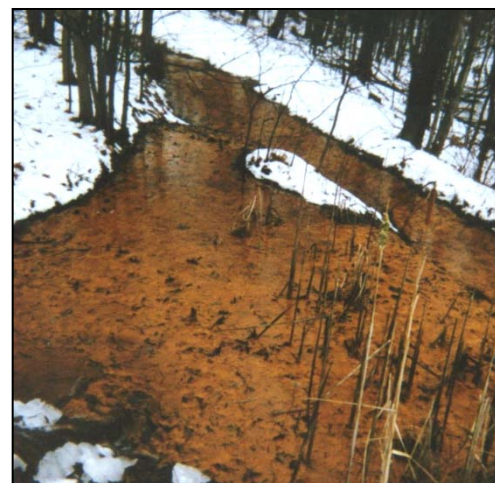
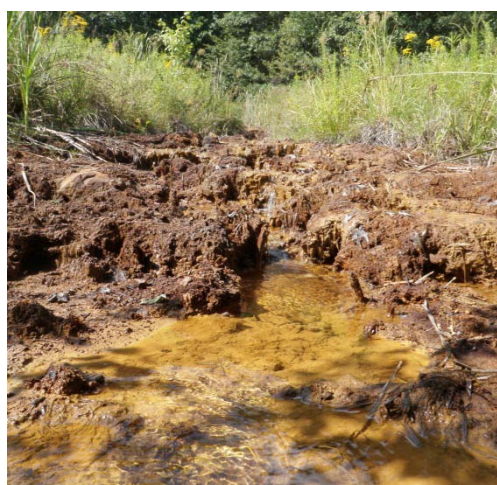
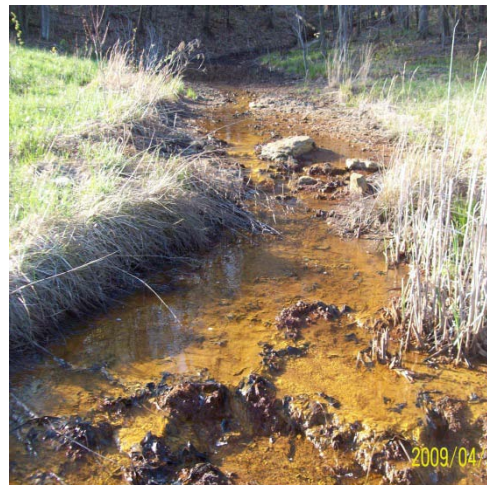
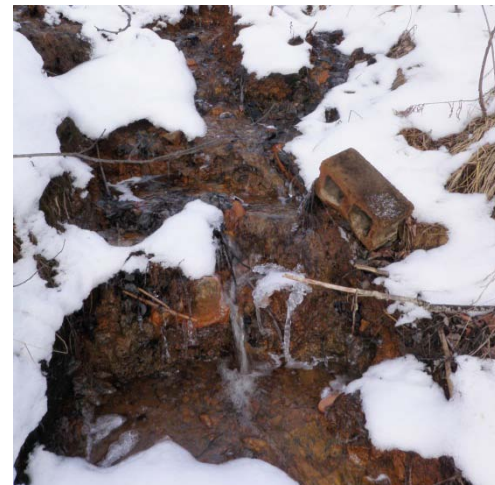
Pre-construction views of former Treatment Pond TB1 (*top row*) which receives discharges MC1, MC2, and MC3 from the old surface coal mine. The effluent of TB1 (*middle row*) forms the headwaters of UNT15. The natural formation of iron minerals at low pH, shown plugging old piping (*top-left*) and accumulating in TB1 and reconstructed UNT15 (*middle and bottom rows*) was utilized and enhanced as part of the McIntire Passive Treatment System.

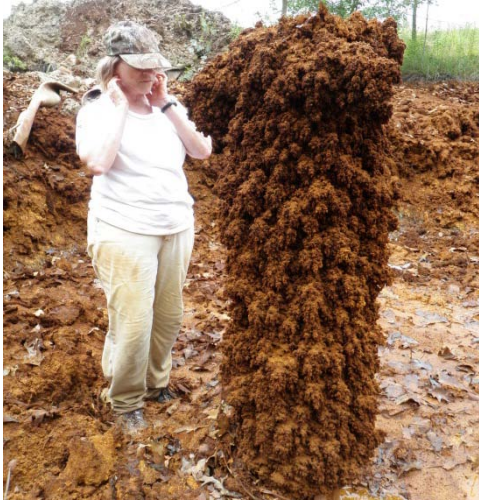
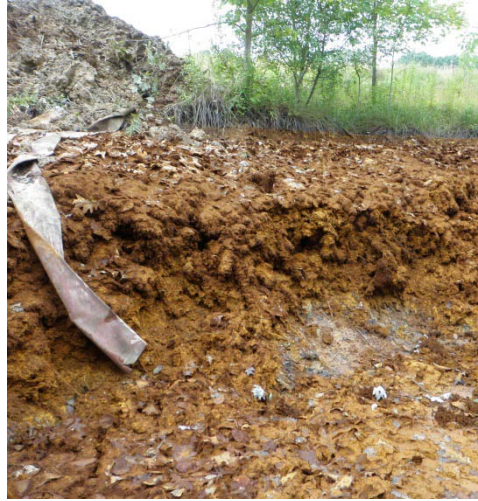
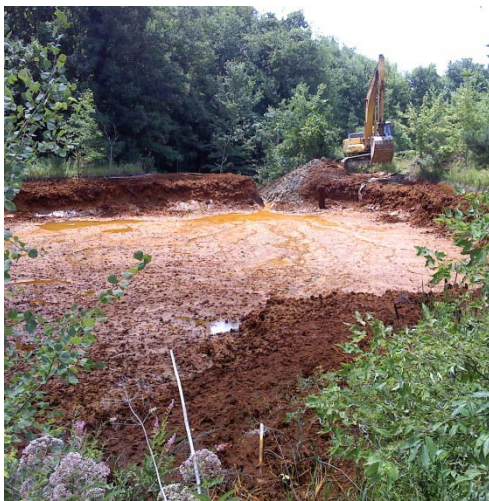
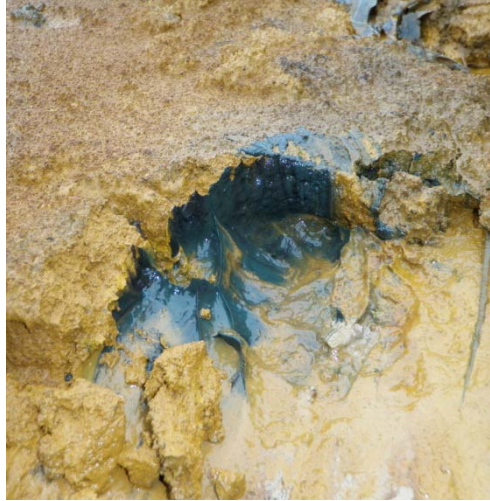
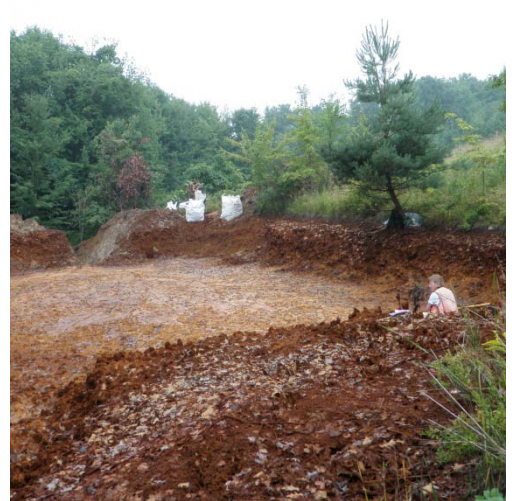
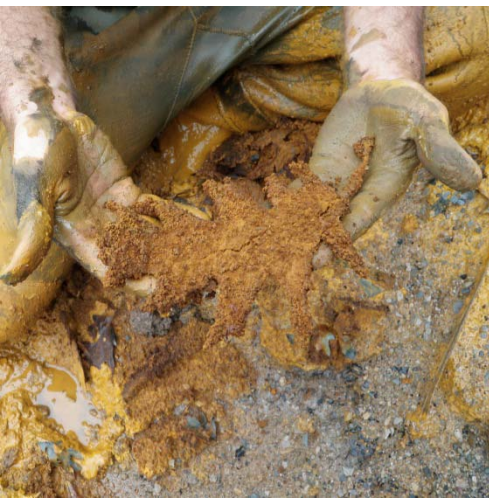
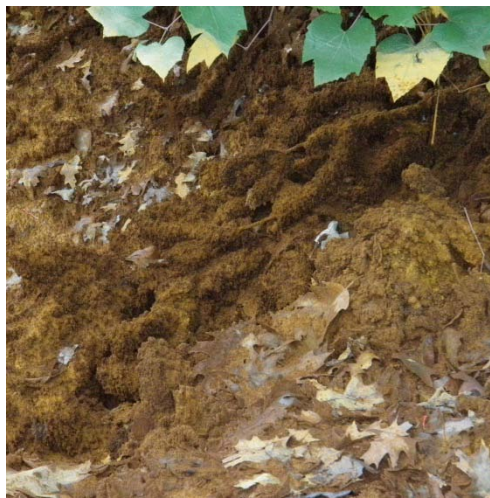
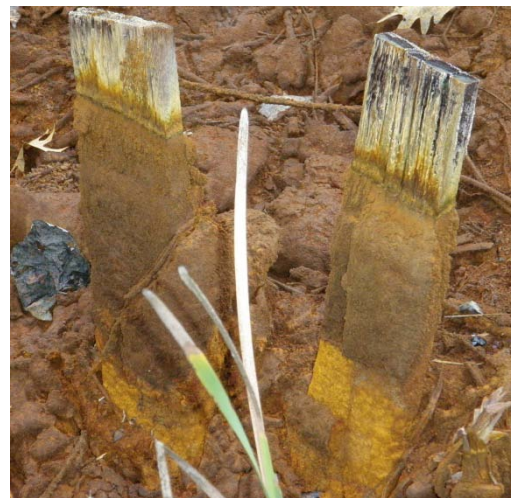
Striking images of TB1 as it was drained to remove old piping and make improvements to the lower embankment while constructing a primary spillway. Unique iron formations were exposed when the existing treatment pond was drained after flowing unabated for over 17 years. The active treatment sludge (*middle-center*) remained unchanged, covered by only inches of iron precipitates. Iron deposits on the pond embankments and exposed surfaces, which were up to 3 feet thick, were recovered for further processing and potential reuse in pigment applications.

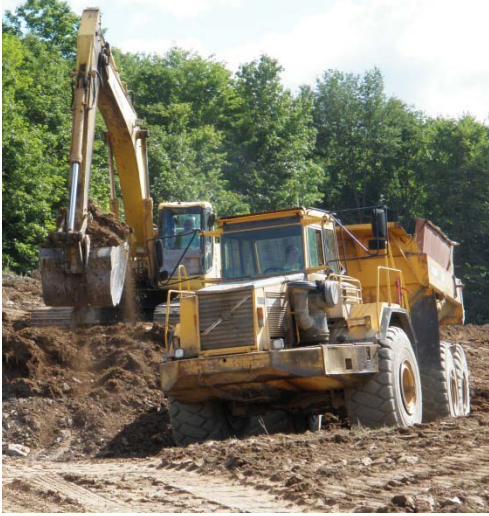
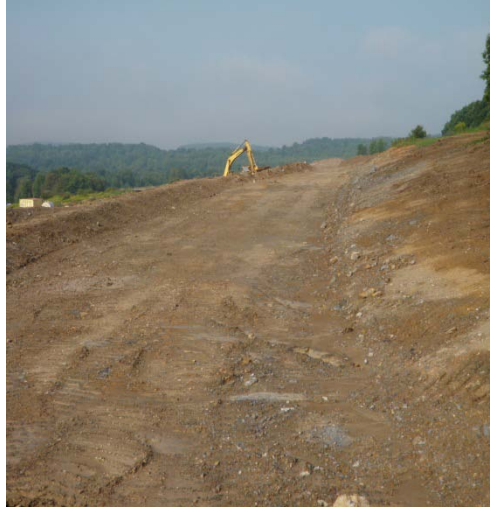
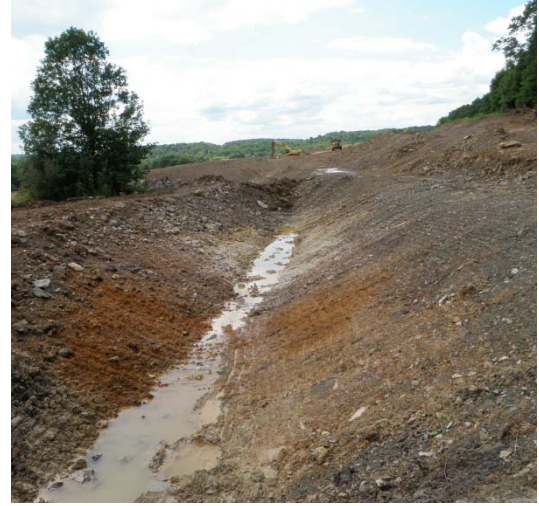
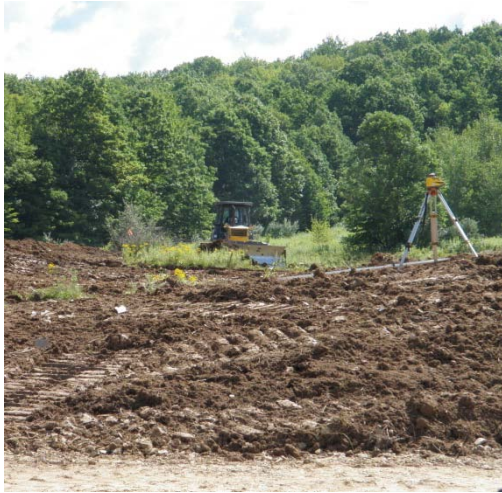
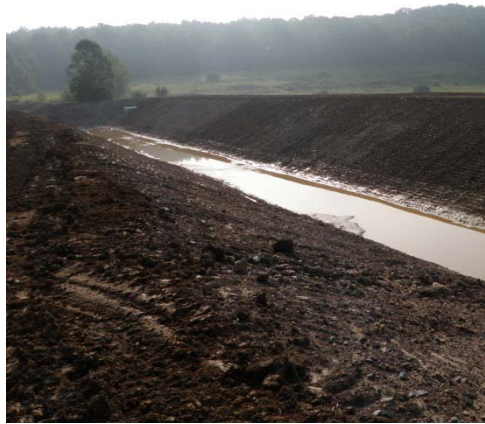
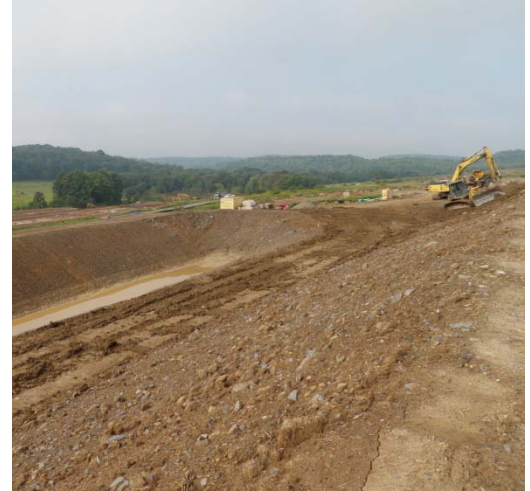
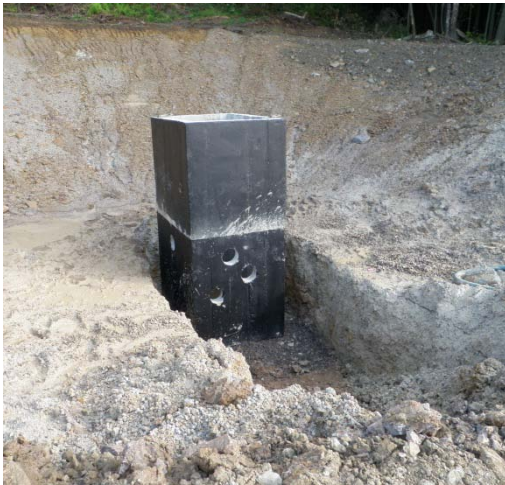
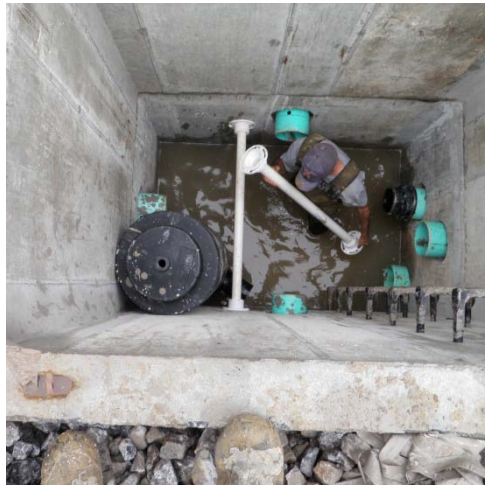
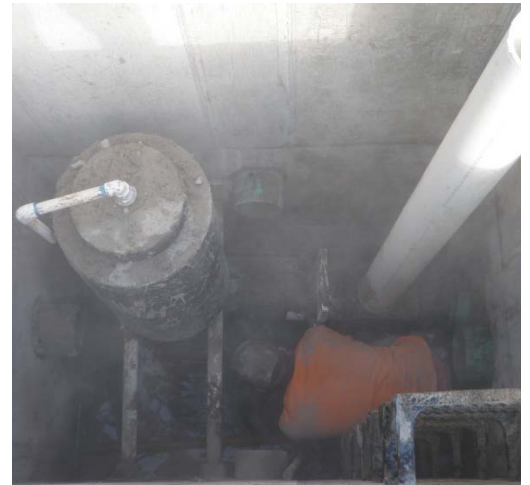
Construction photos from the treatment components north of Porter Road that were installed by Quality Aggregates Inc. employees under direction of Wayne Fuchs. The top and middle rows are scenes from the construction of the OPC, AVFVP, and Settling Pond. AFVFP siphon installation (*bottom row*) was performed by personnel from BioMost Inc., the designers of the system.

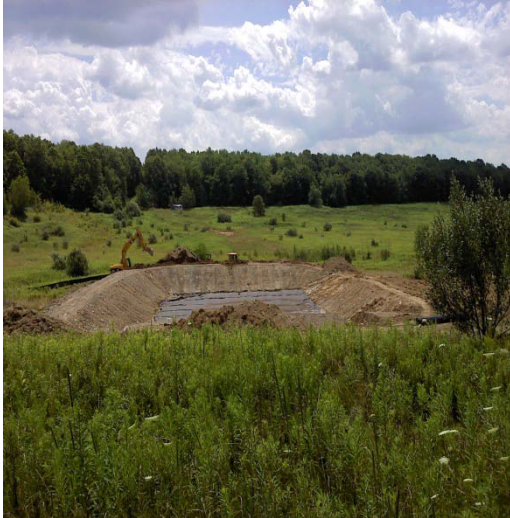
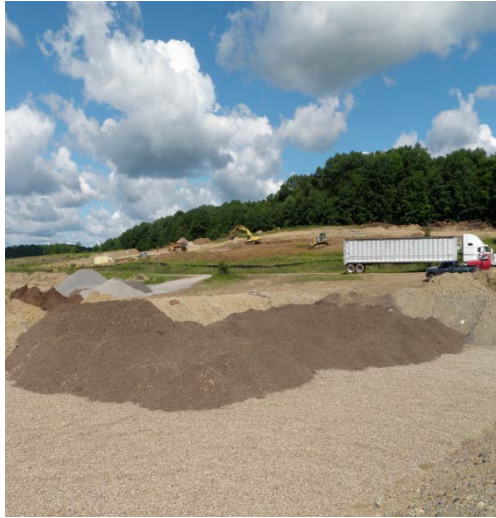
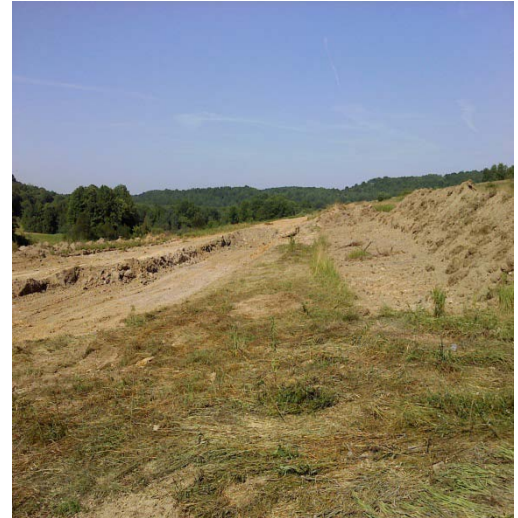
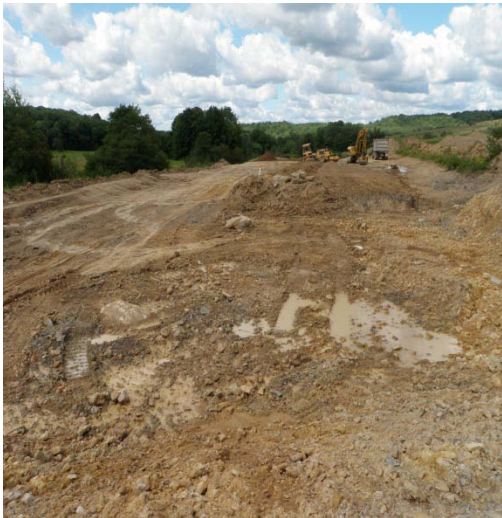
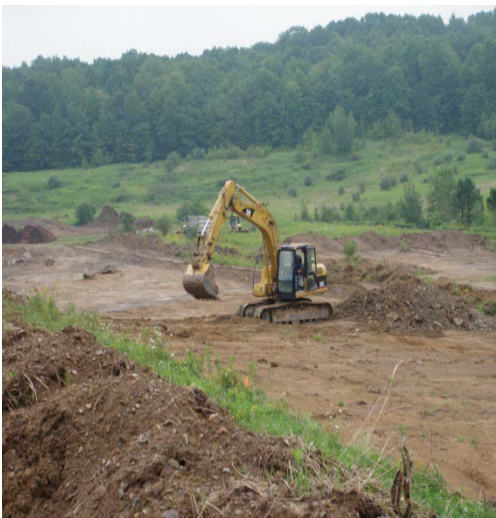
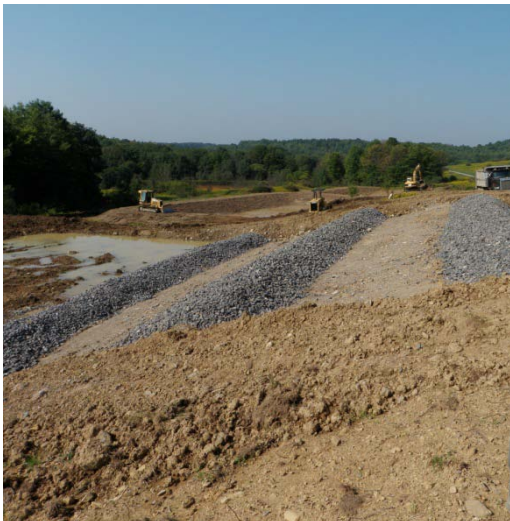
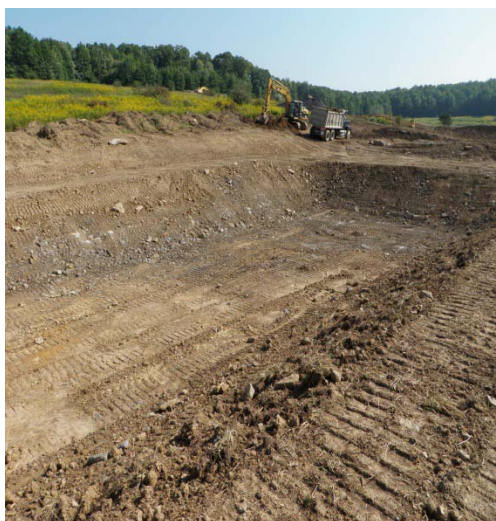
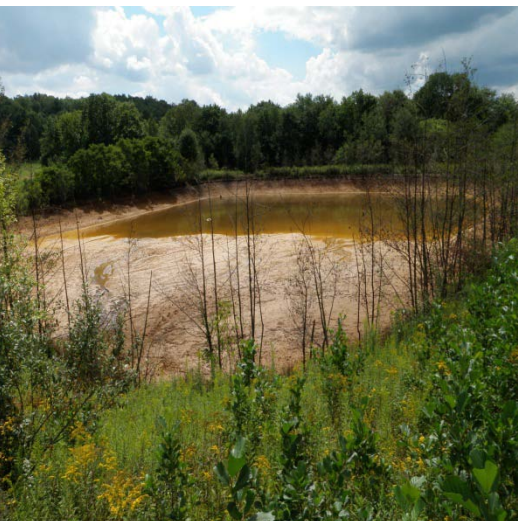
Construction photos of the treatment components south of Porter Road that were installed by employees of Quality Aggregates Inc. under direction of Joe Puryear. The top and middle rows are scenes from the construction of the JVFP and Wetland, while the bottom row shows the construction of the sloped wetlands and HFLBs. The former Sediment Basin (*bottom right*) was drained, as the outlet piping was replaced and emergency spillway was reinforced to restore hydraulic function.

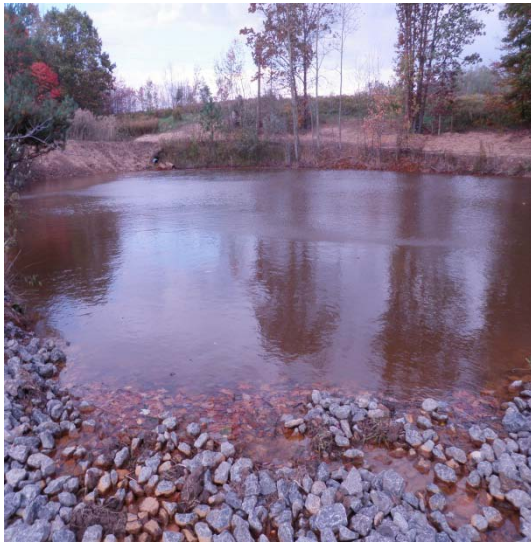
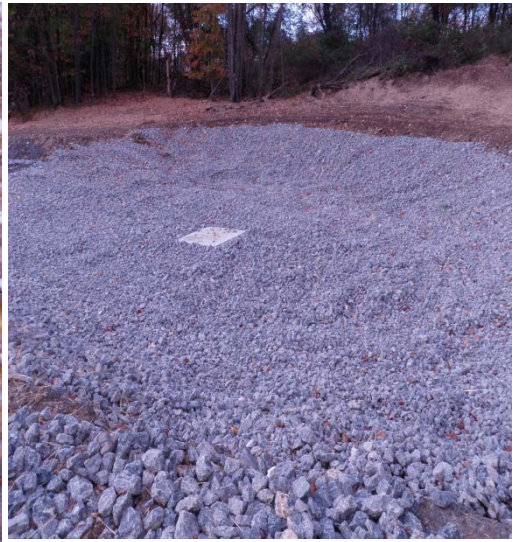
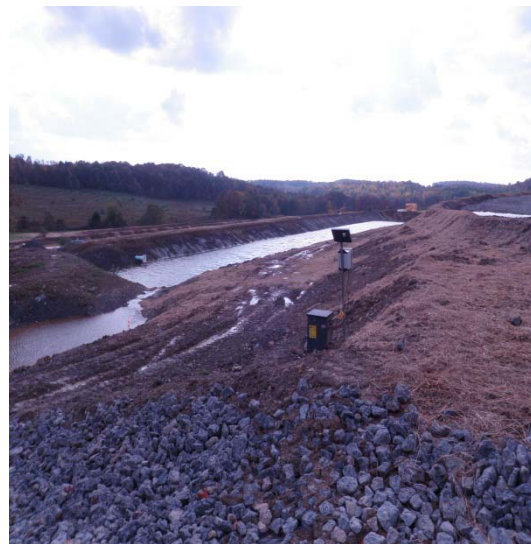
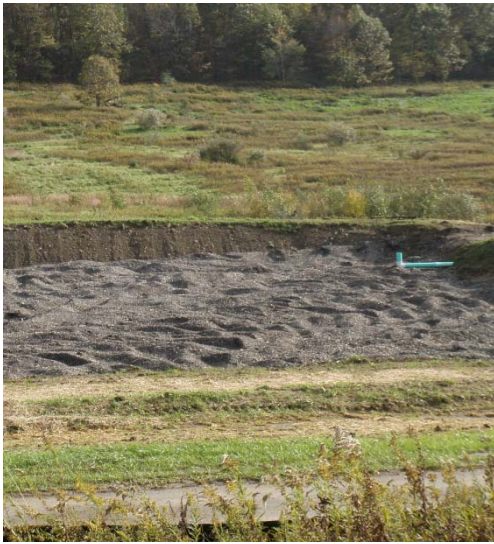
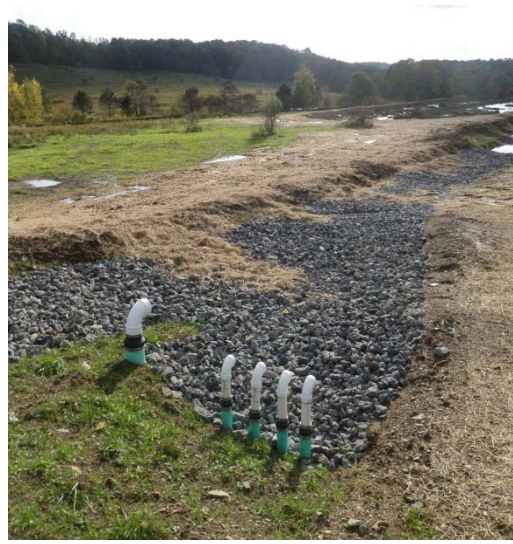
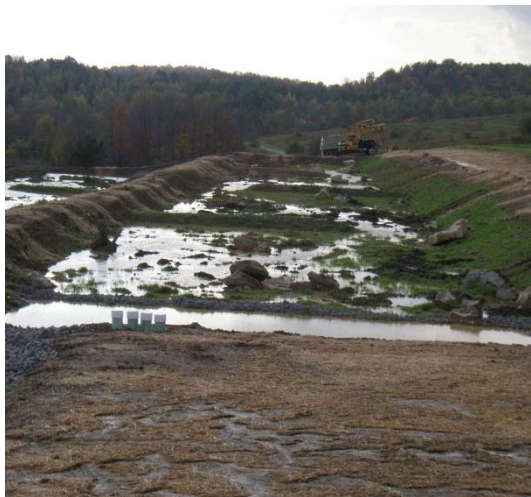
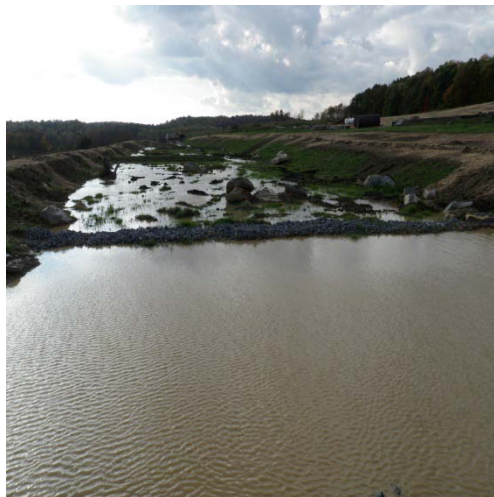
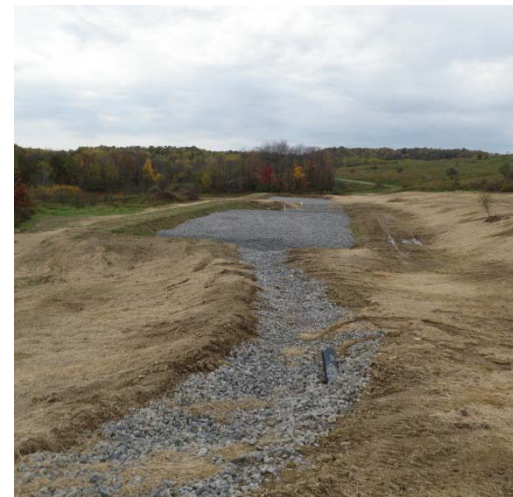
Construction photos of the McIntire Passive Treatment System as the project nears completion. As seen in the middle and bottom rows revegetation efforts are underway. The system was filling with the mine drainage from TB1 (*top left*) and iron precipitates were forming in the OPC (*top middle*). The limestone-filled Auto-Flush VFP (*top right*) with the AgriDrain "Smart Drainage System" (*middle left*) was prepared to be wired and programmed by BioMost Inc., the design company. The middle row depicts the surface of the JVFP treatment media (*center*) and the adjustable outlet pipes (*right*). The bottom row has views of the created wetlands (*left and middle*) and the HFLB (*right*).

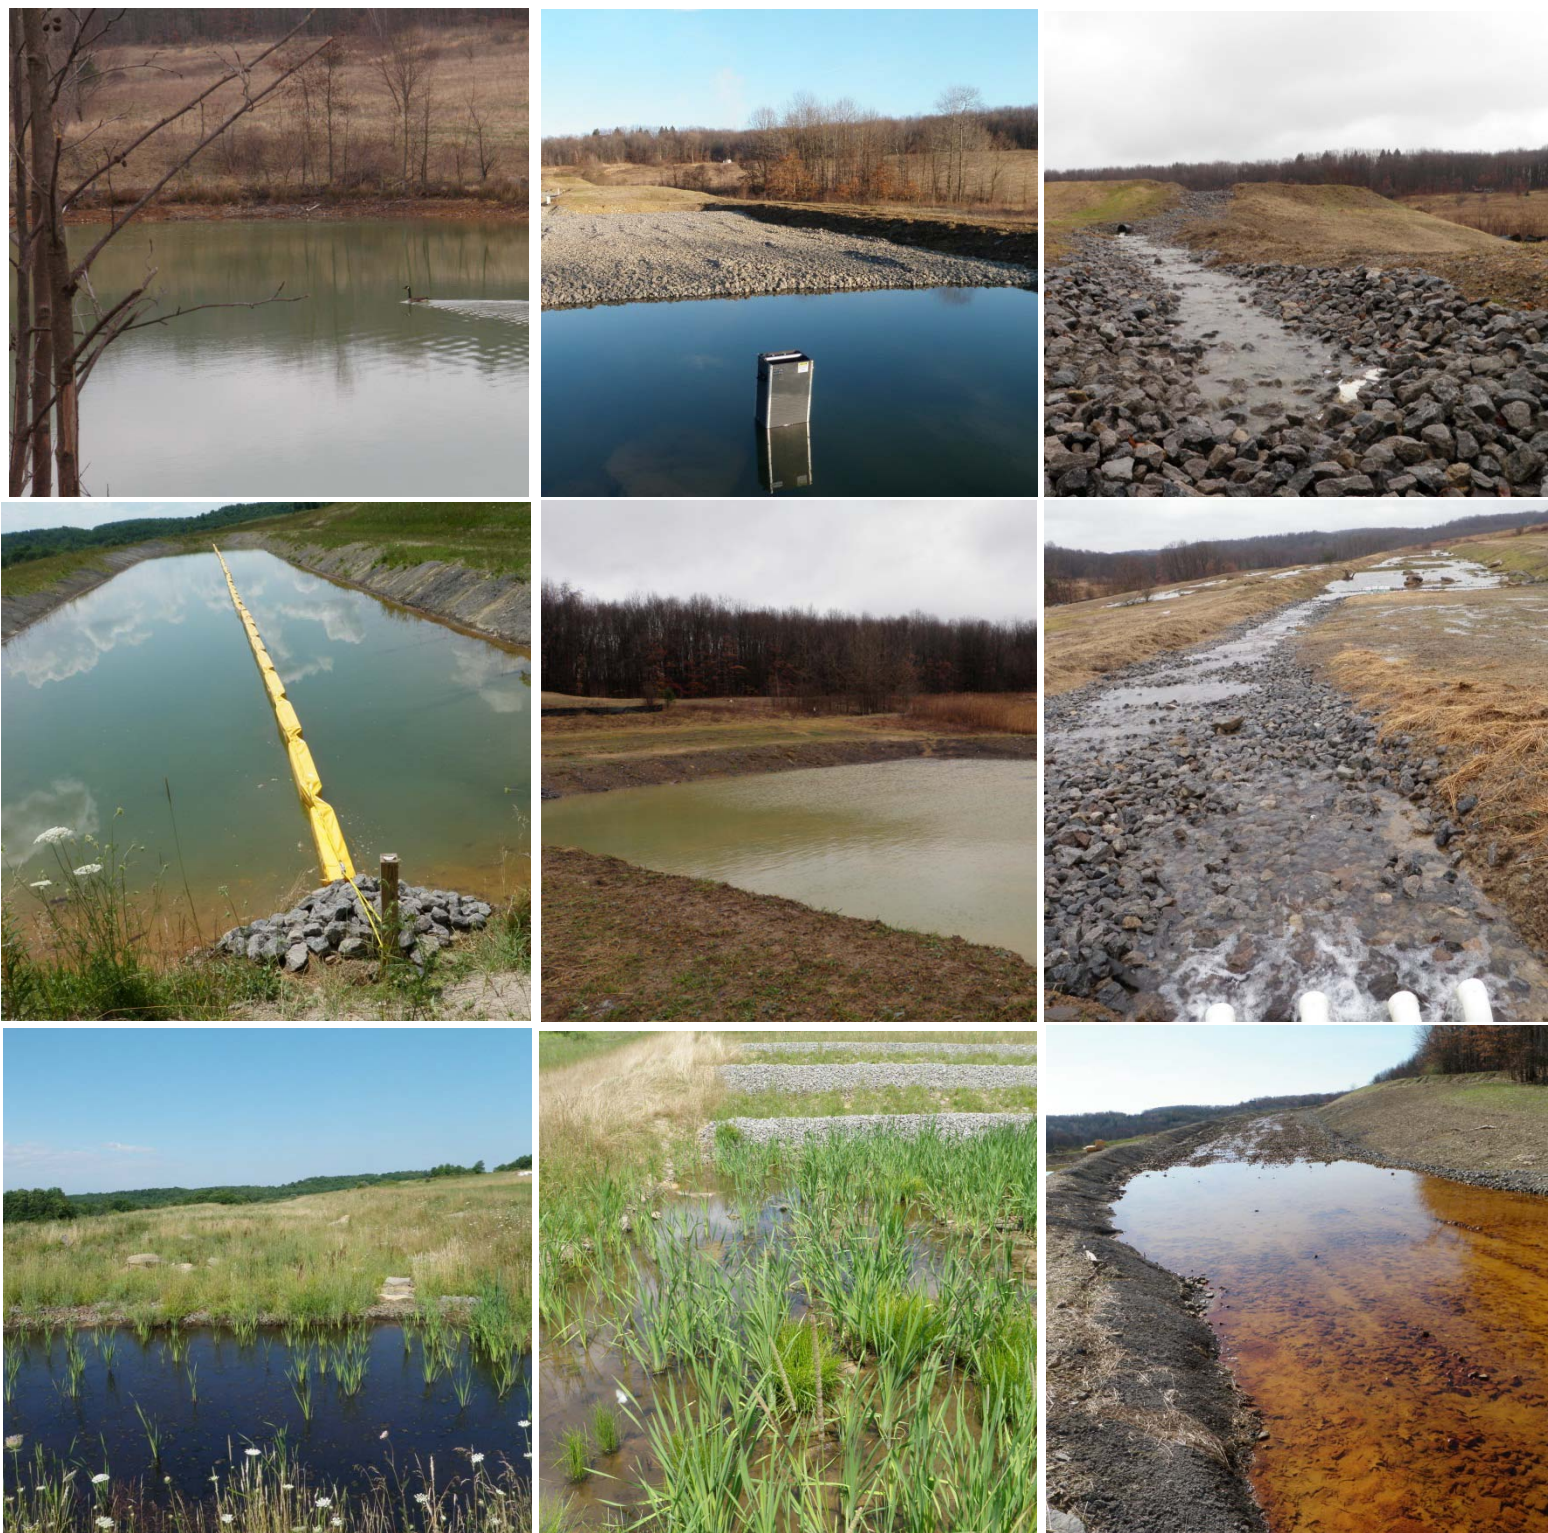
Photos of the McIntire Passive Treatment System upon completion. As seen in the top left picture, wildlife including this Canada goose have begun to utilize the improved waters of SB1 (existing sediment basin). The system has been filled with mine drainage and flow has occurred throughout the system on various monitoring occasions. HFLB2 filled with water (*top center*); Channel between the wetlands and HFLB1 conveying flow (*top right*); Baffle curtain installed in the Settling Pond (*middle left*); JVFP with water cap over the media (*middle center*); JVFP outlet risers discharging with the flow being conveyed via channel to Wetlands (*middle right*); hydrophytic plant species emerging from the wetlands (*bottom left & center*); OPC illustrating iron removal (*bottom right*).

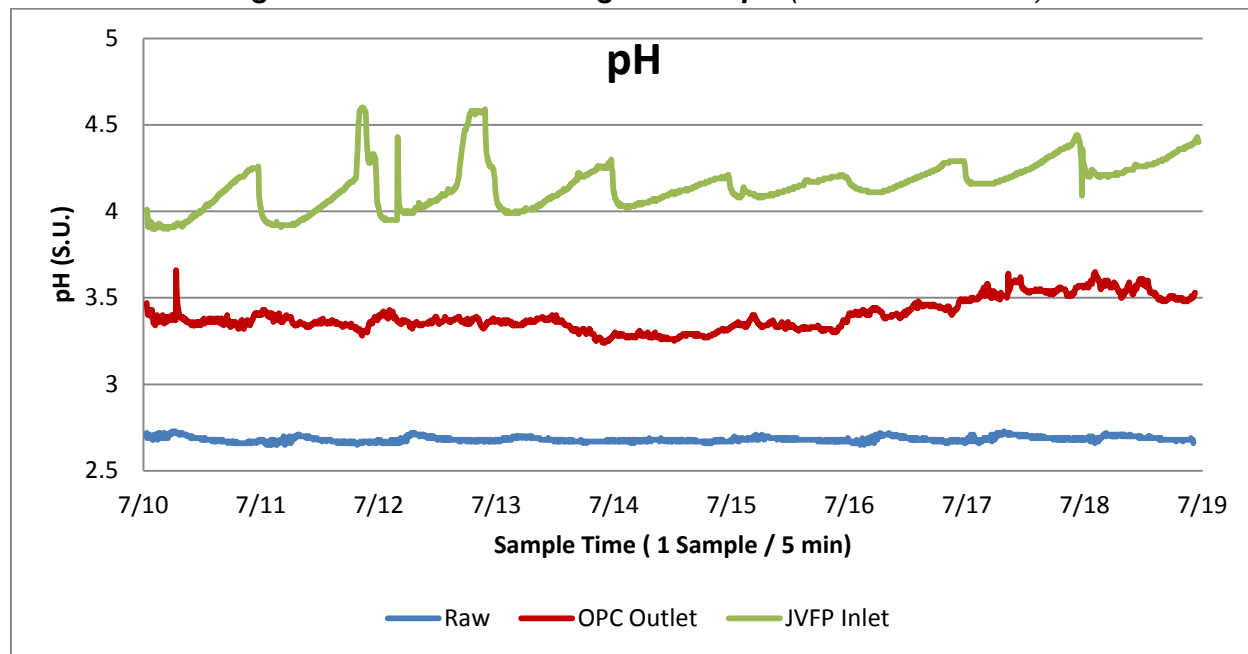
Figure 1: Sonde Monitoring Data for pH (7/10/12 to 7/19/12)

The following figures depict the results of selected sonde locations during the first deployment. The data for the second monitoring event was not available at the time of report preparation. Note the trends of the data are represented by individual graphs for each parameter and color coded for each location.
