# North Liberty Reclamation Area Phase I and II

**Final Report  
March 2004**

# **NORTH LIBERTY RECLAMATION AREA PHASES I AND II**

## **FINAL REPORT**

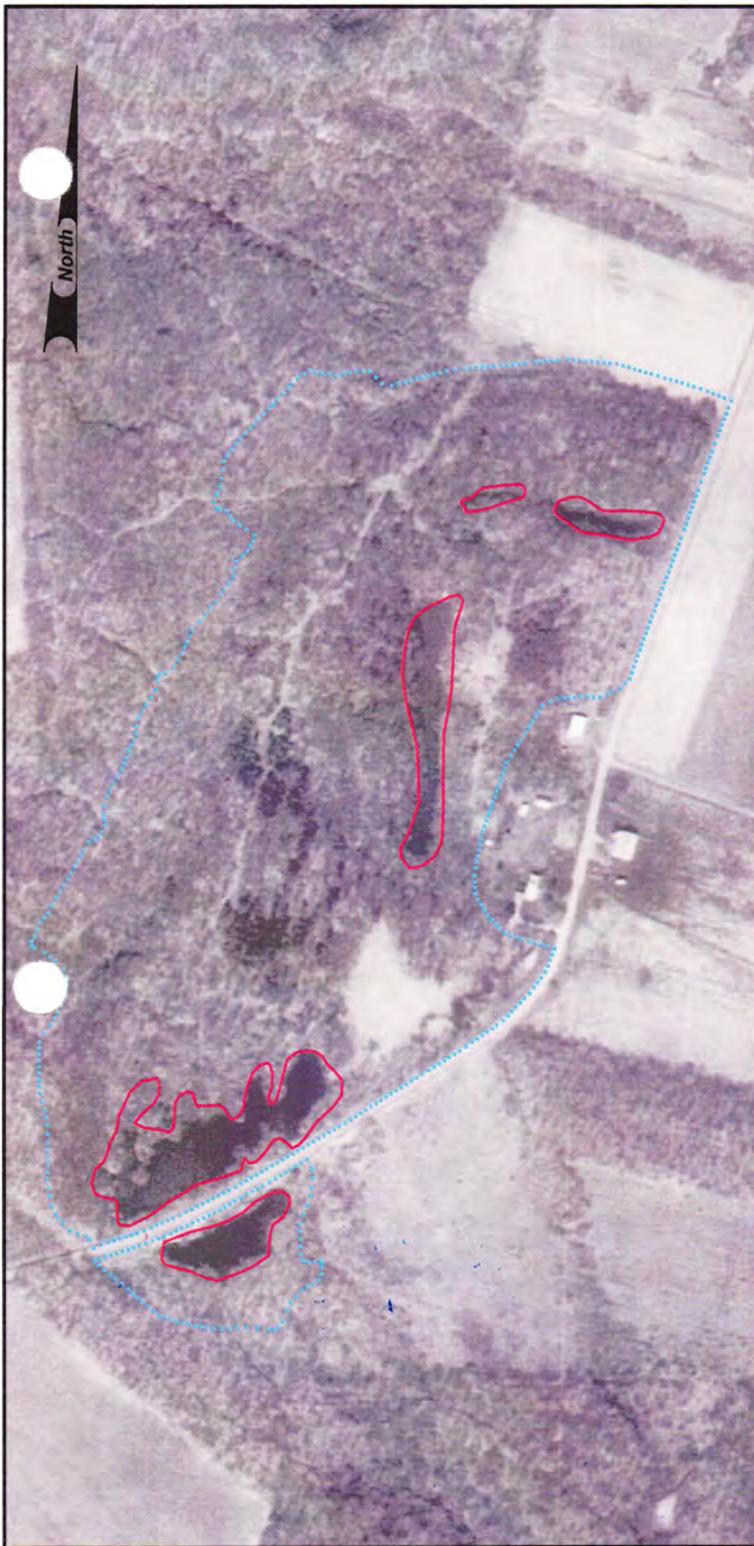
# BEFORE

USGS Digital Orthophoto Quarter Quadrangle (DOQQ)  
Slippery Rock NW, PA

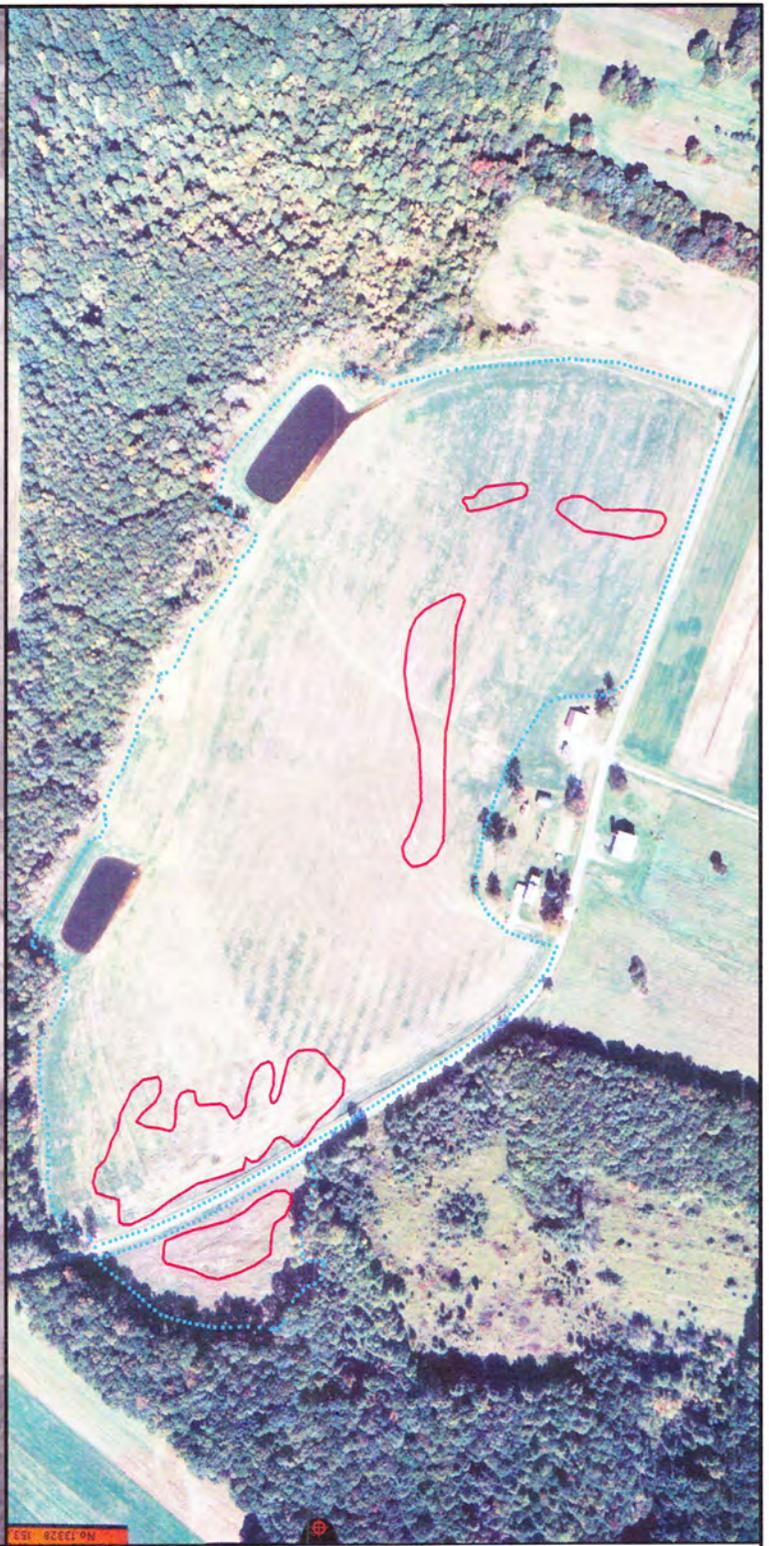
# AFTER

Aerial Photograph Taken on October 6, 2002

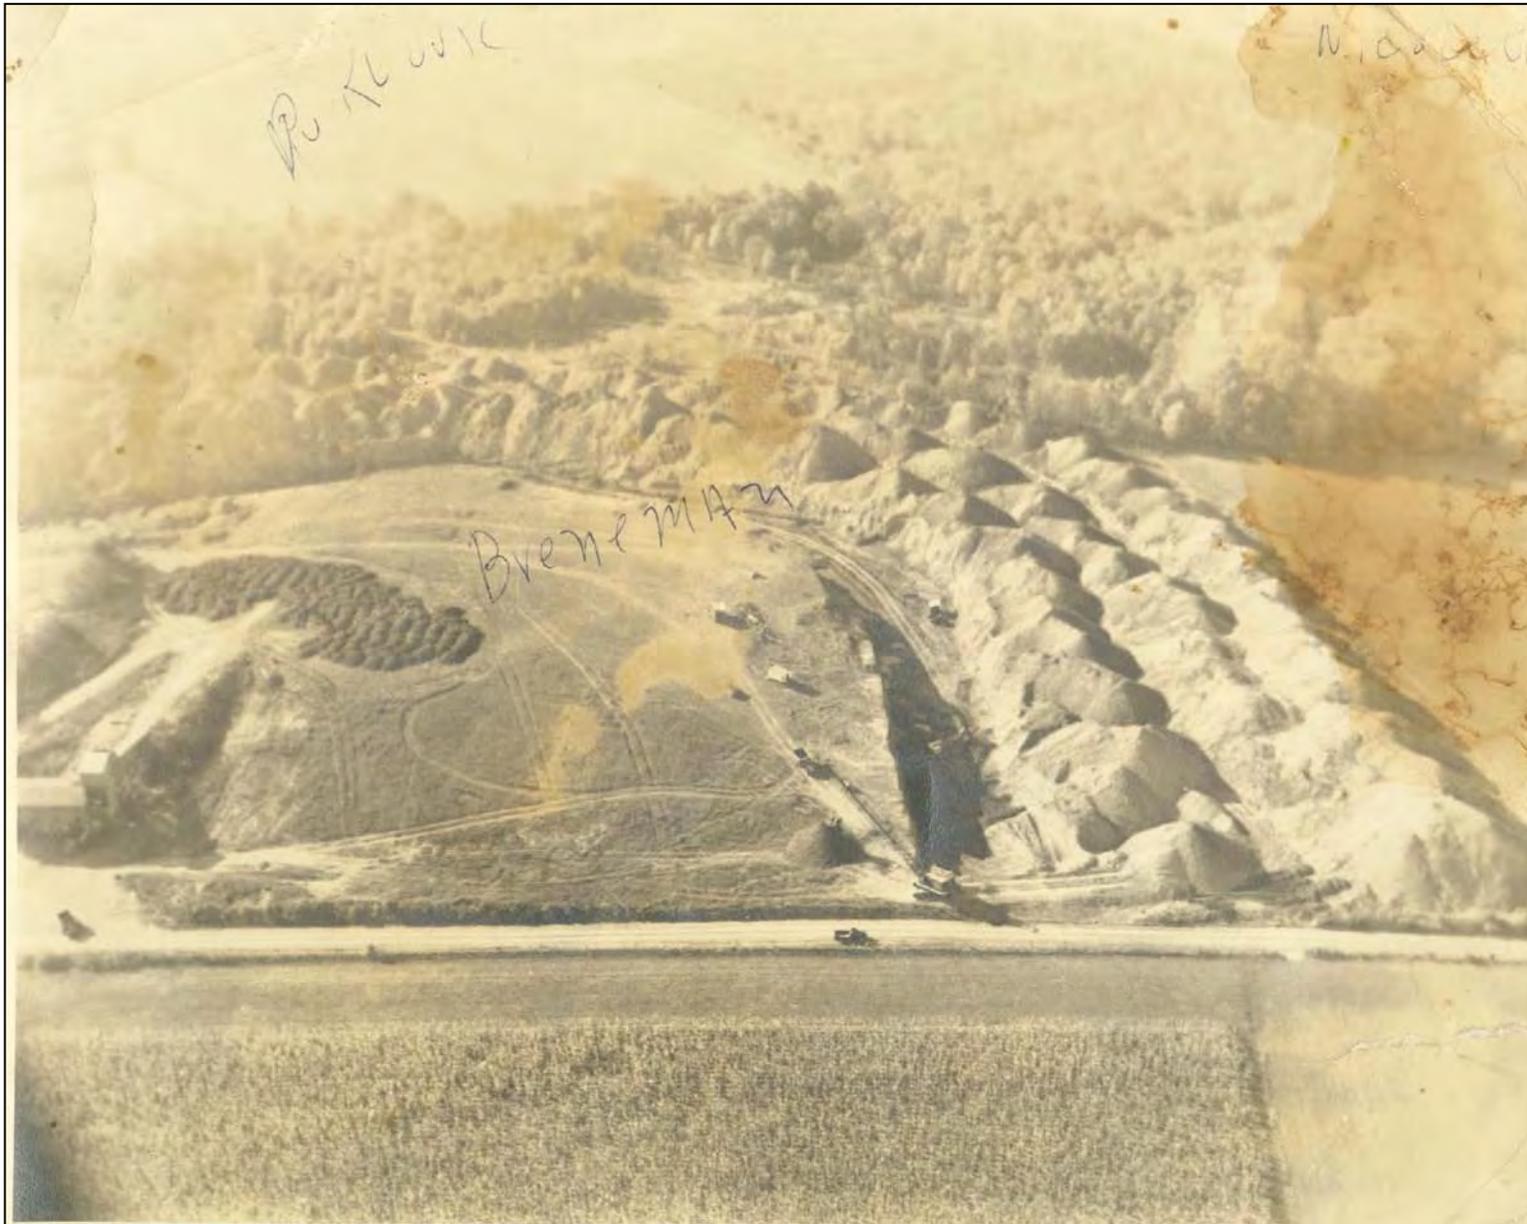
“Aerial” photograph of the original mining (Circa 1940’s). The dragline (near the center), working pit and surrounding spoil piles can be seen. The site was left unreclaimed except for planting trees on the spoil.

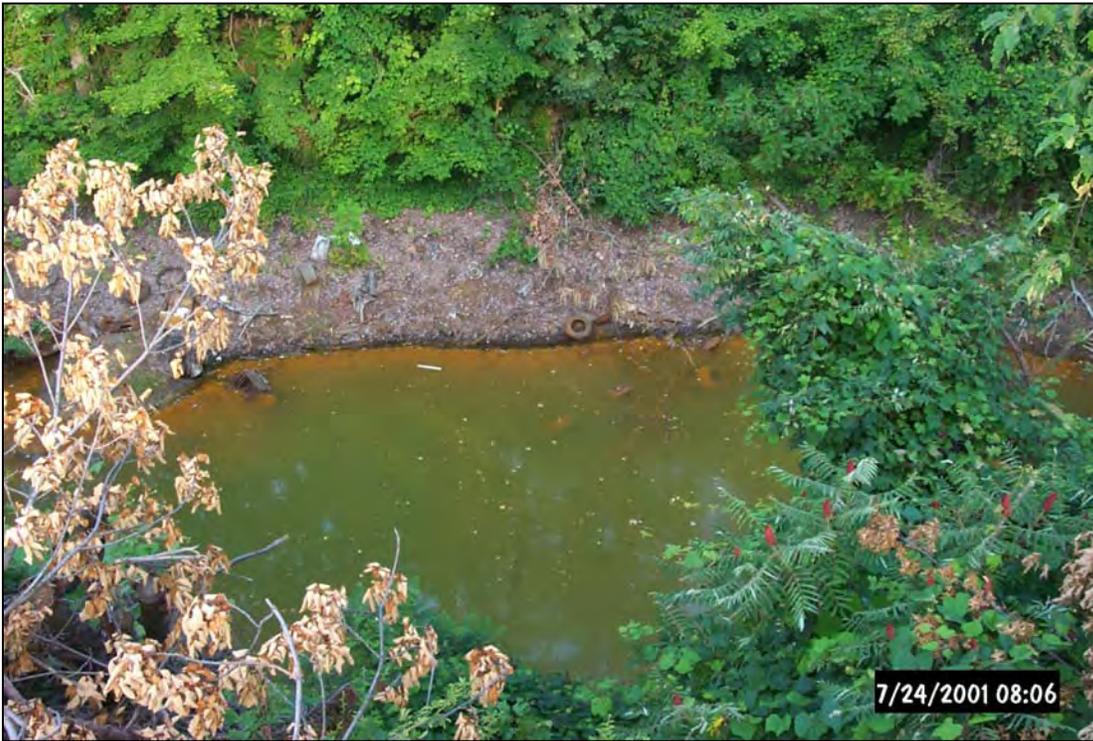
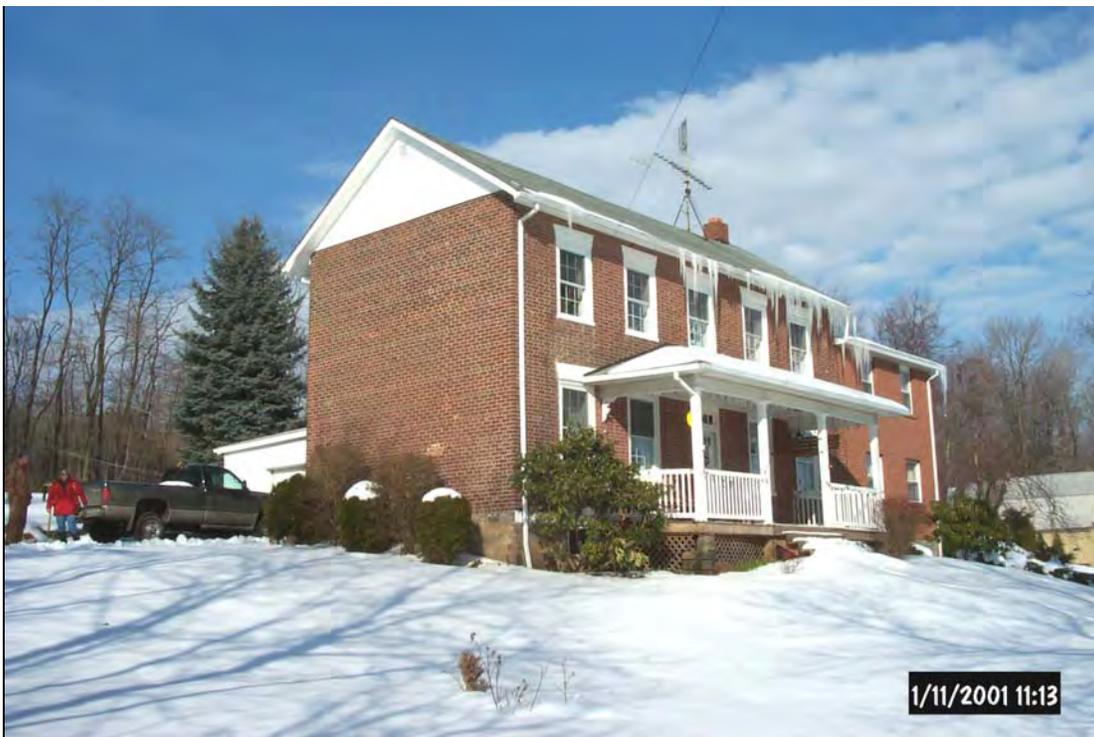
Water-filled abandoned surface mine pits with dangerous highwalls (some as high as 60 ft.) such as this one (**Top**) were scattered throughout the Beatty property and in close proximity (one less than 250 feet away) to their historic farmhouse (**Bottom**) located on Courtney Mills Road, Liberty Township, Mercer County, Pennsylvania.

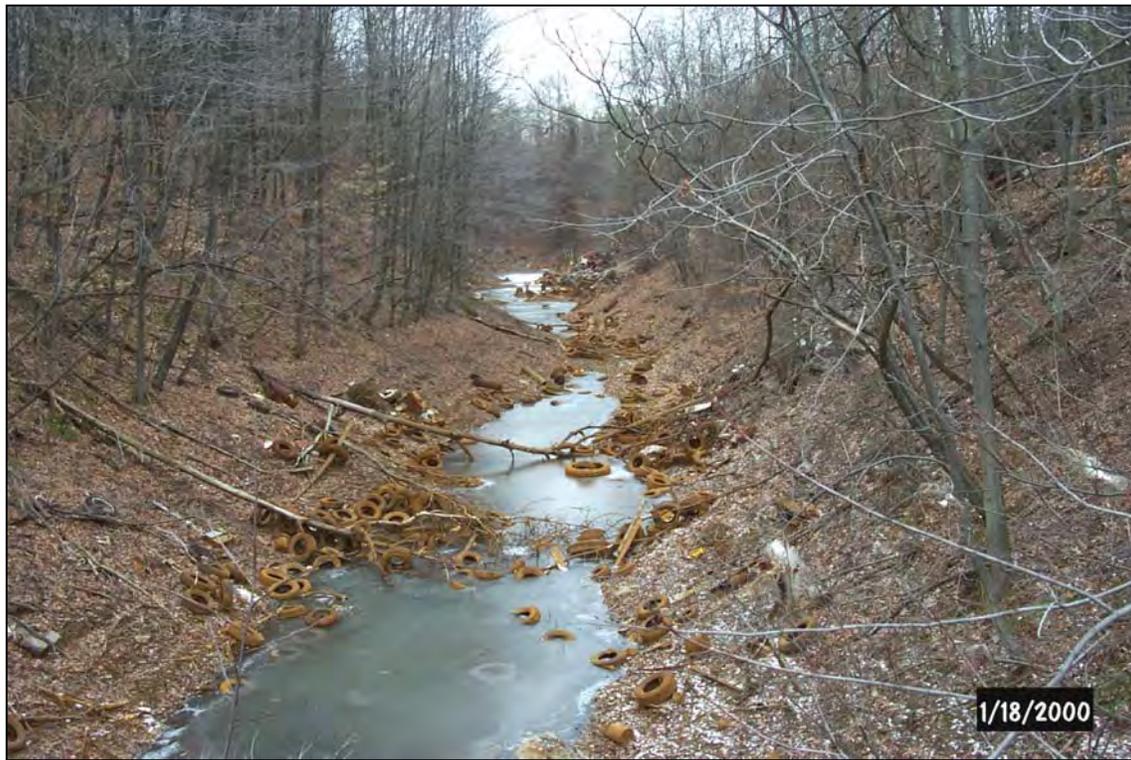
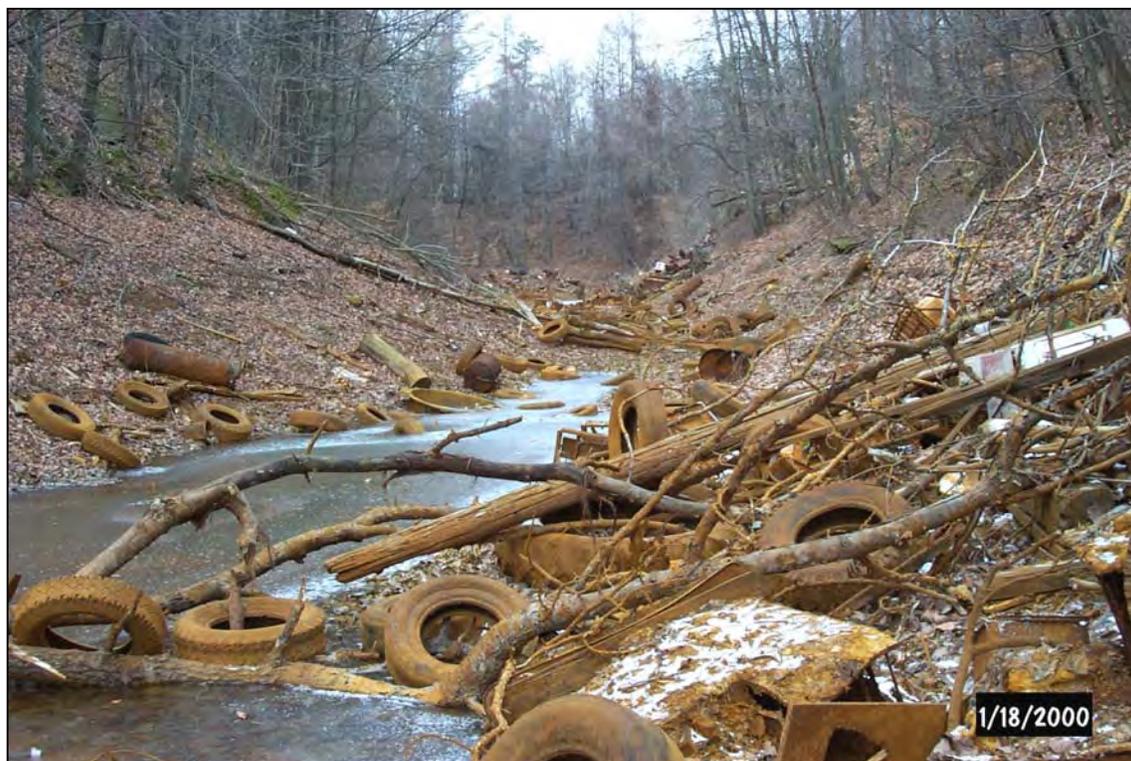
An abandoned, water filled, surface mining pit on the Beatty property that had been utilized as an illegal dumping grounds for decades prior to reclamation. Note the iron staining of the garbage, which indicates that the mine drainage water level can significantly fluctuate within the pit.

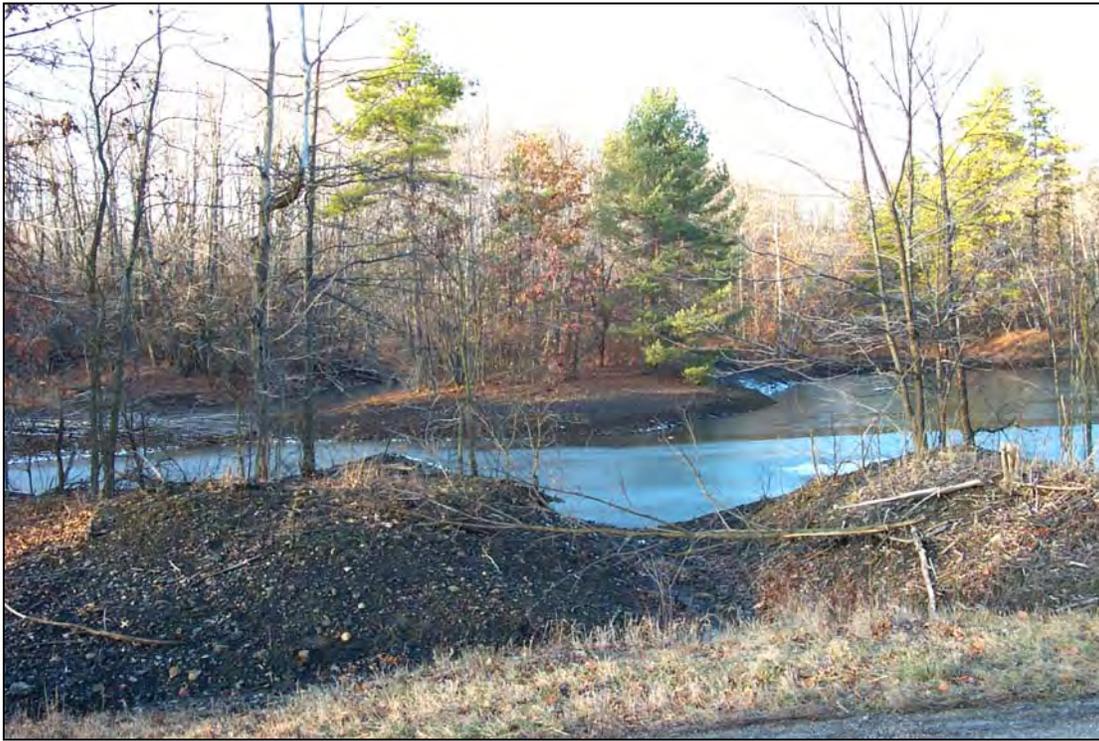
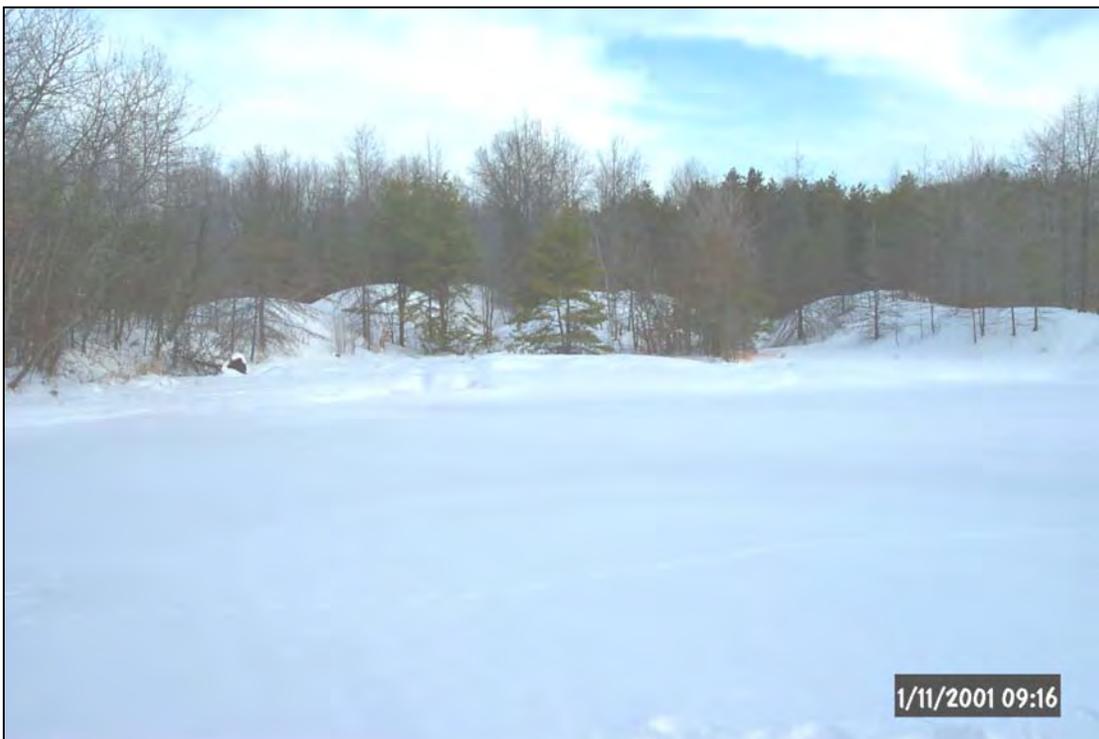
Large open pits were located dangerously close on each side of Courtney Mills Road, a frequently traveled public road. The pit on the north side of the road (**Top**) was reclaimed during Phase I and was estimated to contain approximately 10,000,000 gallons of degraded water while the pit on the south side of the road (**Bottom**) was reclaimed during Phase II and was estimated to contain approximately 1,000,000 gallons of degraded water.

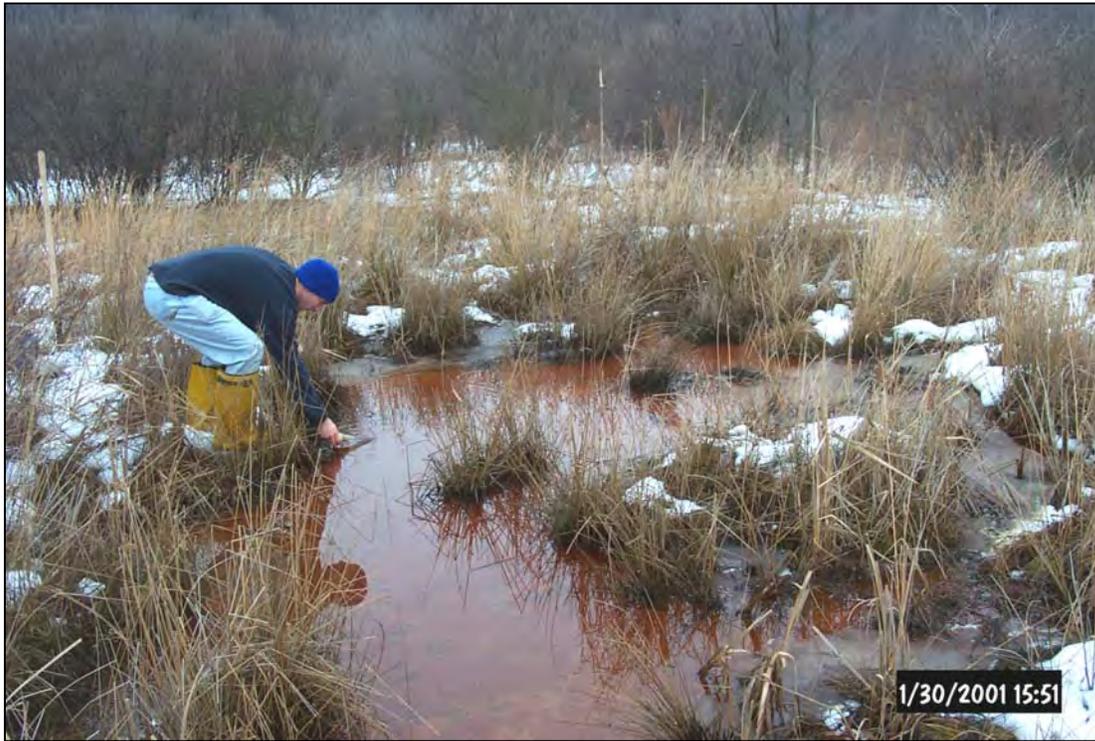
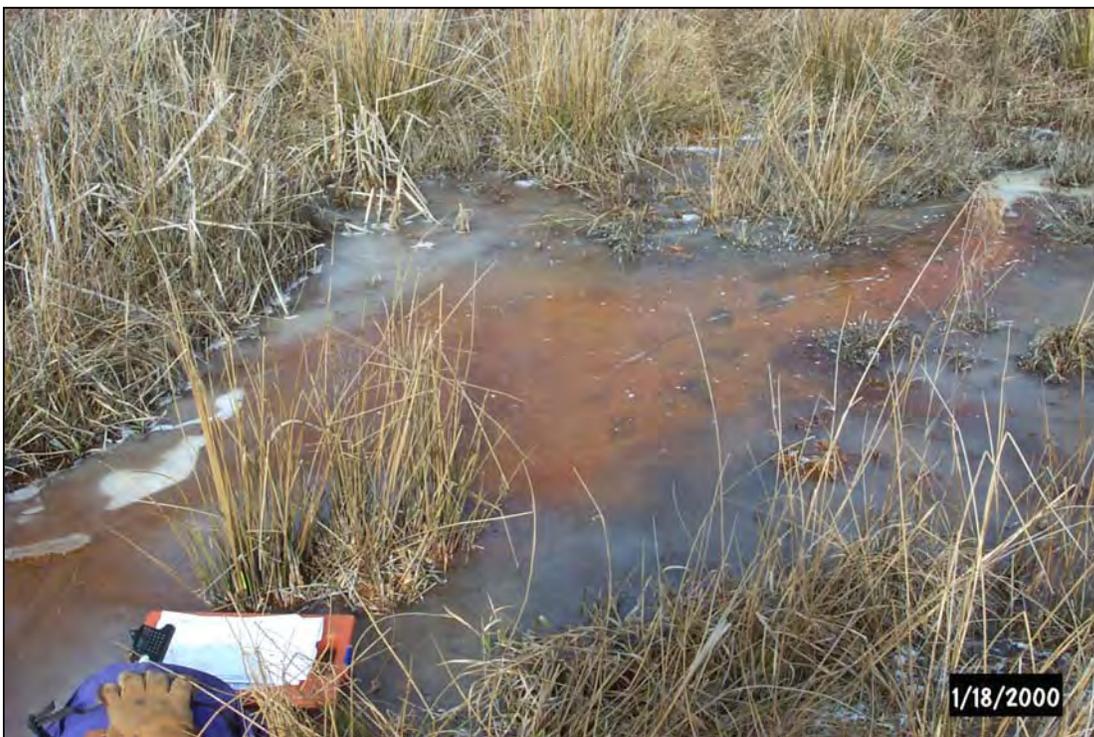
Polluted seeps located throughout the property indicated an impact to the local groundwater. Some seeps were located over 1200 feet from the nearest pit such as Point #4 (**Below**) which contained 37 mg/L of iron. Note the iron staining in both photos.

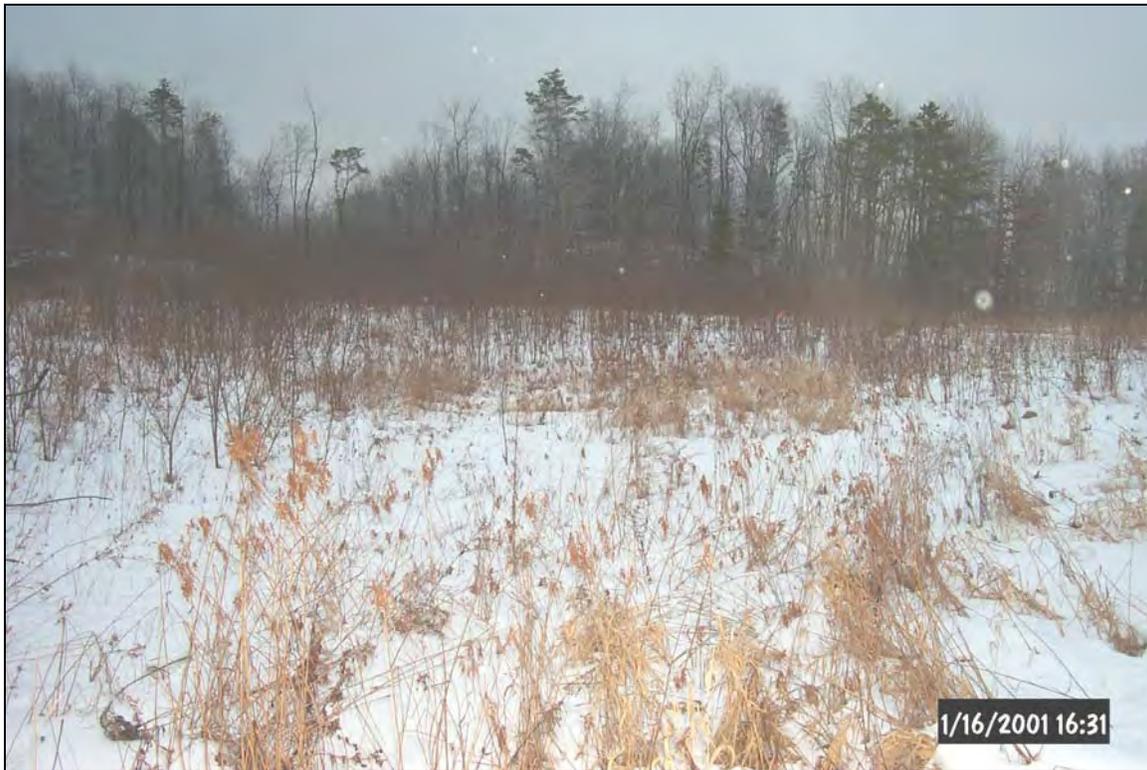
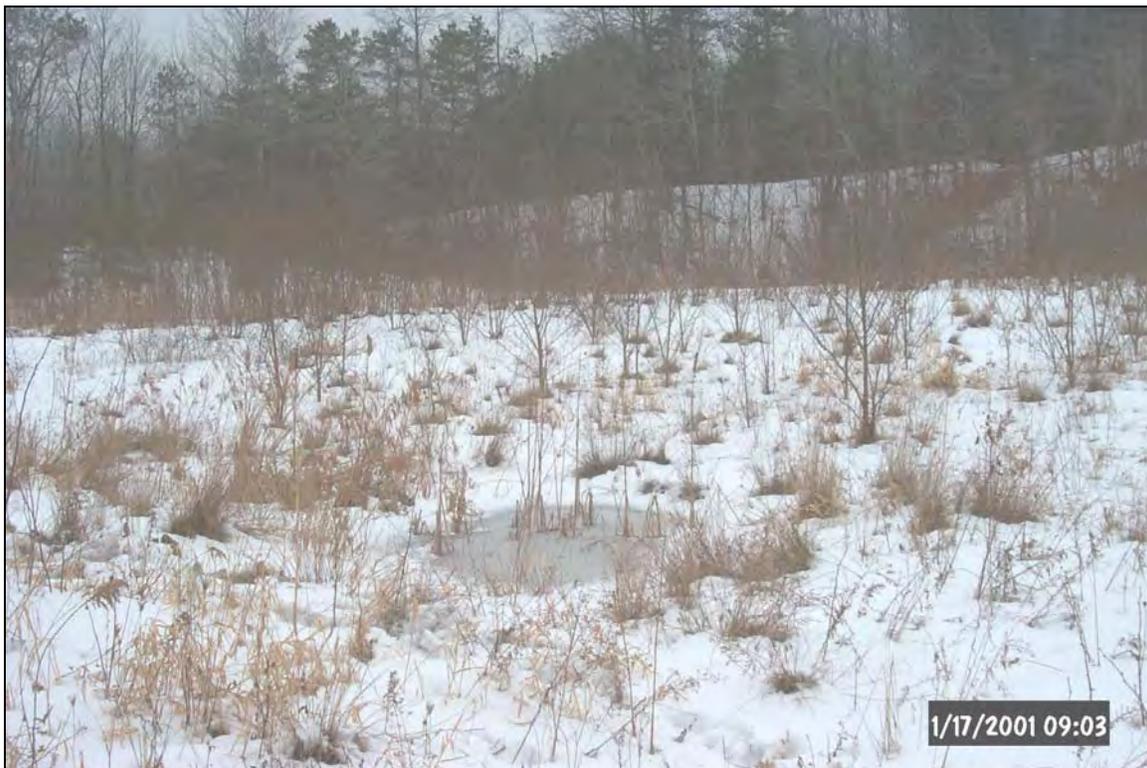
Wetland located where an abandoned open, water-filled pit was backfilled by the Perry Brothers Coal Company in 1992 as part of a reclamation project.

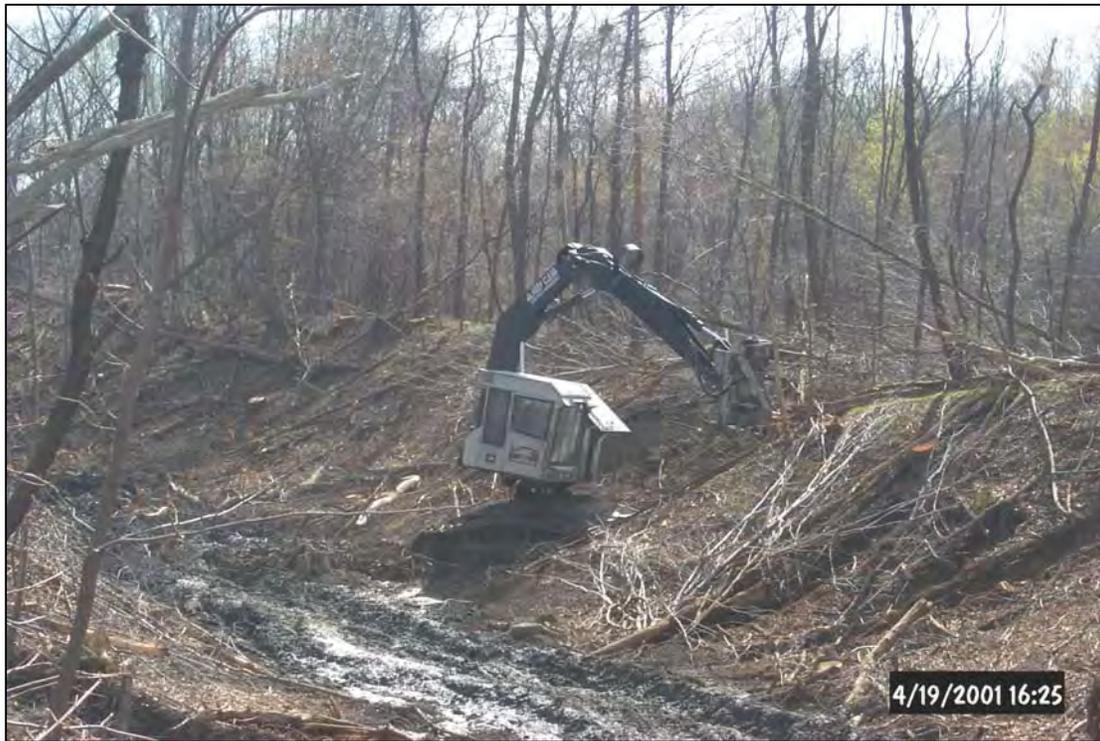
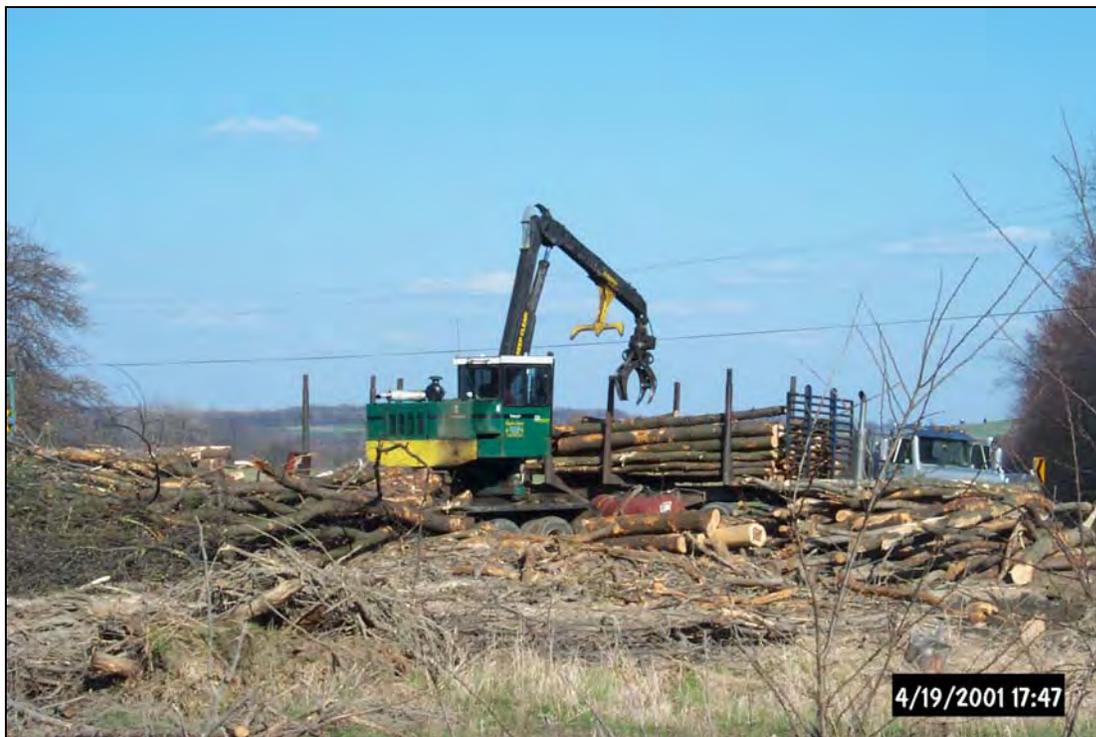
**Top:** Before reclamation, the site was cleared and grubbed.

**Bottom:** Many of the trees were harvested for use.

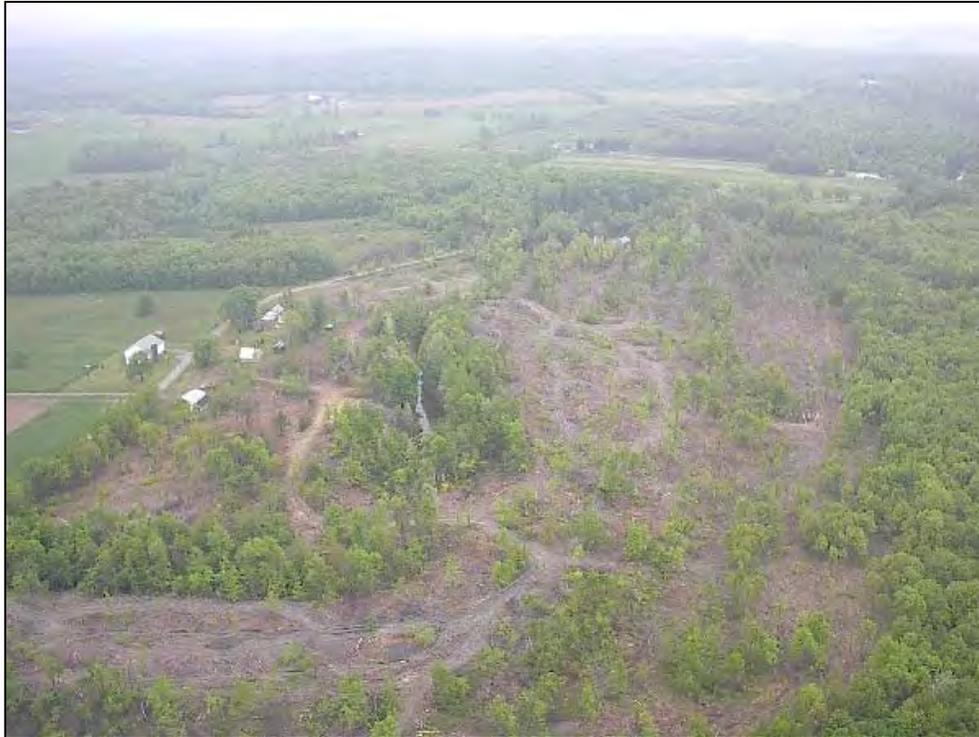
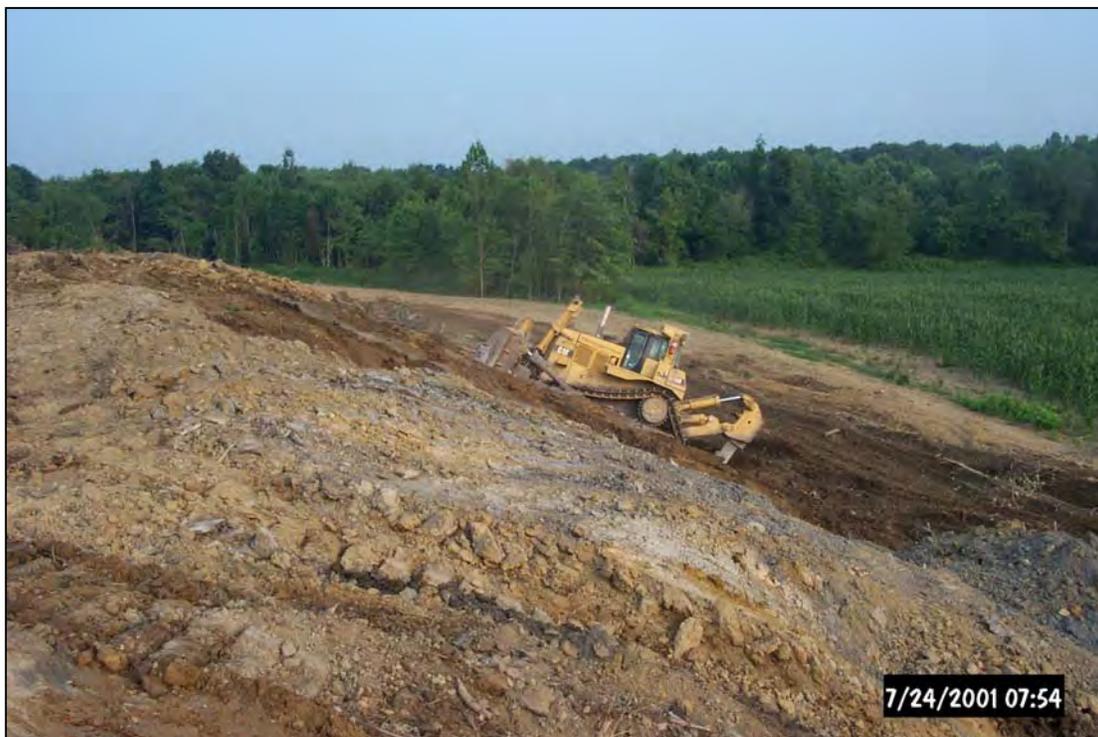
**Top:** “Aerial” photo of the site during the clearing and grubbing operation provided by the former PA DEP Secretary Dave Hess during a helicopter tour of mining reclamation sites.

**Bottom:** Amerikohl Mining Inc. conducted the land reclamation activities at the site.

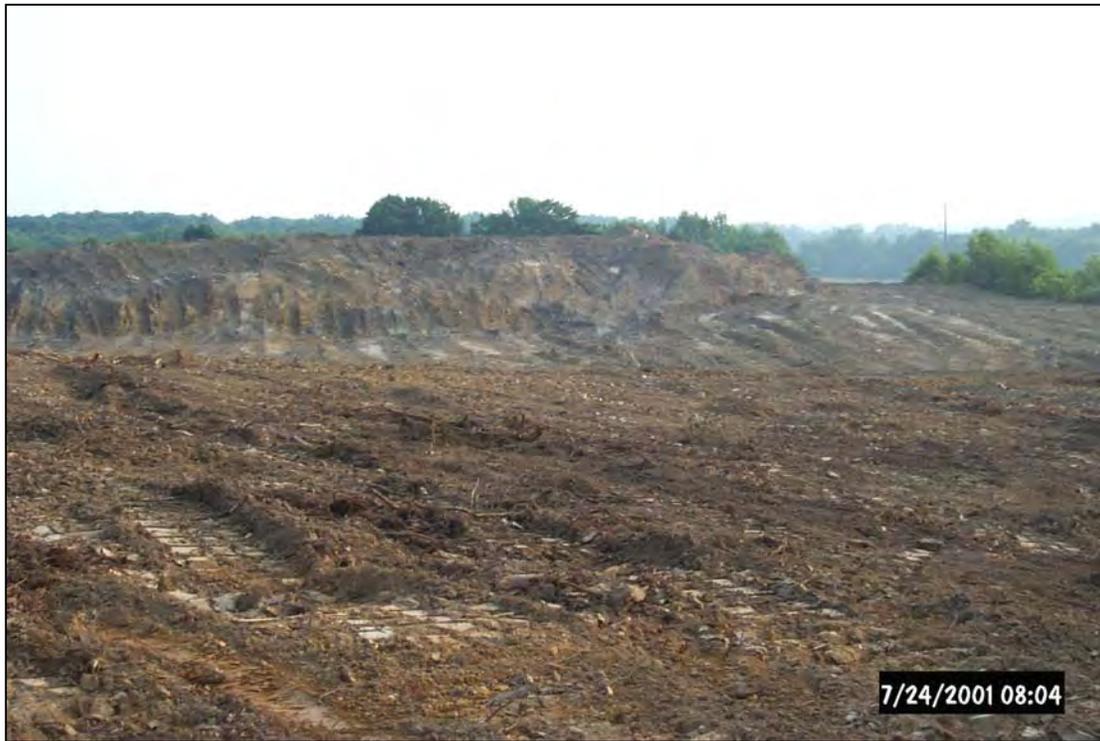
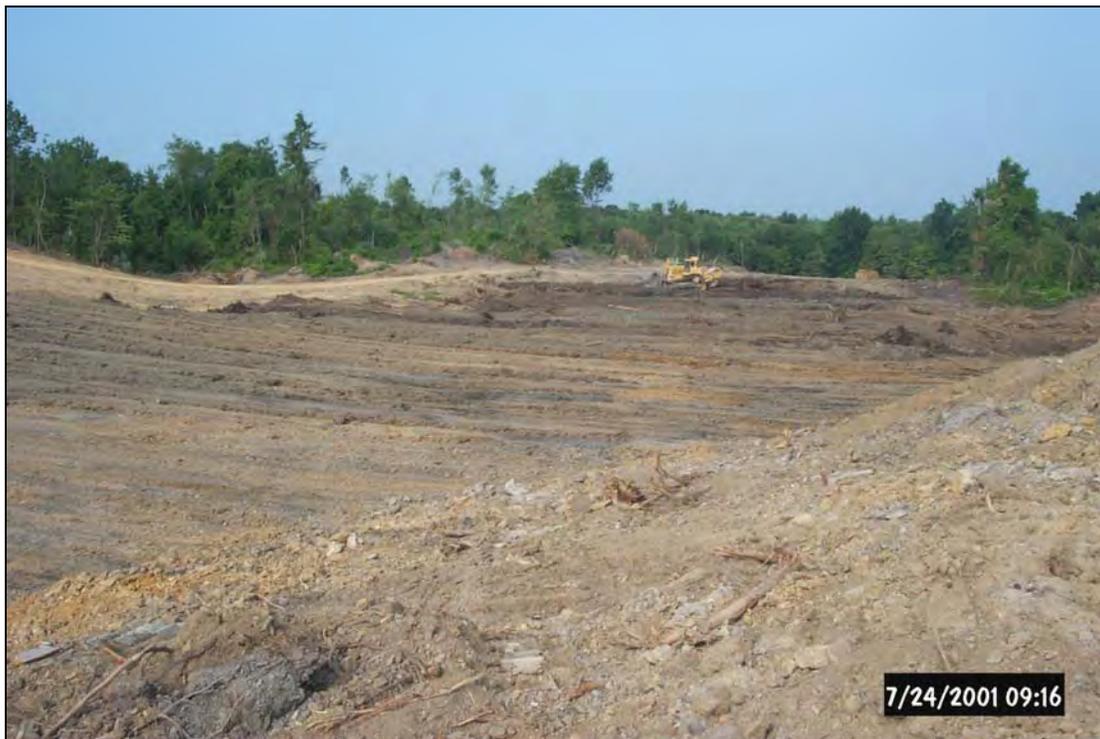
Land reclamation operation in progress.

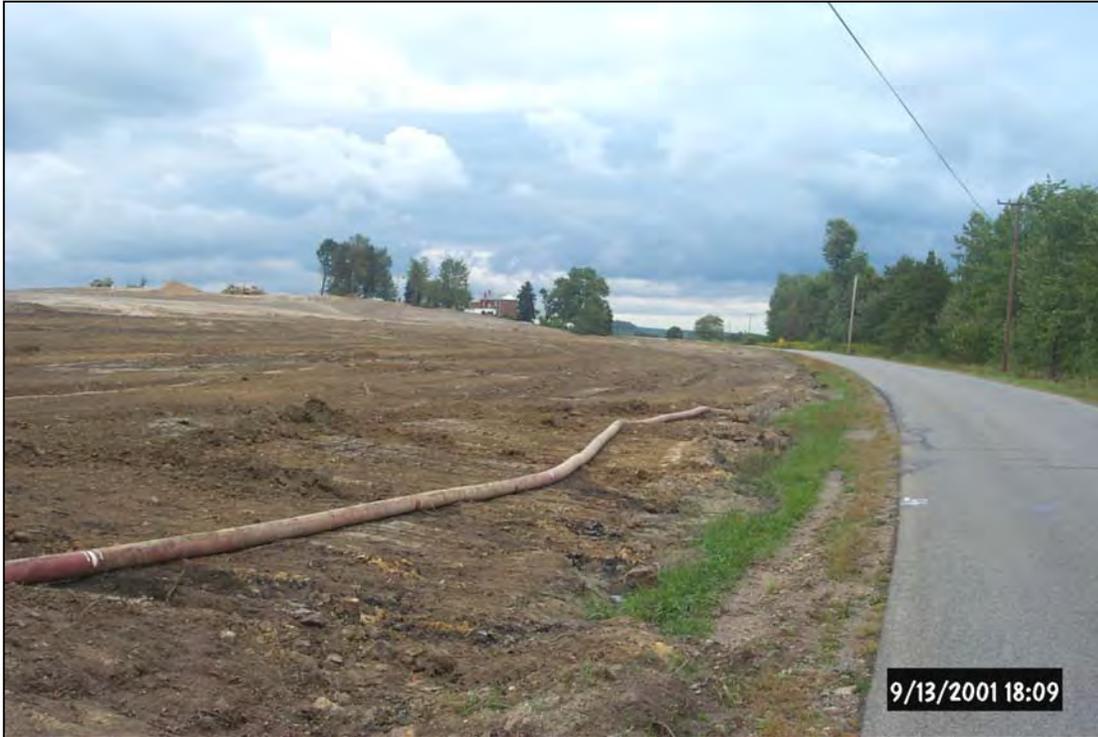
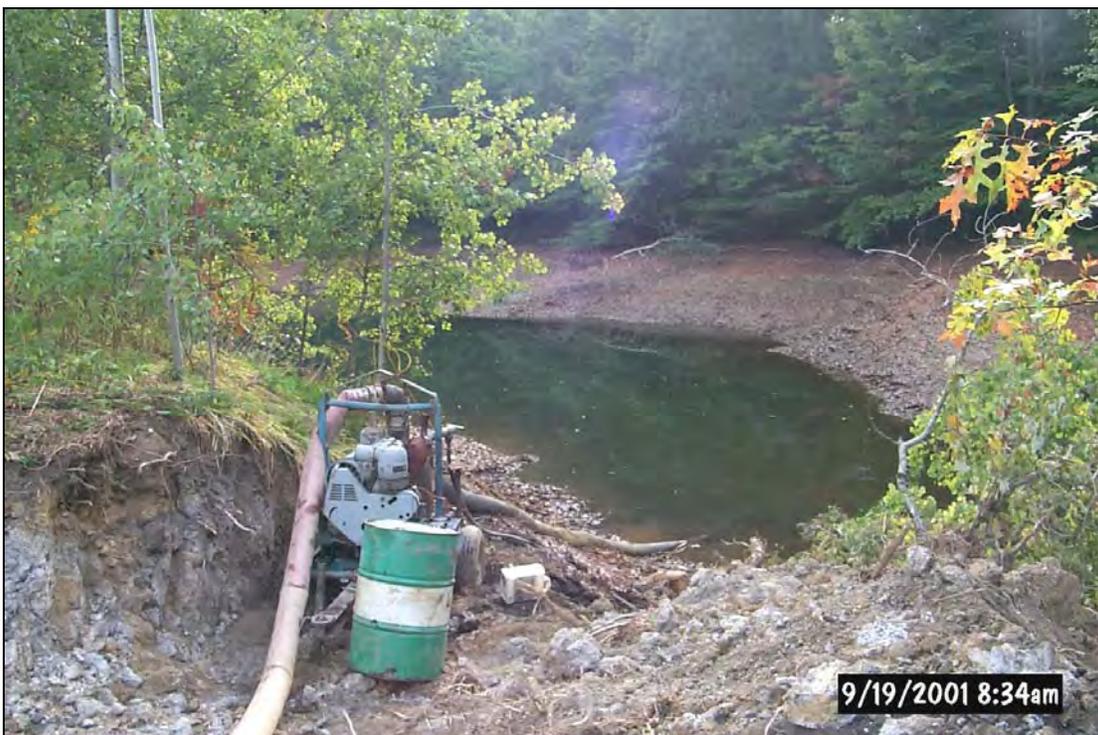
As part of the reclamation process, the acidic, abandoned mine drainage in the open pits was pumped to treatment ponds and chemically treated before discharging to an unnamed tributary to Wolf Creek.

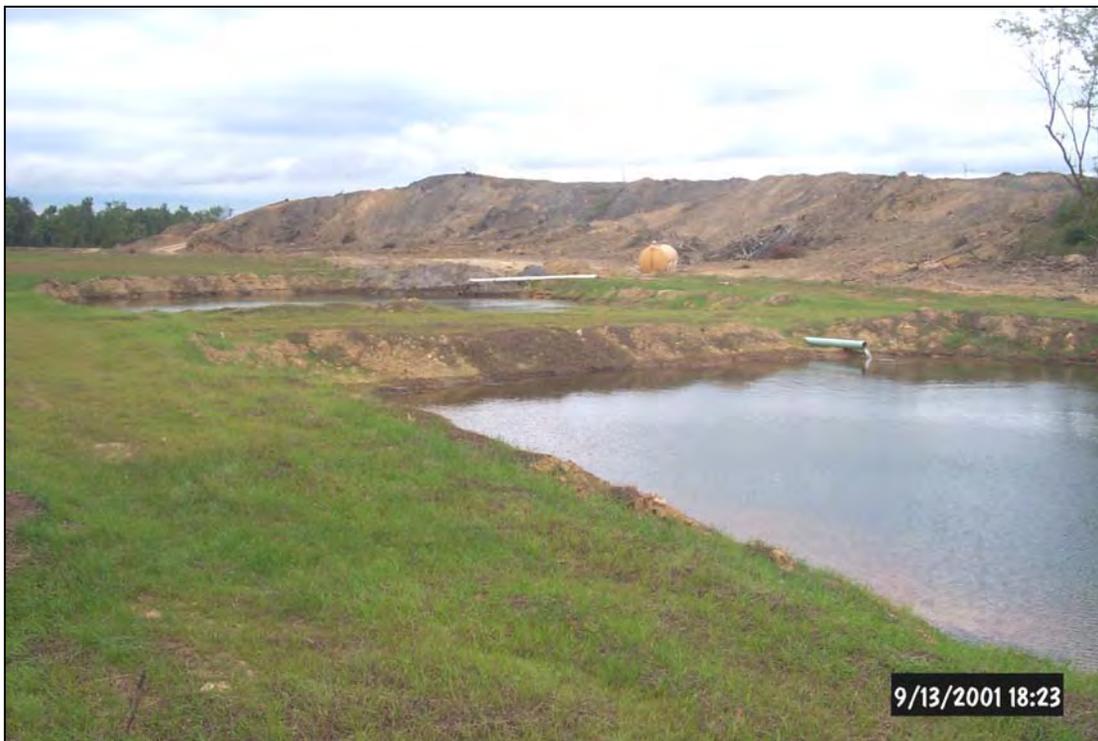
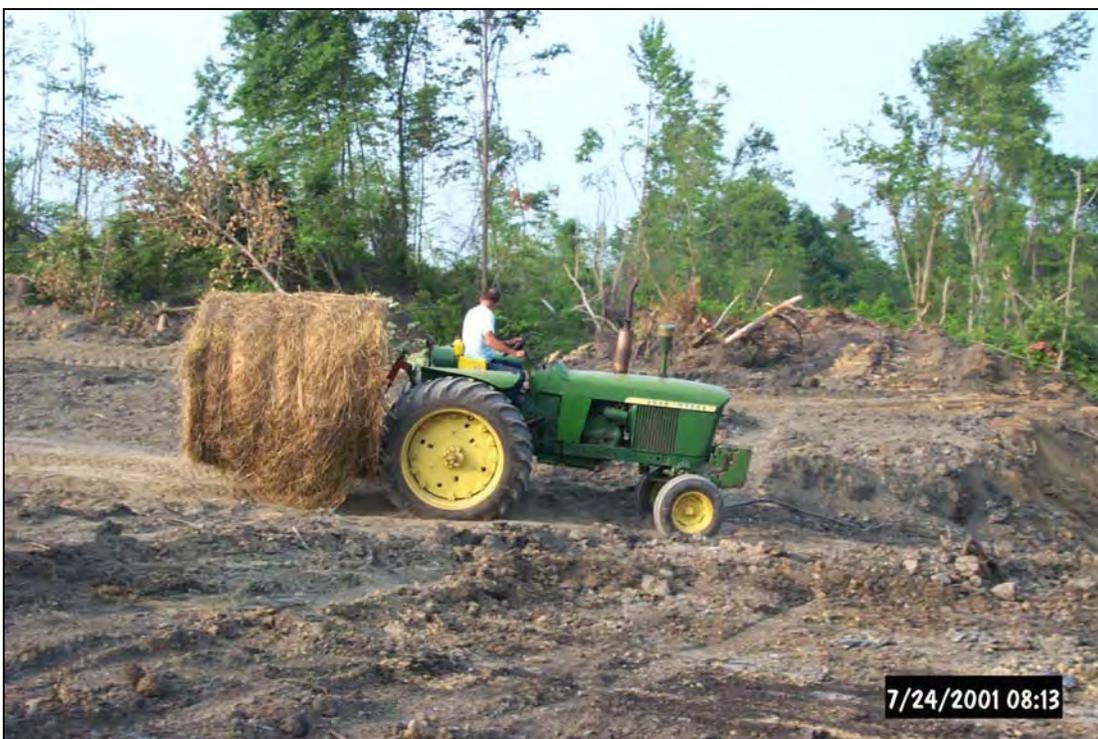
**Top:** View of the temporary treatment ponds used while pumping acidic, abandoned mine drainage from open water-filled pits.

**Bottom:** Seeding and mulching a portion of the site.

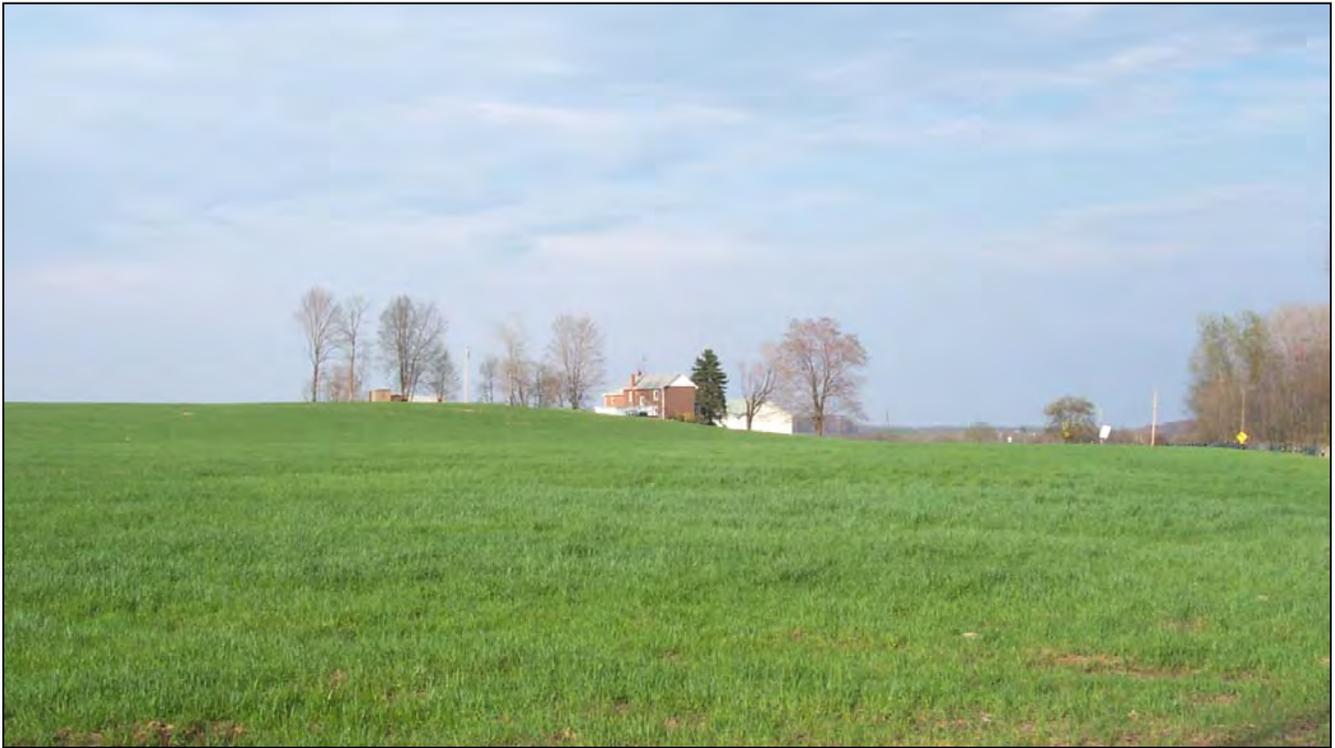
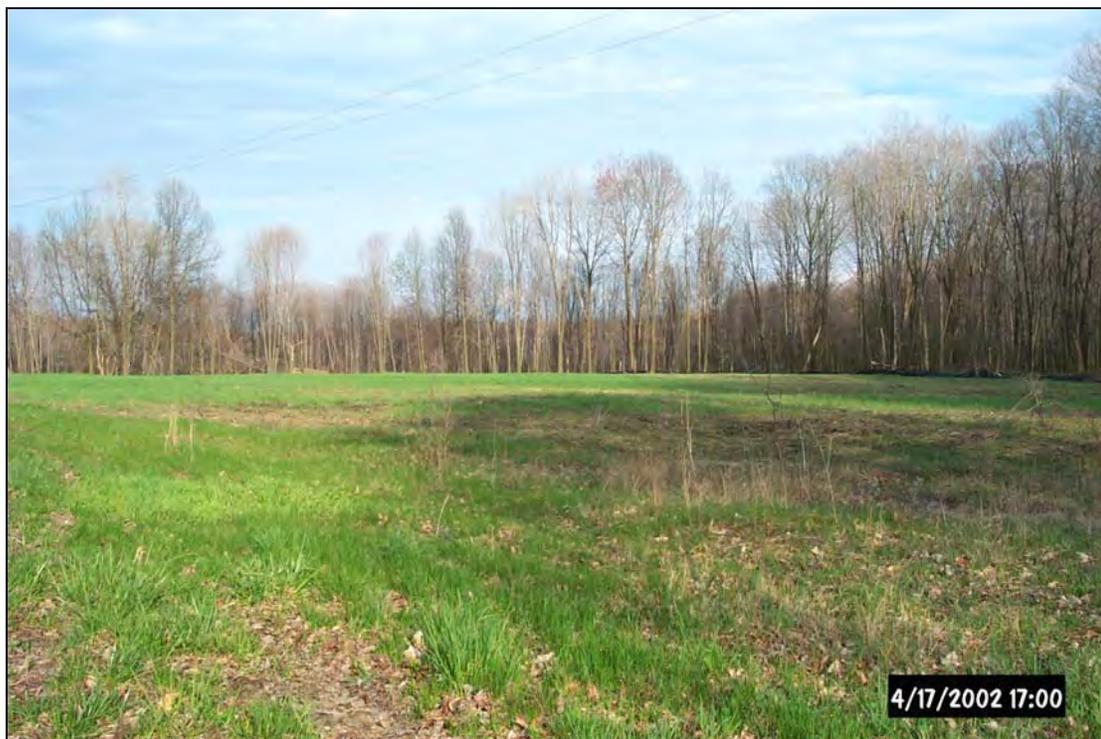
Phase I (**Top**) and Phase II (**Bottom**) following reclamation. The foreground of both photos is the former location of the two large open pits that were located dangerously close to the public road.
