# North Liberty Reclamation Area Phase I and II

**Final Report  
March 2004**

# **NORTH LIBERTY RECLAMATION AREA PHASES I AND II**

## **FINAL REPORT**

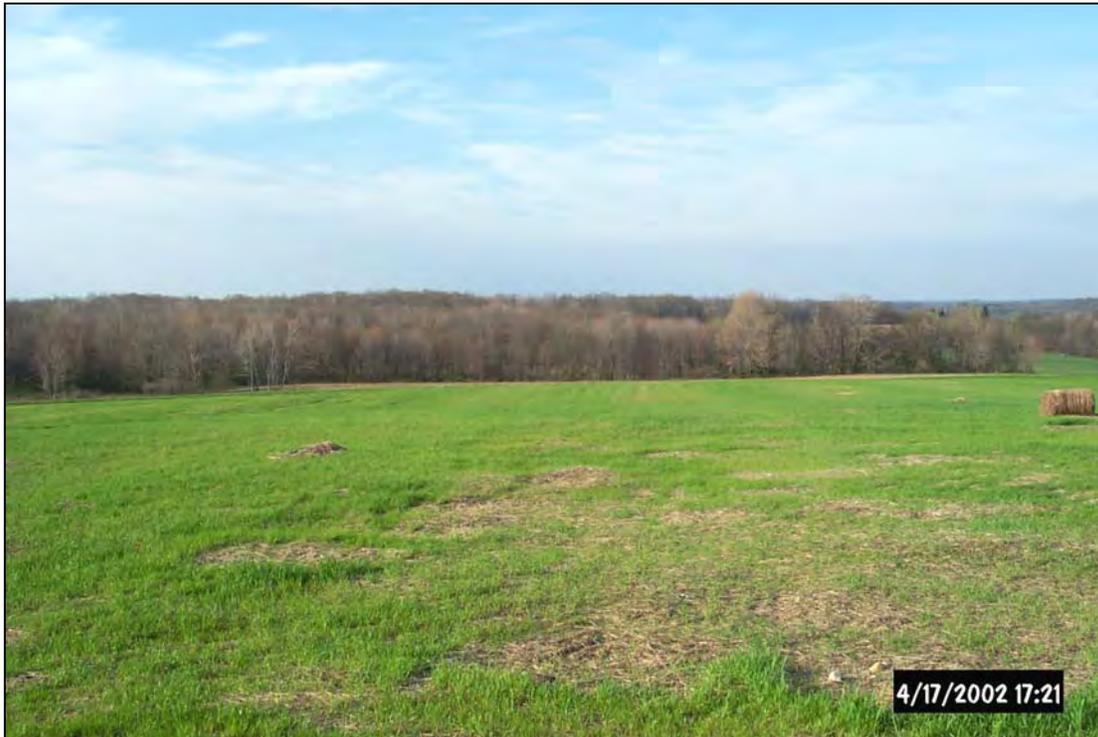
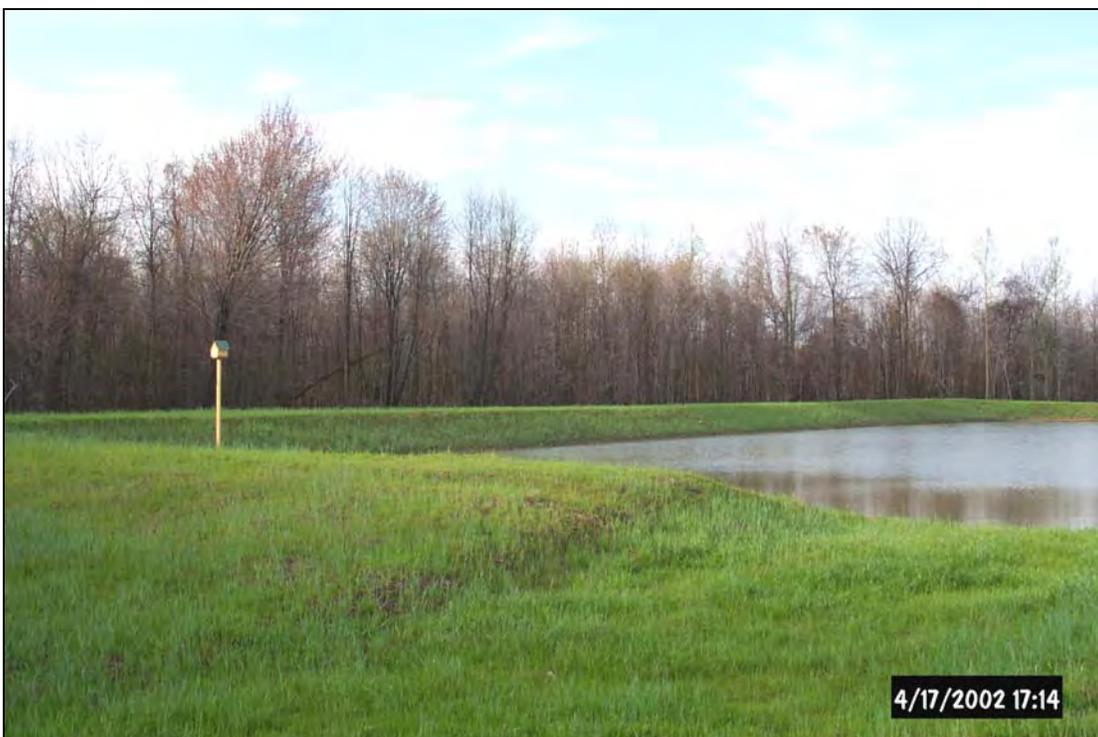
Following reclamation, the property that was once a safety and environmental liability could now be used as productive farmland for hay crops **(Top)** as well as provide aesthetic beauty and wildlife habitat **(Below)**.

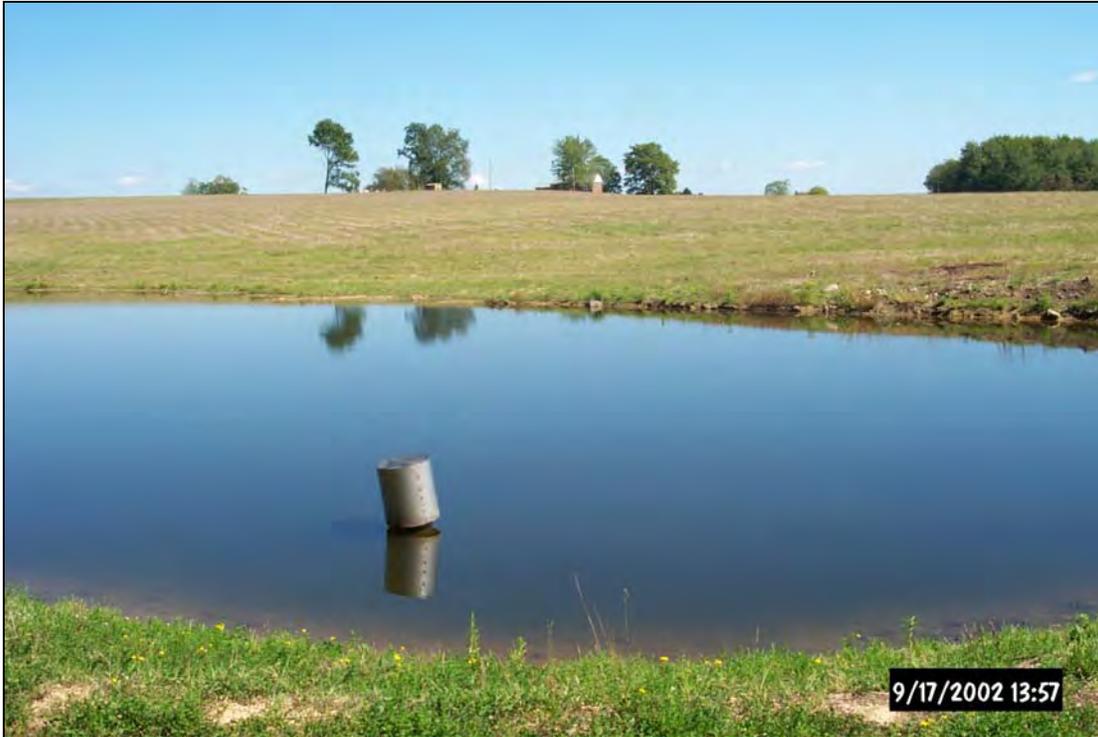
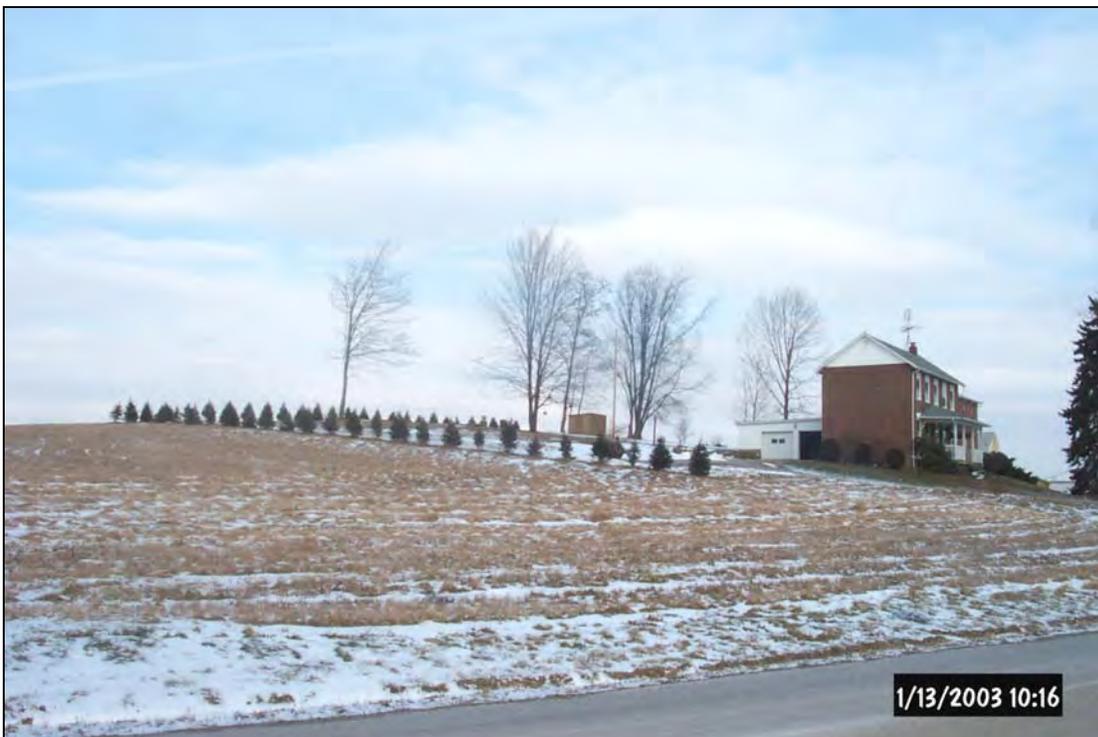
**Top:** One of the two sediment ponds that were left at the landowner's request. Prior to reclamation, ponds constructed at these sites would have been filled with acidic, abandoned mine drainage. The landowner has stocked these ponds with fish. **Bottom:** Trees planted around the historic farmhouse serve as a windbreak and provide wildlife habitat.

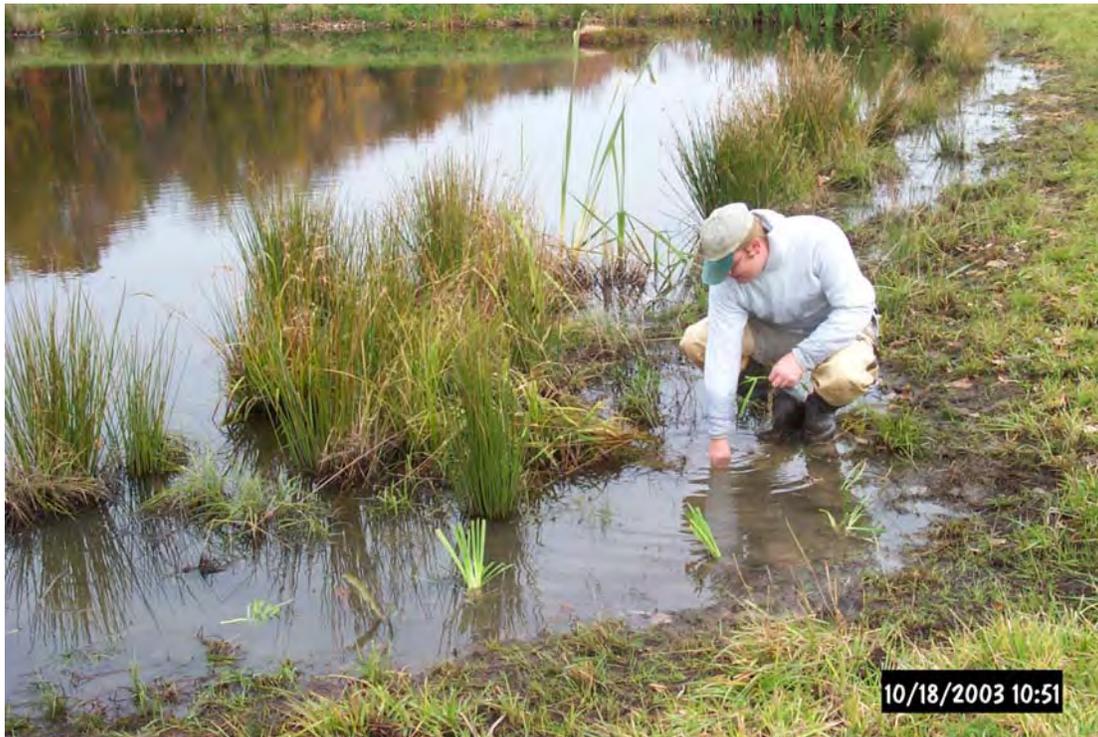
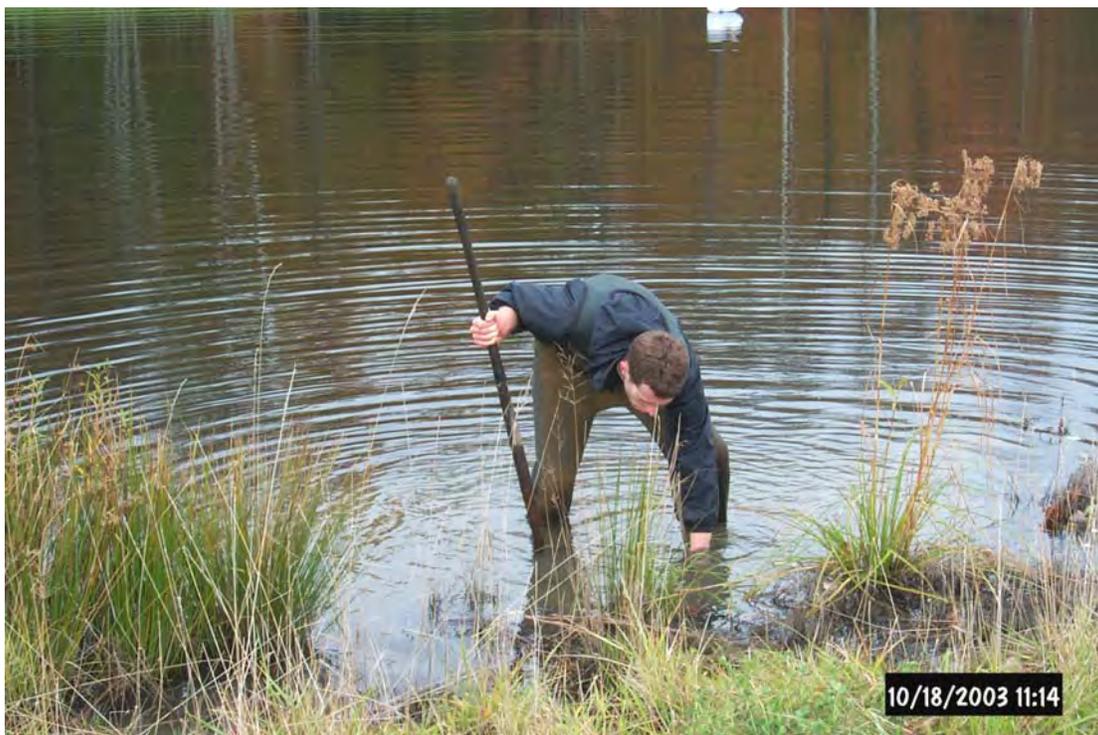
Cliff Denholm (**Top**) and Shaun Busler (**Bottom**) of BioMost, Inc., assisted in the wetland planting with adjudicated youth from George Junior Republic, who are not permitted to be photographed.

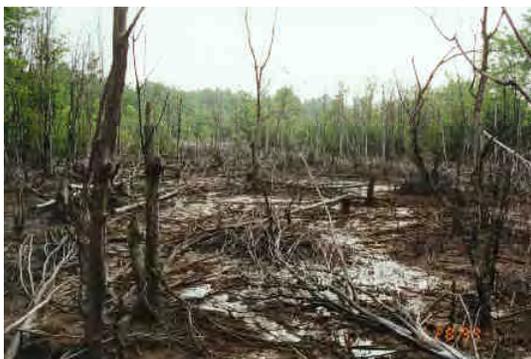
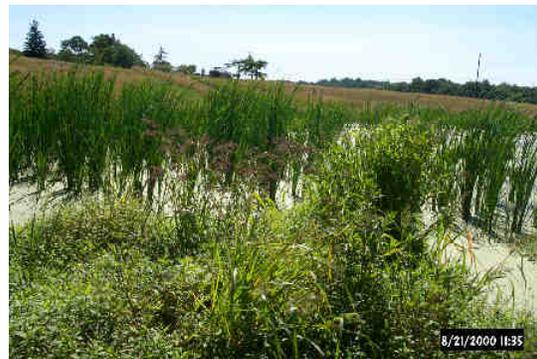
#### De Sale Phase I

Constructed in Spring 2000 by Amerikohl Mining Inc., the passive treatment system treats one of the worst discharges in the watershed. Amazingly it only took five weeks to construct this system. With full support, projects can be completed quickly and cost effectively.

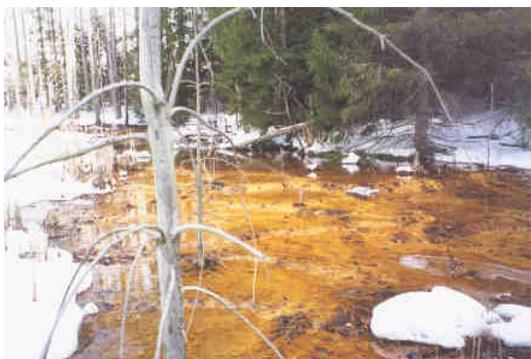
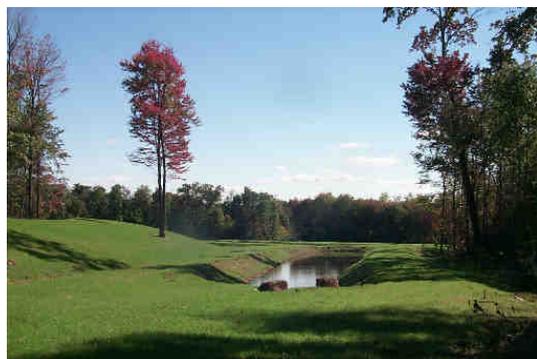
#### De Sale Phase II

After seeing the reclamation of De Sale Phase I, an adjoining landowner with a 200 gpm discharge became interested, which resulted in Phase II. This system treats an entire stream! Using only environmentally friendly materials, the two passive treatment systems at De Sale are the first steps to restore Seaton Creek.

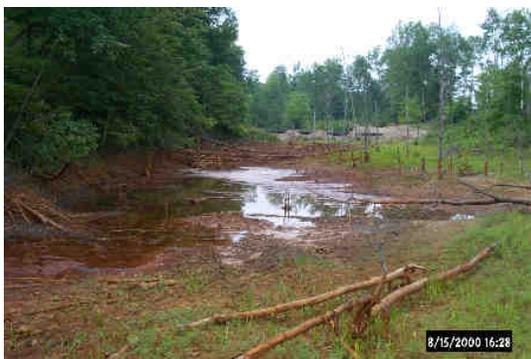
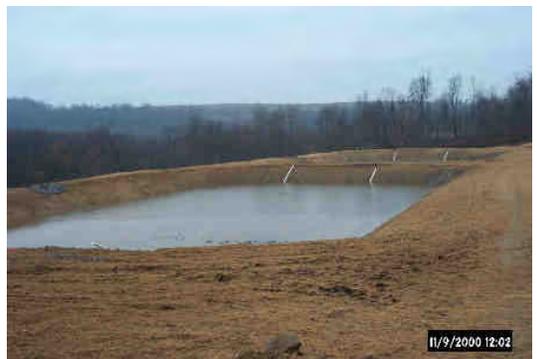
#### Goff Station Restoration Area

Scarred by towering gob piles that form the stream banks of Murrin Run and strip pits filled with acidic mine drainage, Goff Station is one of the largest projects to date within the Slippery Rock Creek Headwaters. Construction will be completed later this year by Quality Aggregates Inc. The construction will include a **bat hibernaculum**, which is first known of its kind east of the Mississippi.  
**(more on bats inside!)**

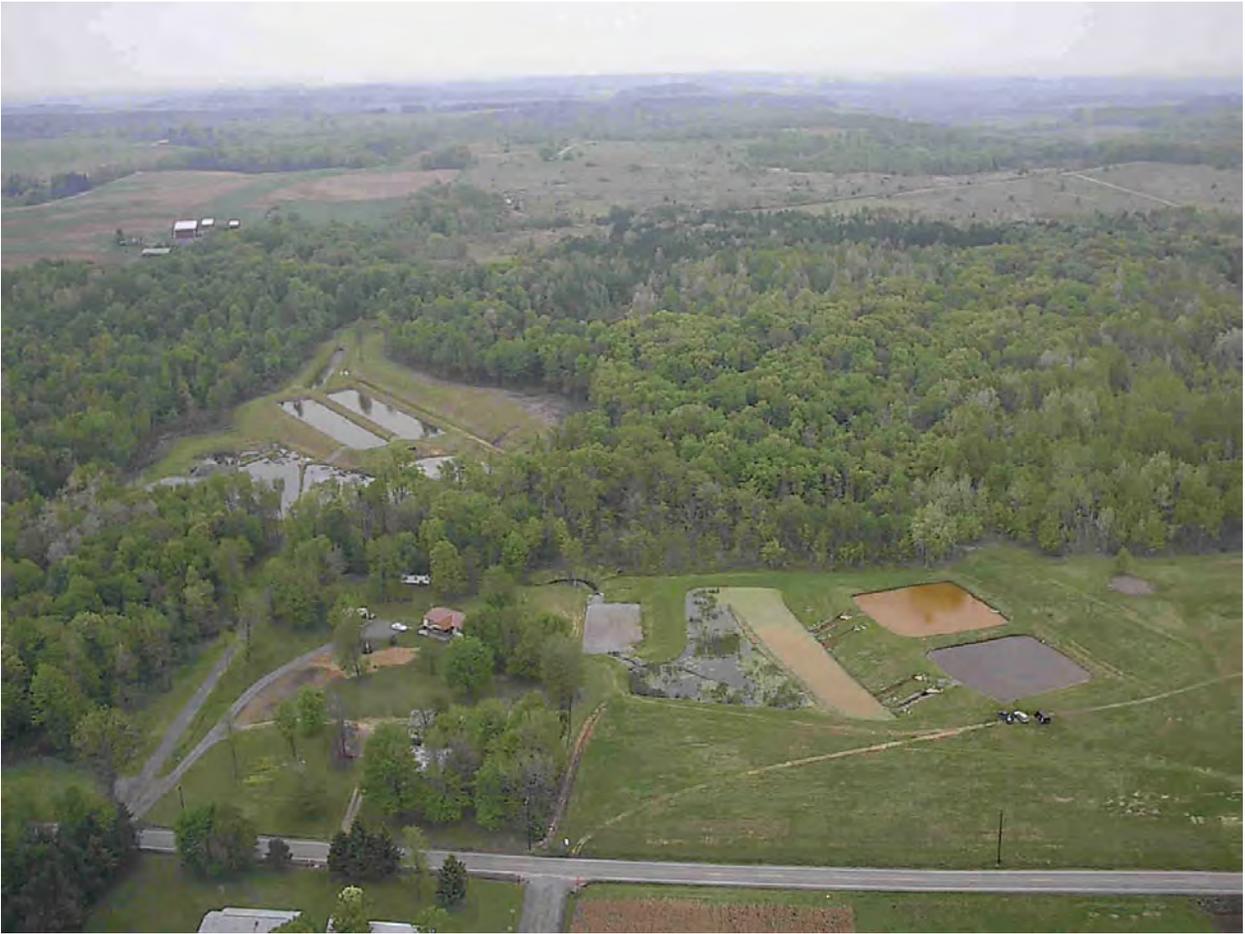
A Look at the DeSale Restoration Area from the air. Phase I is in the foreground and Phase II is center left.
