# **SR286 Passive Treatment System**

## **SR 286 Passive Treatment System: FINAL REPORT**

**Aultmans Run Watershed  
Center Township, Indiana County, PA**

### **A Pennsylvania Growing Greener Watershed Restoration Project**

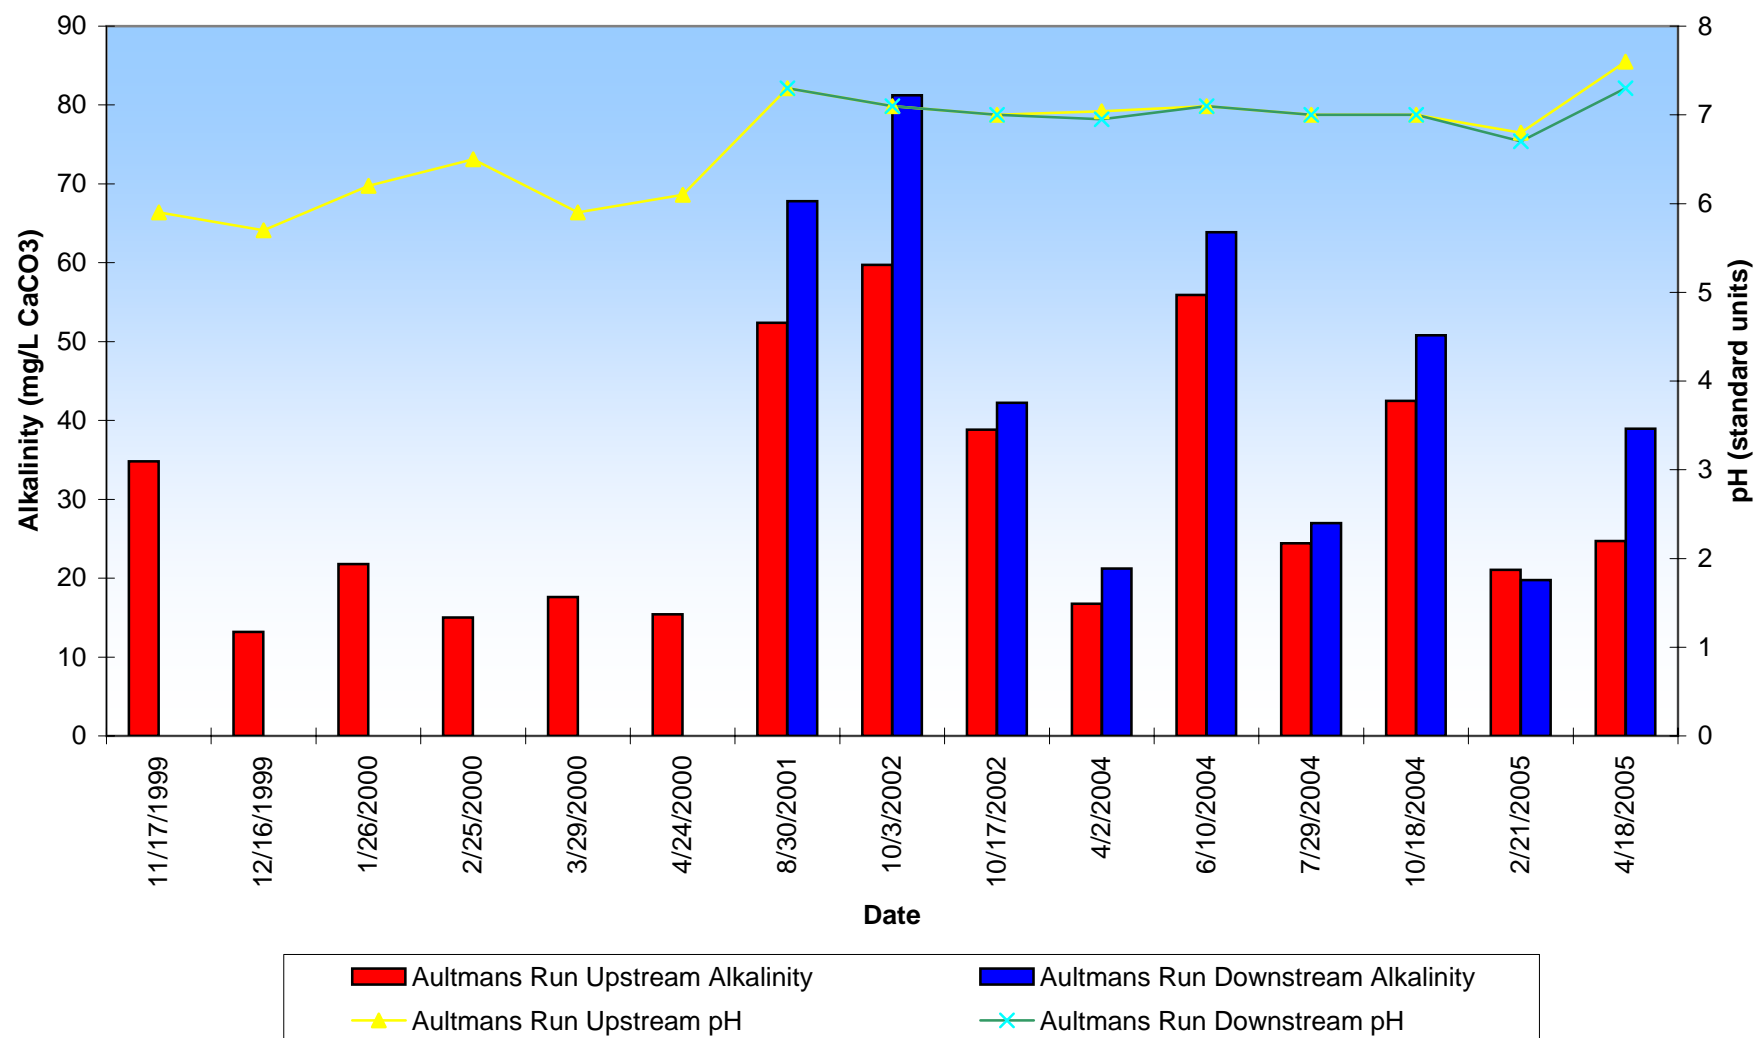
Figure 5.

### Comparison of pH and Alkalinity Values Upstream and Downstream of 286 Passive Treatment System on Aultmans Run

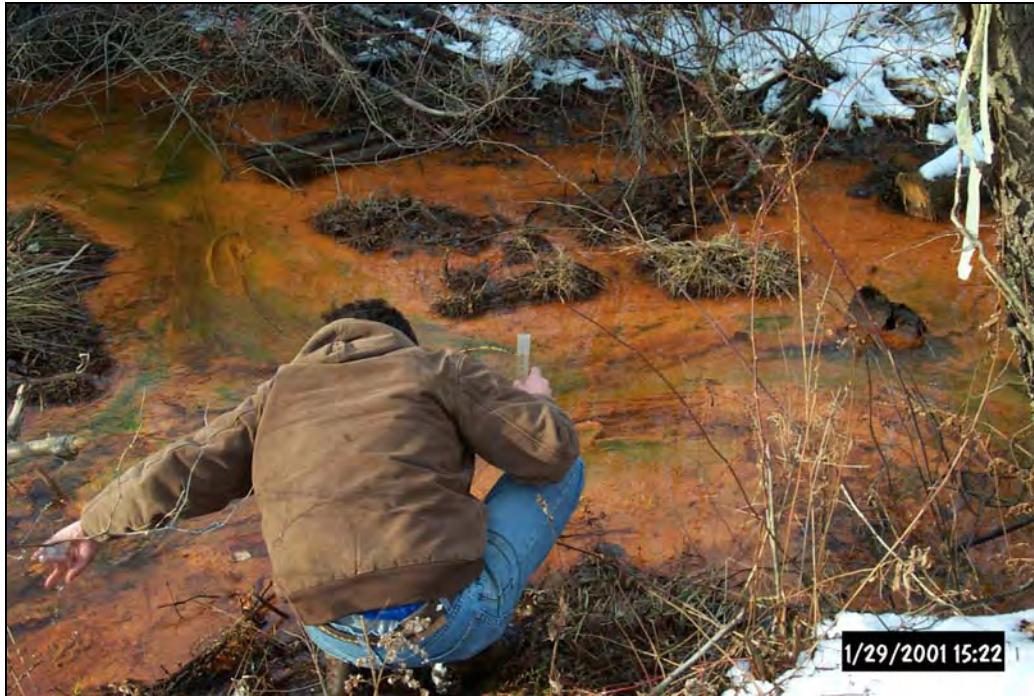
Tim Danehy, BioMost, Inc., carefully takes a water sample of the SR286 discharge. Several feet of iron had accumulated within the channel.

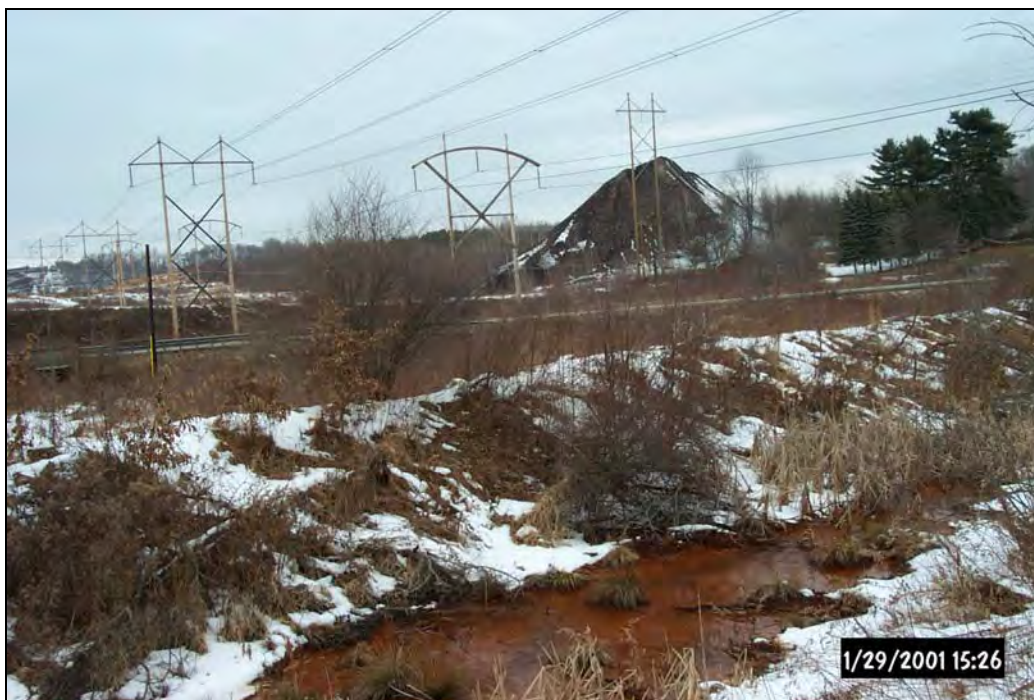
A narrow channel conveyed the discharge to Aultmans Run. Wetlands had developed within the channel; however, they were not large enough to treat the discharge.

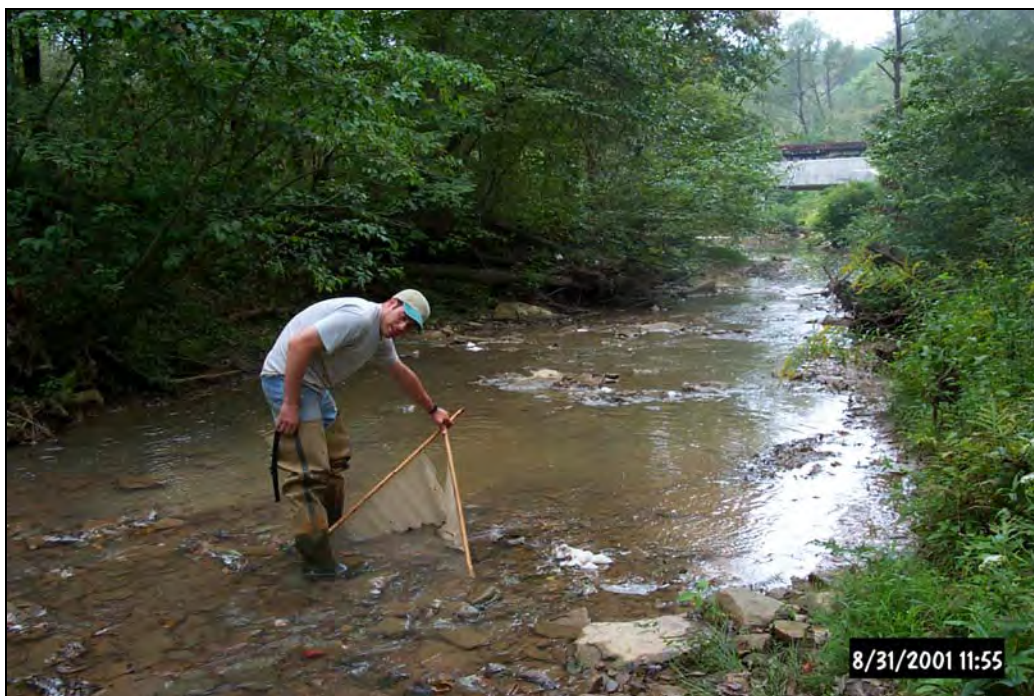
Scott Alexander, PA DEP, Bureau of Mining and Reclamation, along with several volunteers, conducted a watershed assessment of a portion of the Aultmans Run watershed to determine the impacts of the abandoned mine drainage to the aquatic life within the stream.

Above: Scott takes a conductivity reading of Aultmans Run upstream from where the SR 286 Discharge enters the stream.

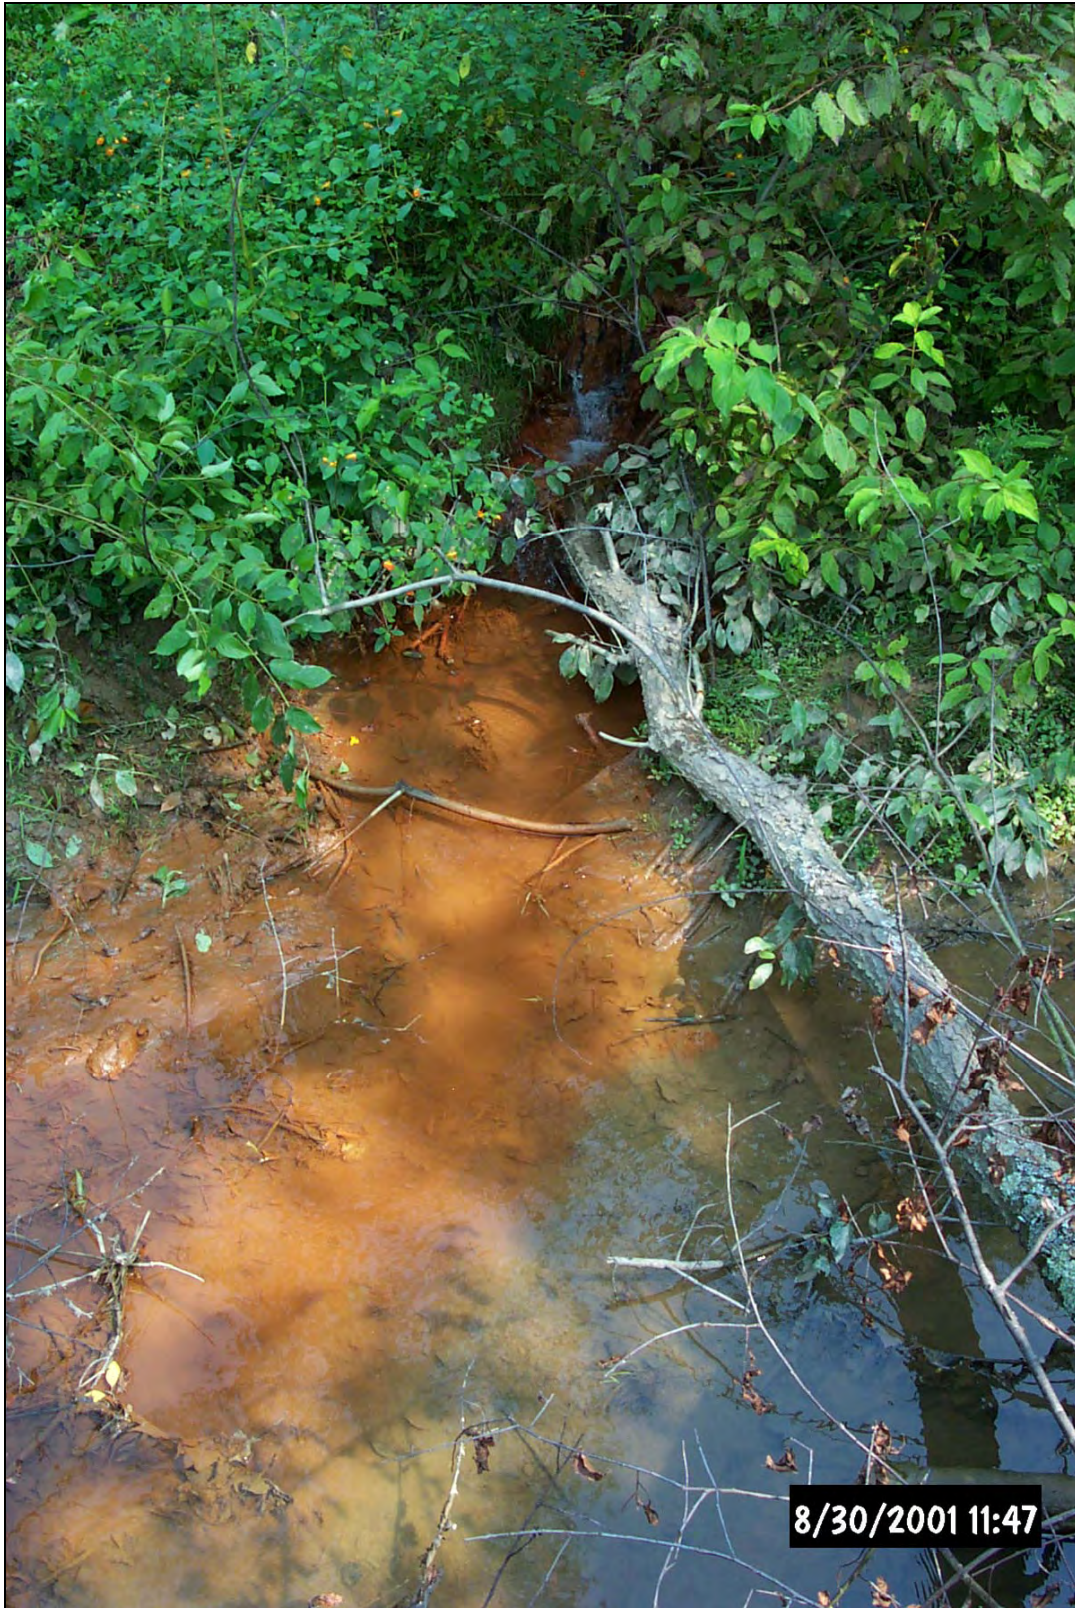
The discharge created a large iron plume within Aultmans Run impacting aquatic life.

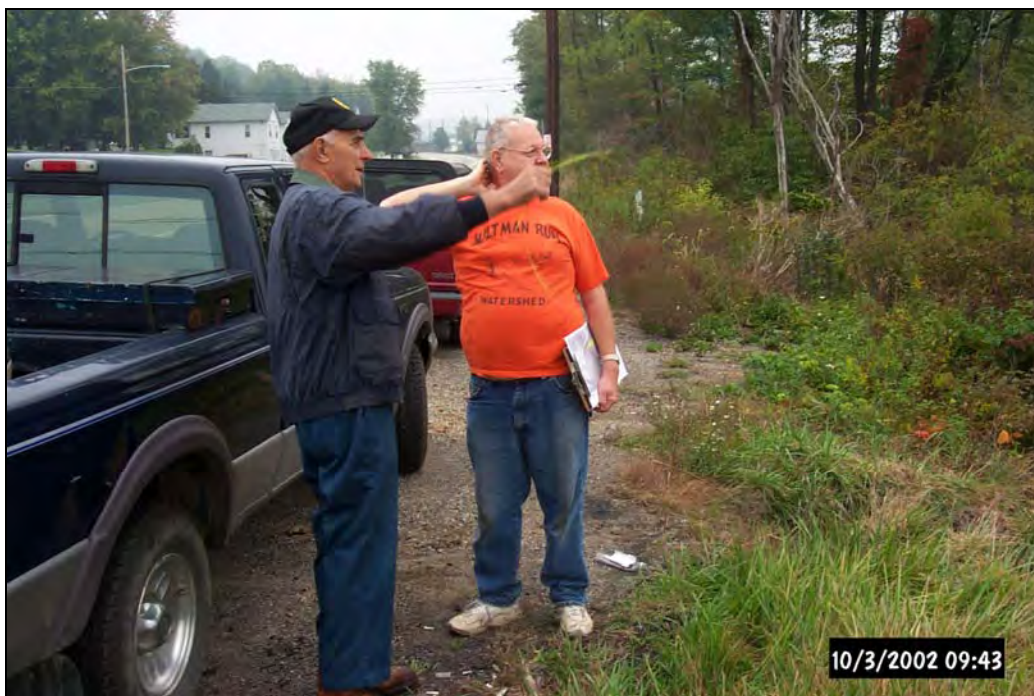
Looking upstream of the SR 286 discharge. During portions of the year, the SR 286 discharge provides the primary flow to the stream.

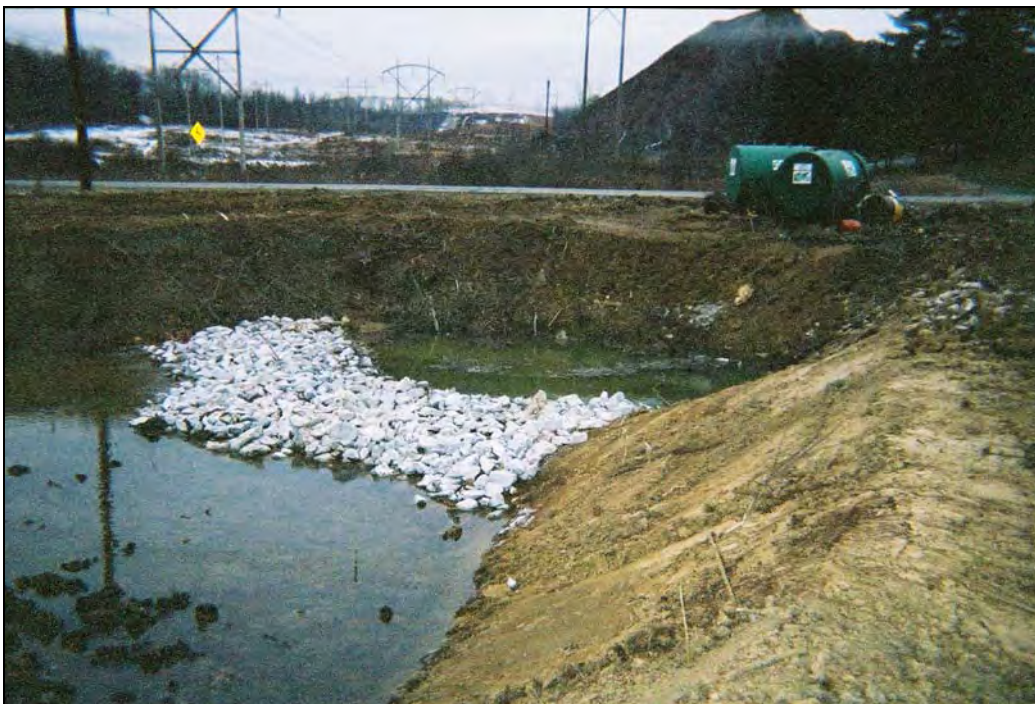
The forebay shortly after construction. The freshly laid limestone has not yet been coated with iron.

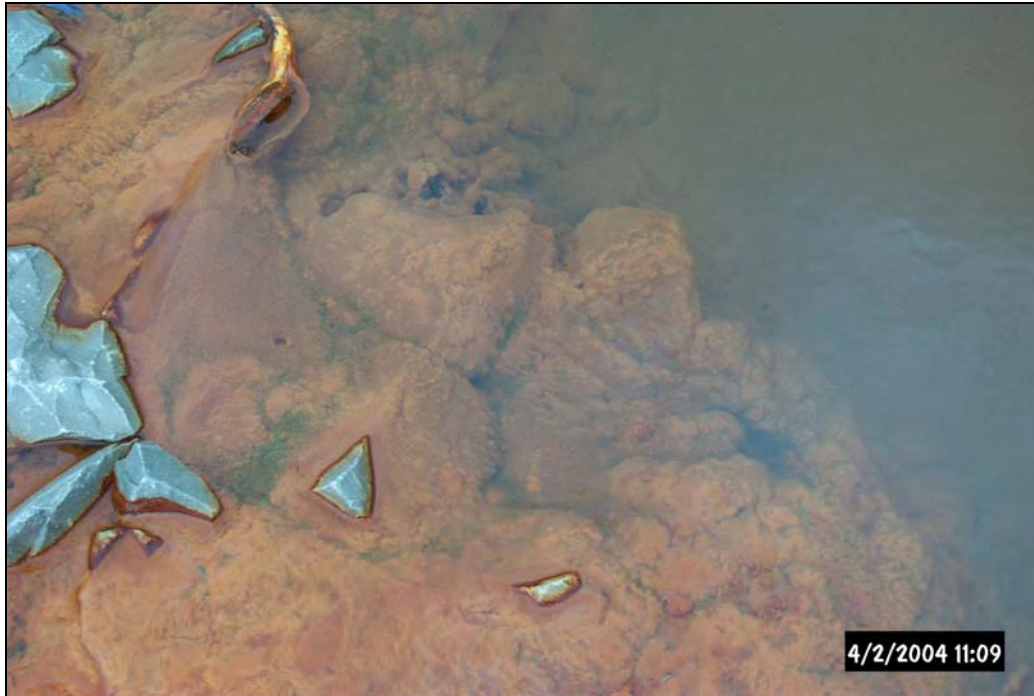
Iron has begun to thickly coat the rip-rap level spreader after only three months of operation.

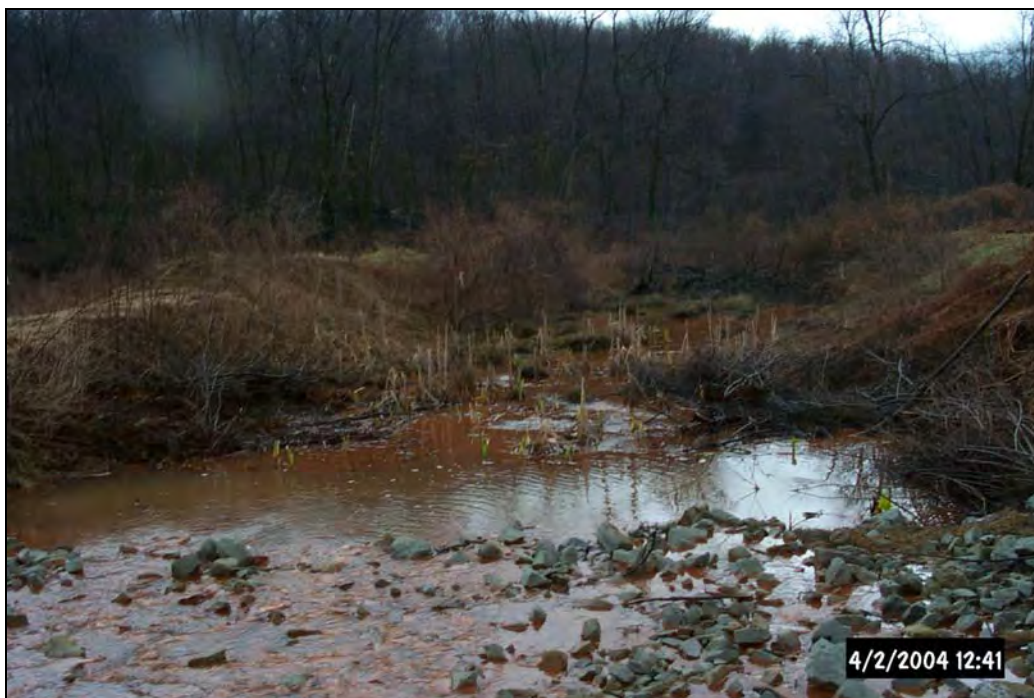
The wetland outlet flows into a small “drop” pool before entering the existing channel wetland.

**"Drop" Pool:** With a depth of ~2.0 feet, the "Drop" Pool is a small structure used to encourage uniform flow into the Existing Channel Wetland and to allow for settlement and retention of metal particulates. The water elevation in the "Drop" Pool is 1076.1± feet.

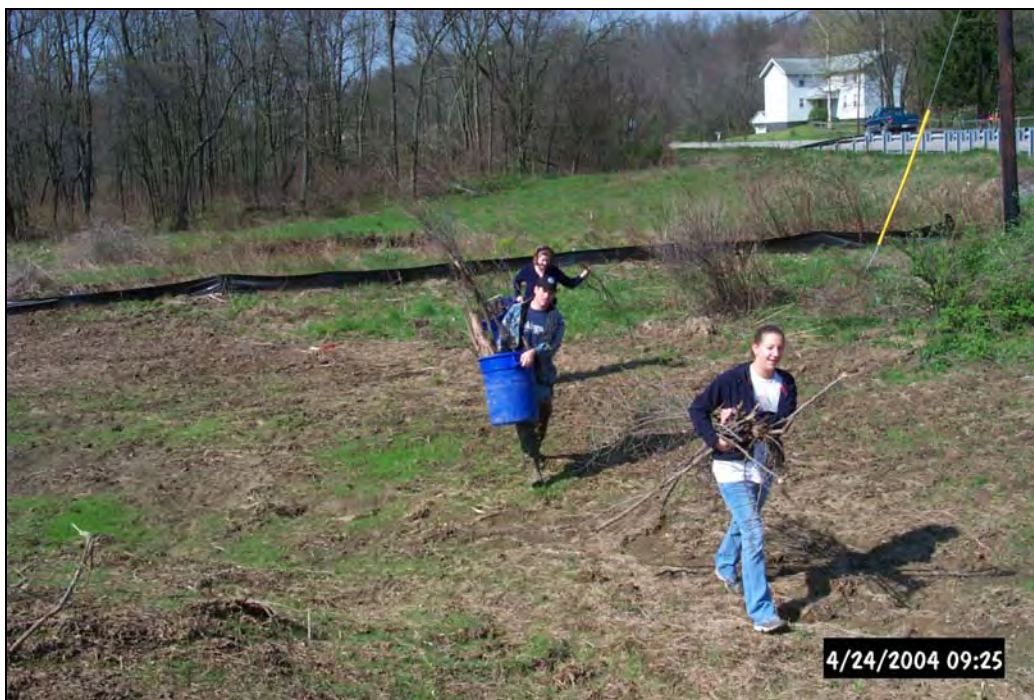
As part of the wetland planting, woody debris from the surrounding area was gathered and strategically placed throughout the wetland to add habitat diversity and help prevent preferential flow paths.

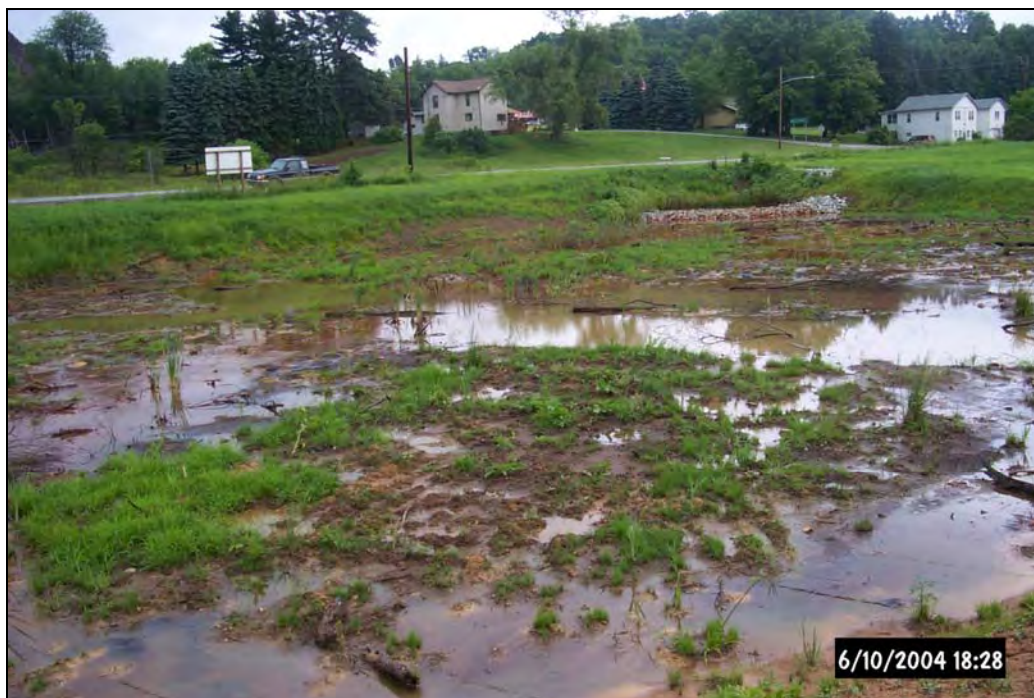
Wetland vegetation that was planted on 4/2/04 and has colonized naturally has begun to grow. The wetland was constructed with microrelief and several deeper pools to enhance the system performance for treatment and wildlife value.

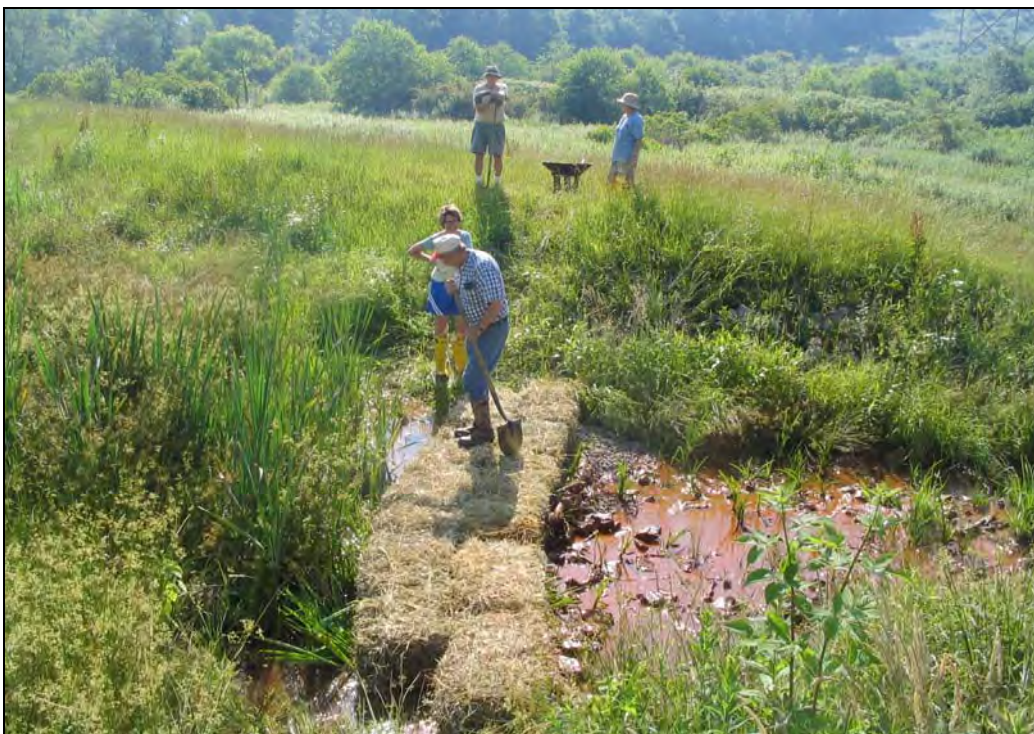
Hay bales were placed at the outlet of the wetland to encourage more uniform distribution of the mine discharge throughout the wetland.

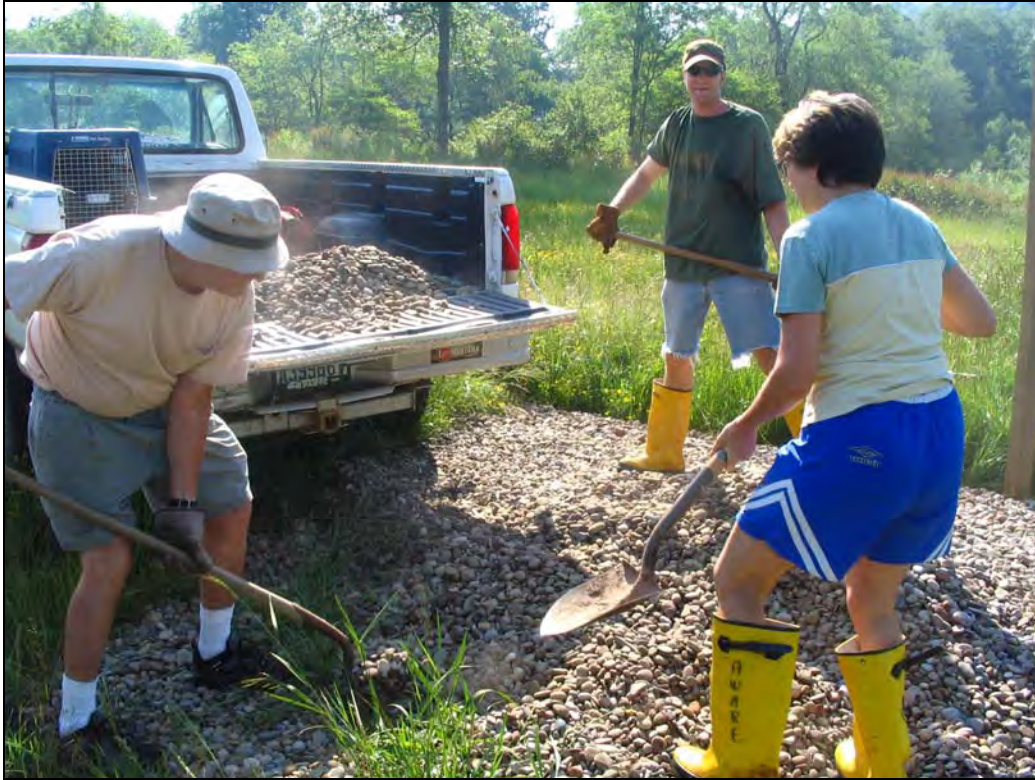
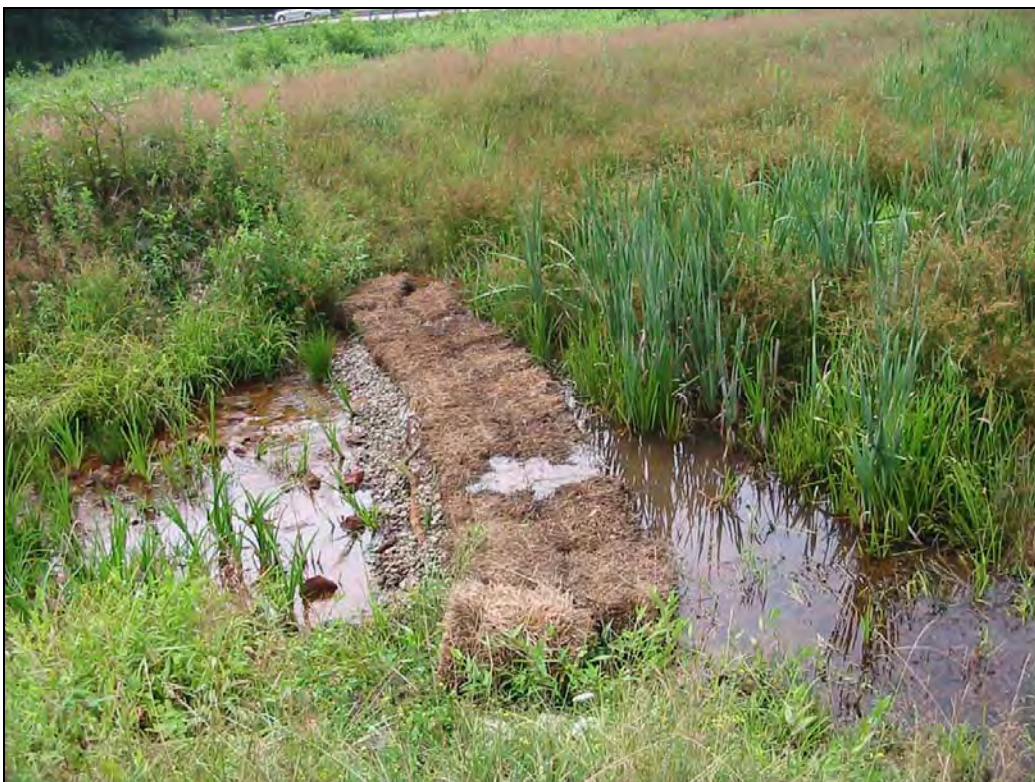
Rock was placed below the hay bales to help keep them in place.  
Notice that the water elevation is at the top of the of hay bales (below).

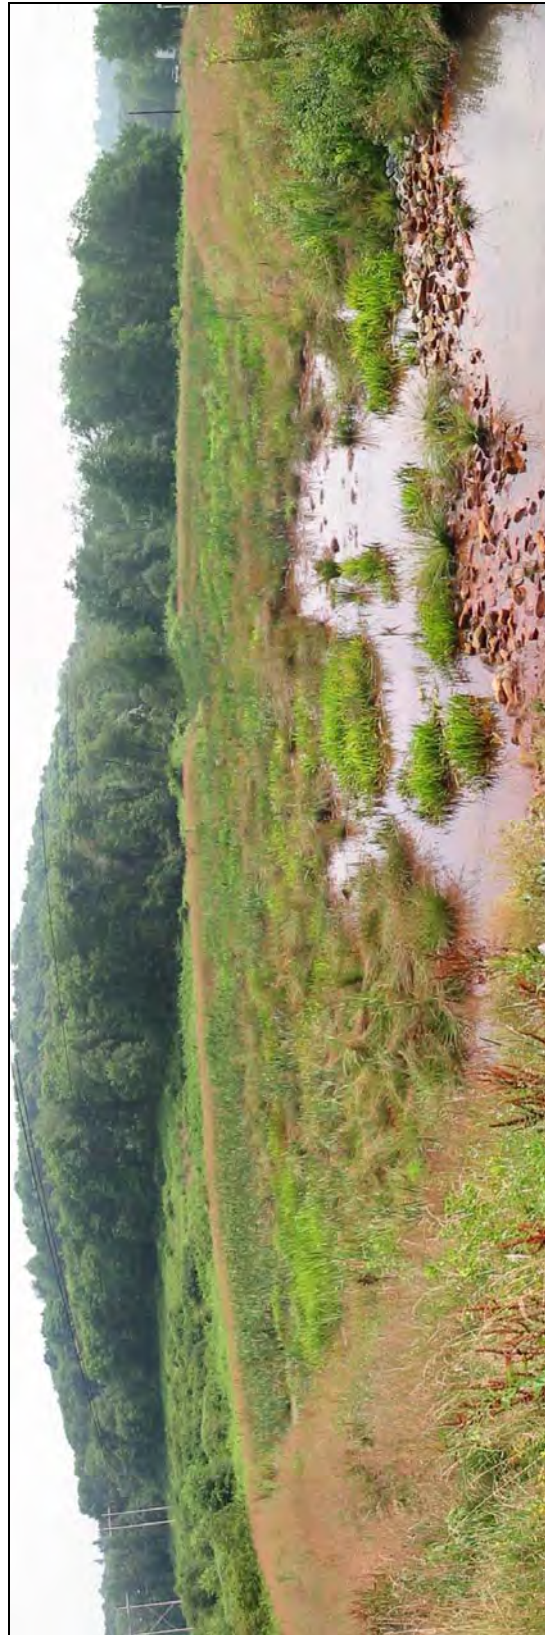
The constructed aerobic wetland on 02/20/04 shortly after construction (left) and on 07/18/05 after 1.5 years.

**Aerobic Wetland:** The effluent from the Forebay and Level Spreader flows into a ~215-foot long by ~125-foot wide rectangular, constructed wetland confined between State Route 286, Aultmans Run, a non-degraded wetland, and an unnamed tributary. Spent mushroom compost provides a ~½-foot thick organic substrate. This **0.6-acre** Aerobic Wetland was designed with microrelief and woody debris to enhance performance relating to both treatment and wildlife value.

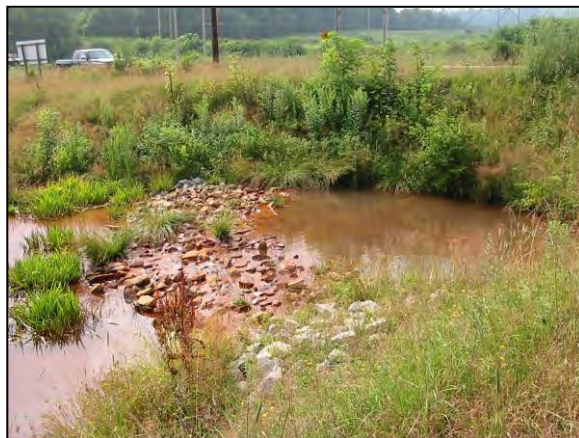
**Forebays** (right) can serve multiple purposes. They can be used to convey water, provide for settling of debris, and allow for oxidation, precipitation, and accumulation of metal solids. There is one forebay at the SR286 Passive Treatment System. The forebay captures the water from the pre-existing mine water conveyance piping. The forebay outlet spillway to the wetland agitates and aerates the drainage to further encourage formation of metal solids.

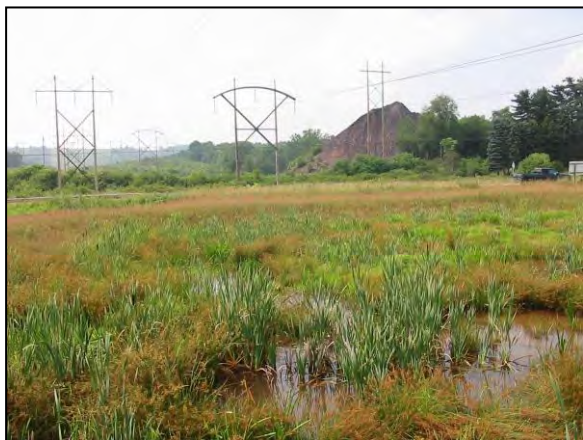
**Wetlands** (left) are typically used in passive treatment systems to allow for the oxidation, precipitation, and accumulation of metal solids that occur when alkaline drainage issues from a minesite or after acidic drainage has passed through an alkalinity-generating treatment component. Although many treatment wetlands are angular-shaped shallow ponds with predominantly cattails, the wetlands at this site have been designed, built, and planted to look and function as natural wetlands with high species diversity to provide not only treatment but also wildlife habitat. There is one aerobic wetland at the SR286 Passive Treatment System.

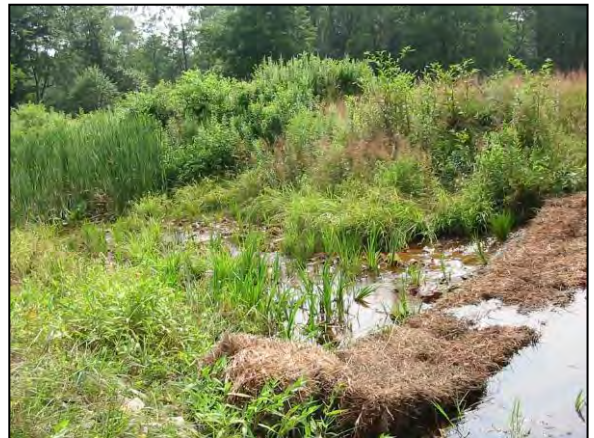
Hay bales were placed in front of the spillway to raise the water elevation of the wetland to encourage uniform flow distribution throughout the wetland. The water elevation of the wetland is dependent upon condition of the hay bales.

The outlet of the wetland is a ~38-foot wide limestone aggregate spillway. The broad spillway discourages channelization of the water leaving the Aerobic Wetland. Hay bales were placed at the spillway inlet to raise the water elevation to encourage uniform flow distribution. The water elevation, currently 1078.2± feet, is dependent upon the condition of the hay bales, vegetation, and debris. The spillway provides ~2 feet of drop aiding in aeration. A "Drop" Pool is located at the spillway outlet.

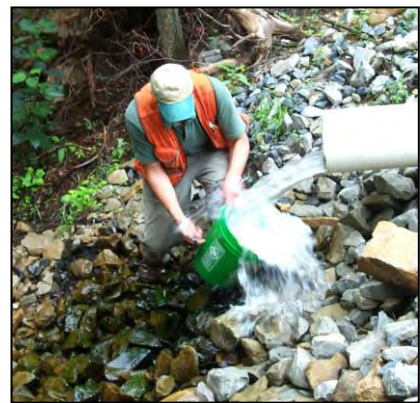
Flow measurements from pipes can be easily made using a bucket and stopwatch. The bucket and stopwatch method consists of timing (in seconds) the filling of a bucket of known volume (preferably calibrated in gallons). The flow rate in gallons per minute can then be calculated utilizing the following formula:

$$\text{Flow (gal/min)} = \left( \frac{\text{Gallons}}{\text{Seconds}} \right) \times 60$$

A large bucket (15- to 20-gallon capacity) may be calibrated and used for flow measurements. To calibrate a bucket, use another container of known volume to add metered amounts of water (i.e., 1-gallon increments). Mark on the bucket with a permanent marker, desired volume gradations. For example, on a 20-gallon bucket, gradations might be at 5, 10, 12, 15, 16, 17, 18, 19, and 20 gallons although any gradation scheme is acceptable as long as relatively accurate measurements can be made. Due to the awkwardness and weight of a filled 15- to 20-container, using a 5-gallon container may be more suitable. With a measured maximum flow of 200 gpm, however, a 5-gallon container would be filled quickly (1.5 seconds).

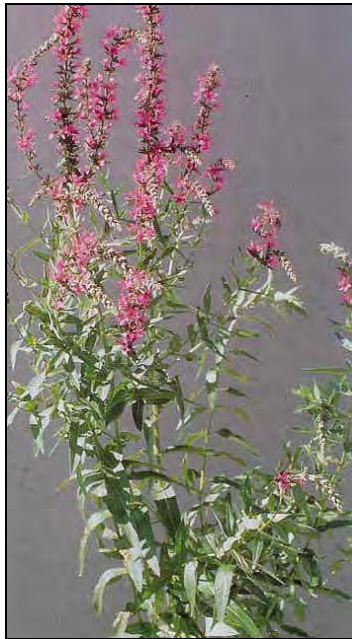
Common Reed

It is also recommended that a Wetland Plant Diversity Report be completed at least once per year. The primary purpose of this report is to assess the diversity of plant species within the constructed treatment wetland in order to determine if species diversity is increasing or decreasing. Species diversity is believed to optimize the health, productivity, and treatment capability of the wetland. In addition, increased plant species diversity should result in an increase in wildlife diversity. A secondary purpose is to identify if unwanted invasive plants have become established, such as common reed (*Phragmites australis*) and purple loosestrife

(*Lythrum salicaria*). (See pictures below.) These plants should be removed from the wetlands. On the report provide the common name and/or scientific name for each plant, the plot number, the location of the plot, and the population within that plot.
