Laurel Run Headwaters Restoration Project Blacklick Creek Watershed Stream Restoration Incorporated A Public Private Partnership Effort Brushvalley and Center Townships, Indiana County, PA

Re: Final Report
Laurel Run Headwaters Restoration
Project# WR23; ME# 350803; 351179
Brushvalley and Center Townships, Indiana County, PA
500205/FR-trans

LAUREL RUN HEADWATERS RESTORATION

FINAL REPORT

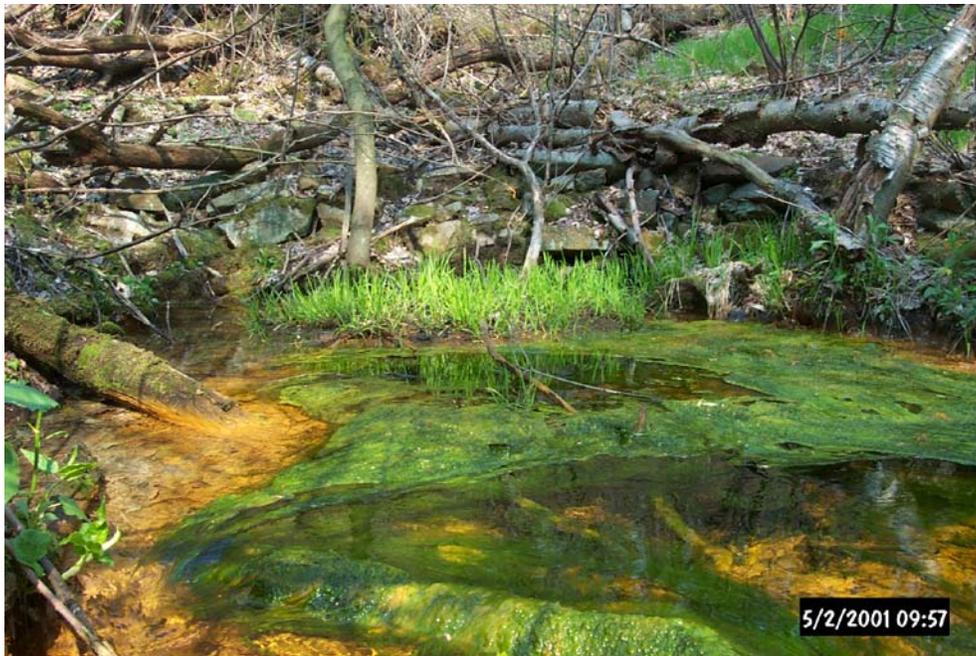
An acidic, iron-laden, aluminum bearing abandoned mine discharge emanates from this century old underground mine gravity drain.

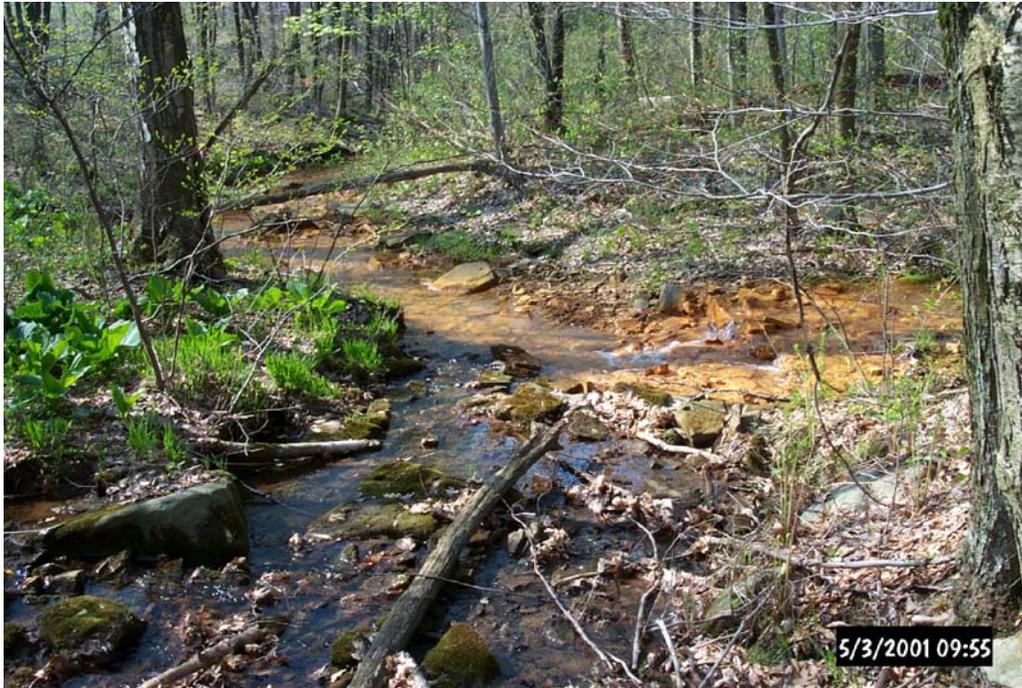
View of the abandoned mine drainage (right) entering Laurel Run (left).

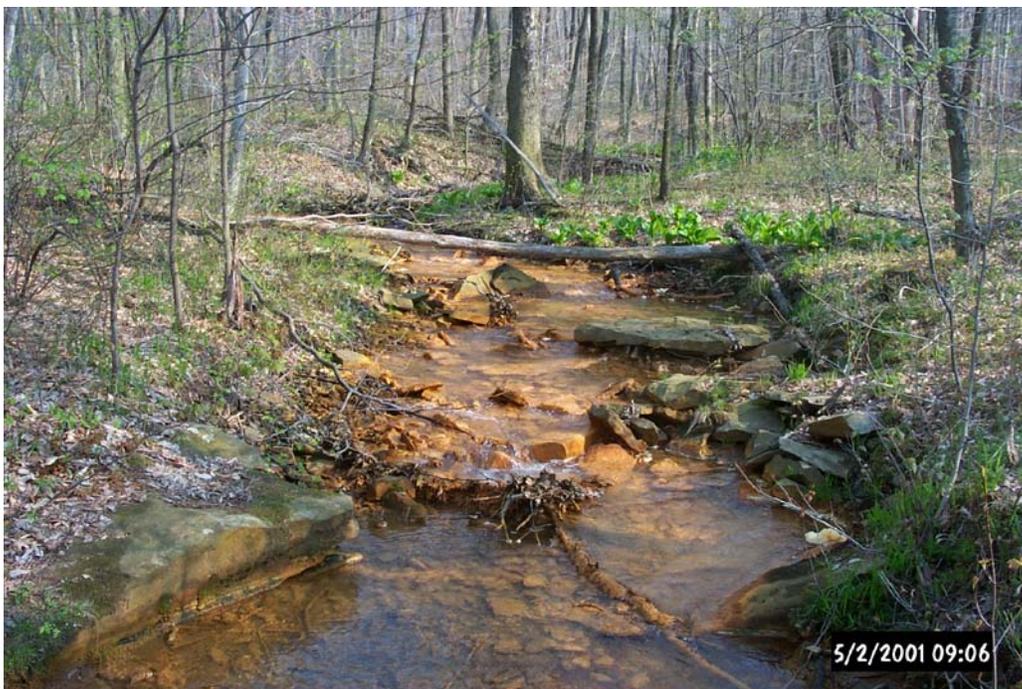
Laurel Run downstream of where the abandoned mine discharge enters the stream. Note the heavy iron staining.

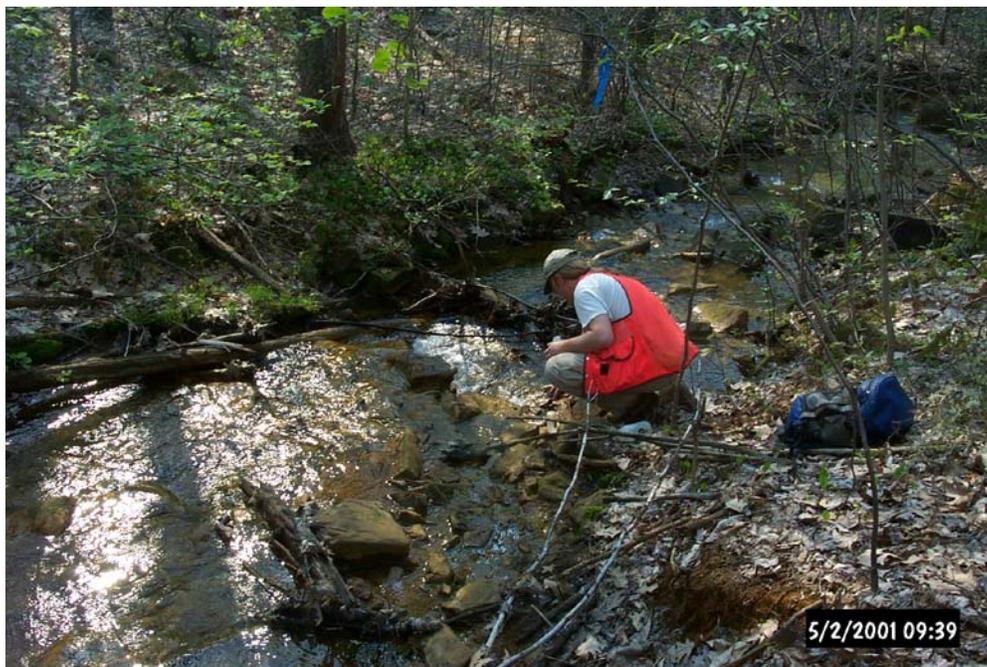
Water sampling conducted by Cliff Denholm, BioMost, Inc., along Laurel Run to document the impact of the abandoned discharge before construction of the passive treatment system.

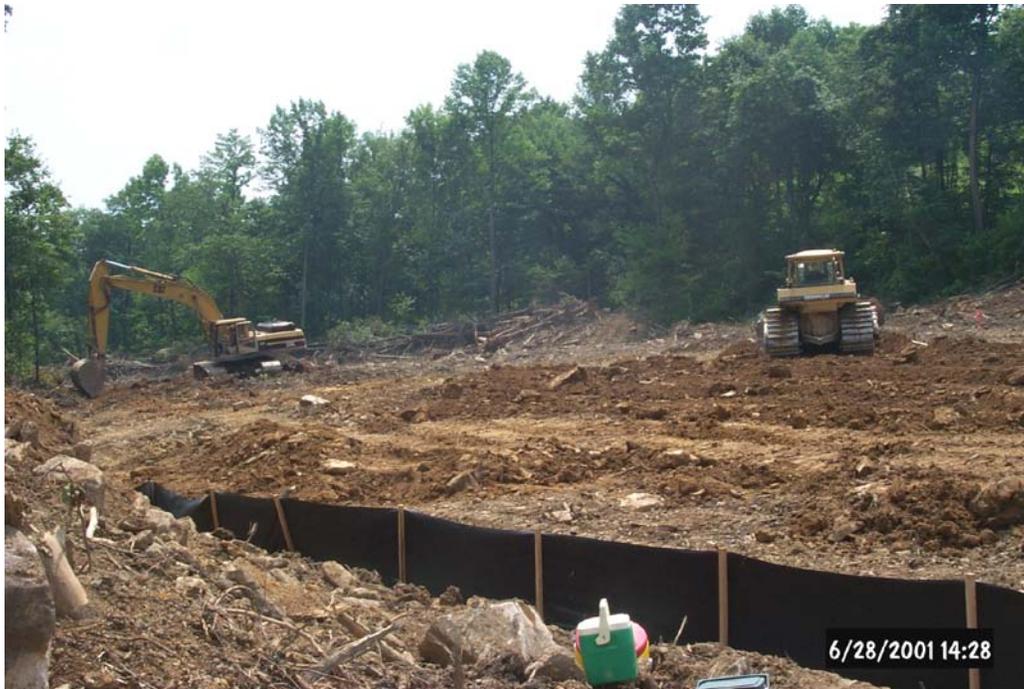
Clearing and grubbing must be completed as part of the site preparation before construction begins.

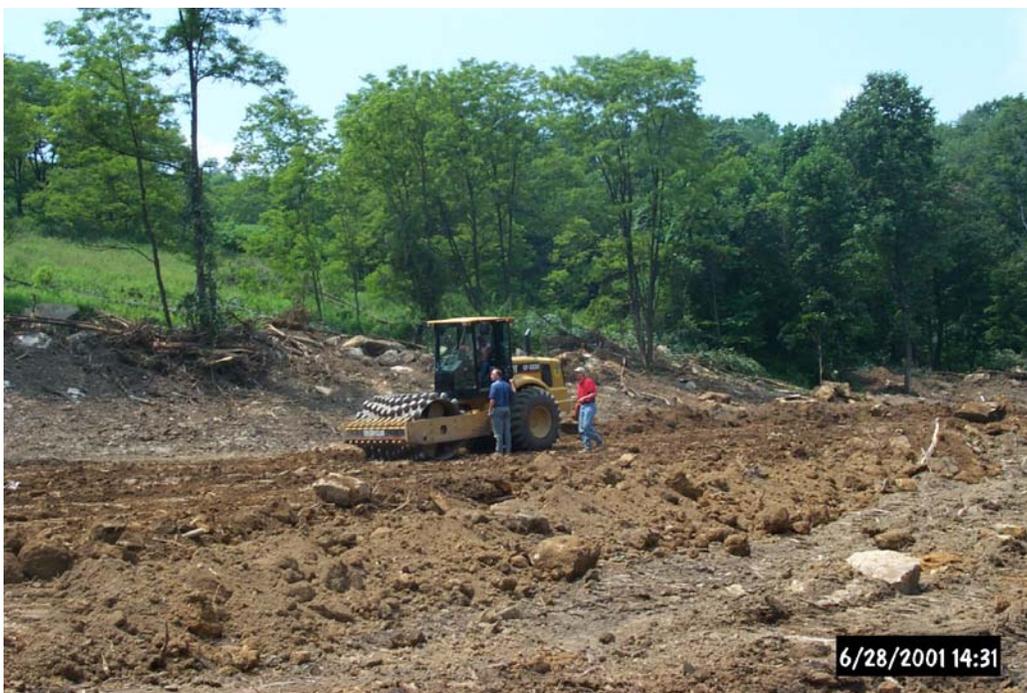
View of the compactor that was used at the site.

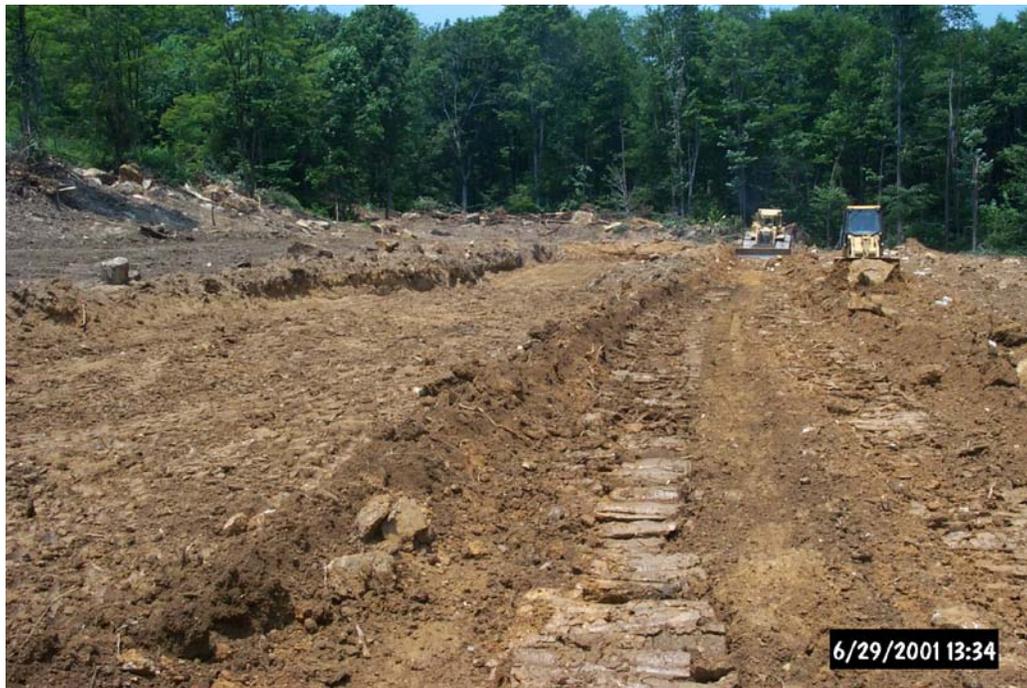
Construction of the Vertical Flow Ponds at the Laurel Run North Passive Treatment System by Amerikohl Mining Inc.

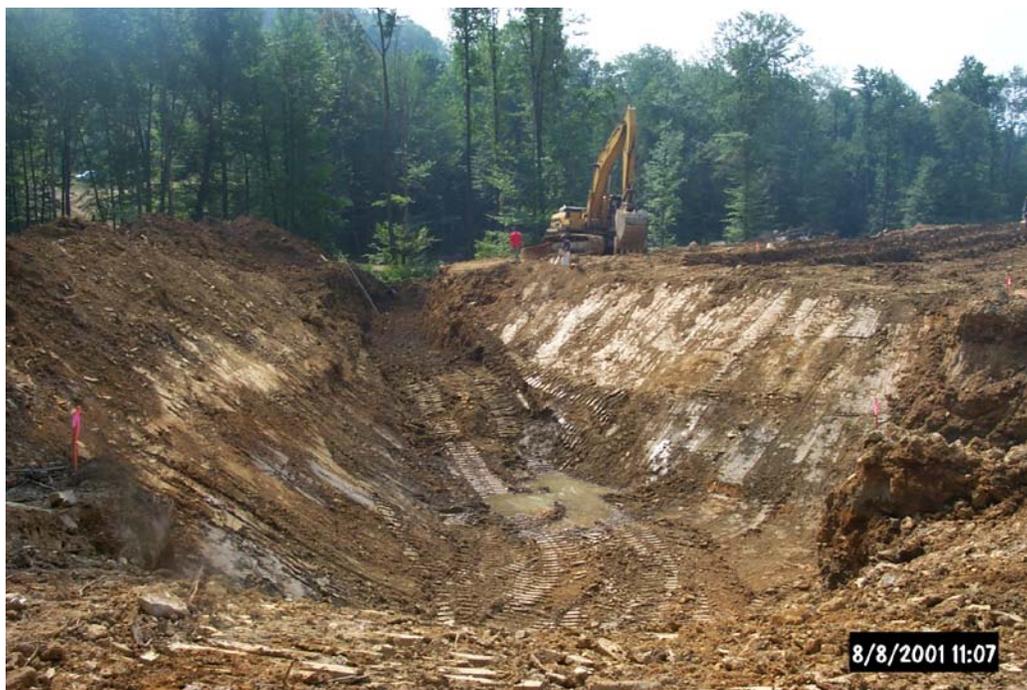
Construction of the passive treatment system required meeting many challenges due to difficult site conditions.

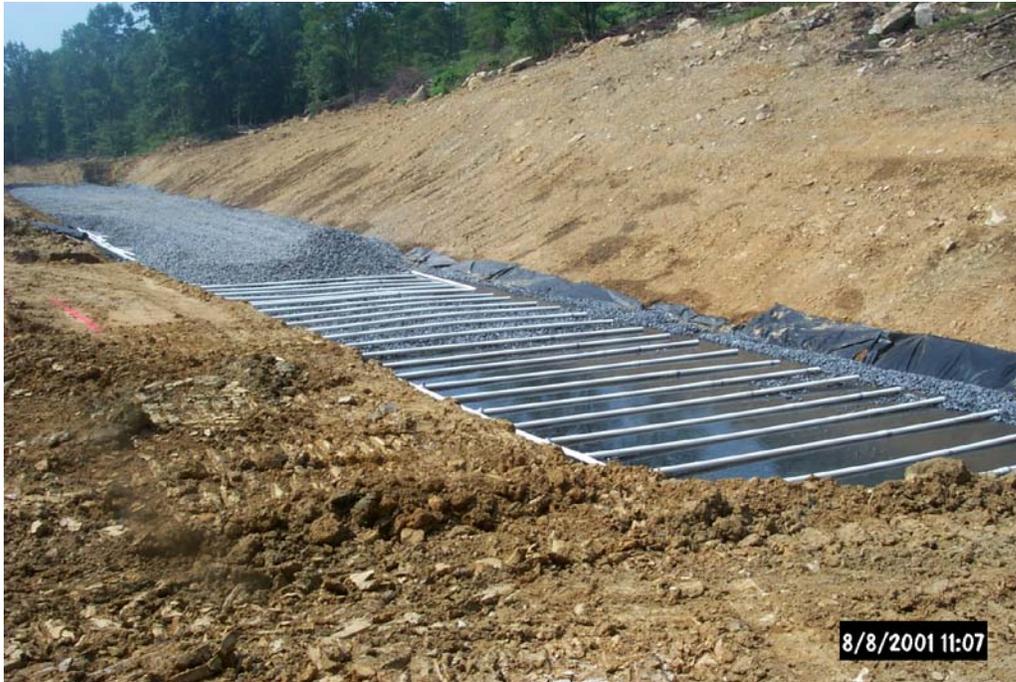
Vertical Flow Pond under construction. Note the underdrain piping system and a portion of the second layer of limestone put in place.

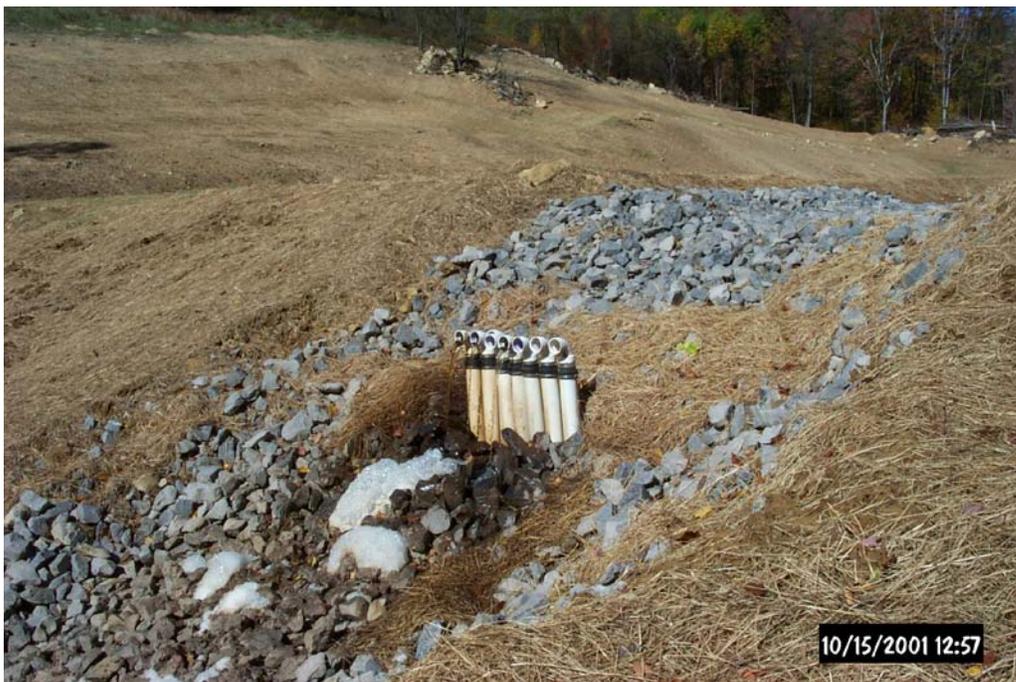
Peripipe discharge pipes for the Vertical Flow Ponds allow for easy balancing, control, and adjustments to flow rates within the ponds.

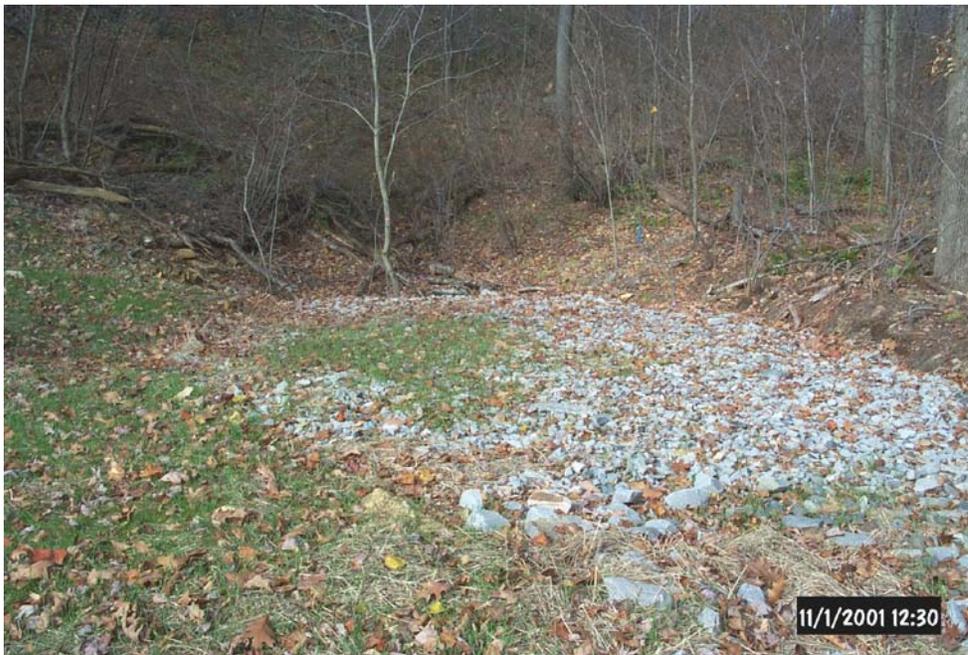
Former location of mine drain, which is now utilized as part of the collection system and covered with limestone.

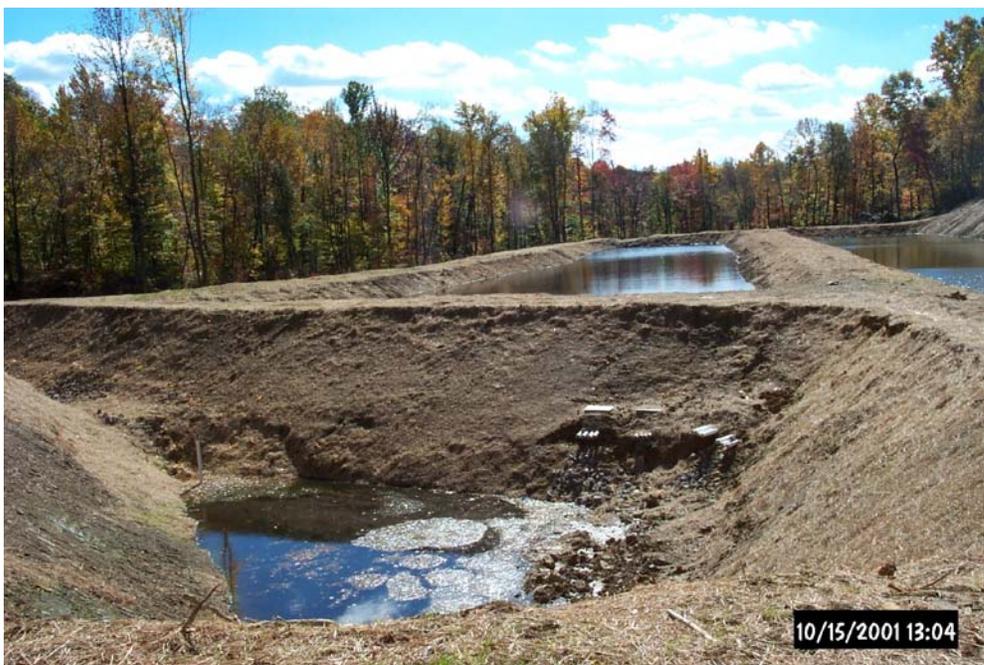
Flush Pond in the foreground is used as a holding pond during flushing events of the Vertical Flow Ponds behind it.

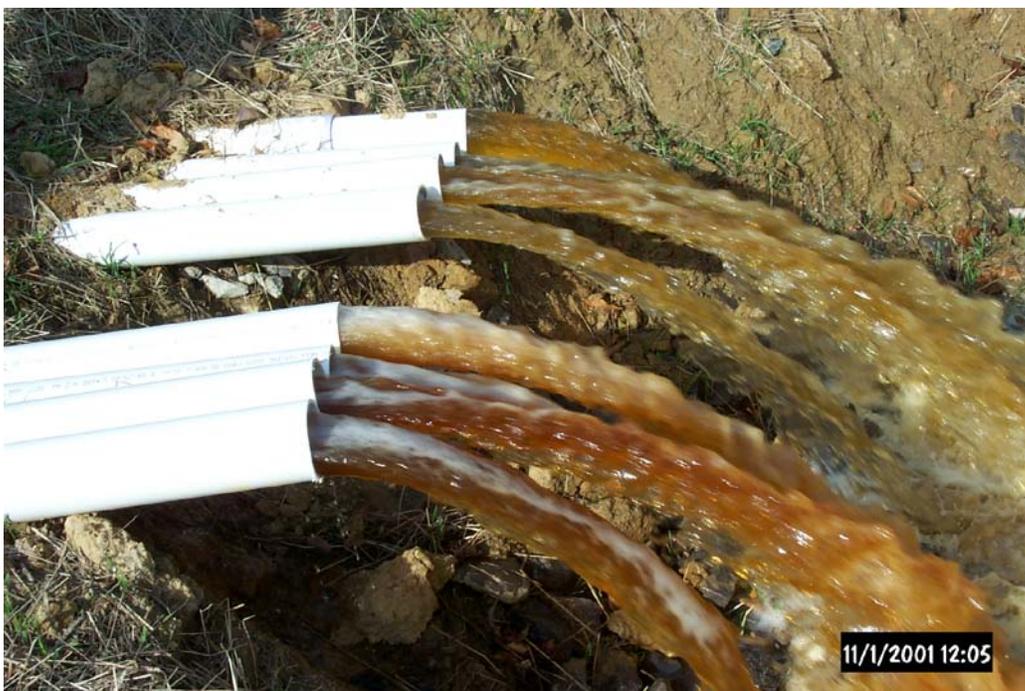
A flushing event only a couple of months after the passive treatment system was placed on line.

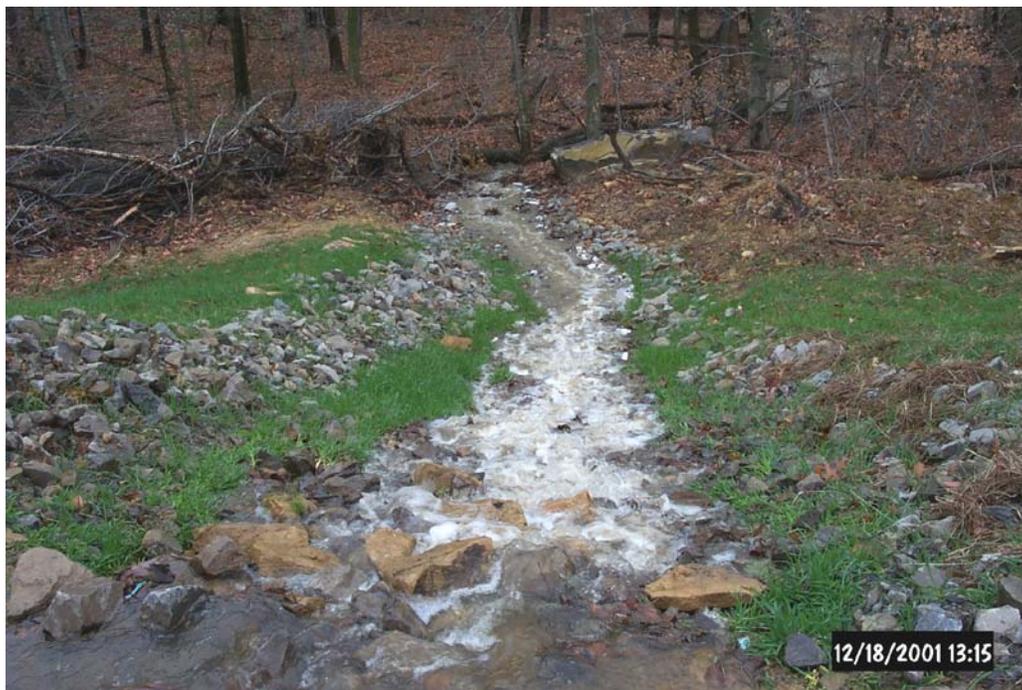
Final effluent from the passive treatment cascading down the rip-rap lined spillway to enter Laurel Run.

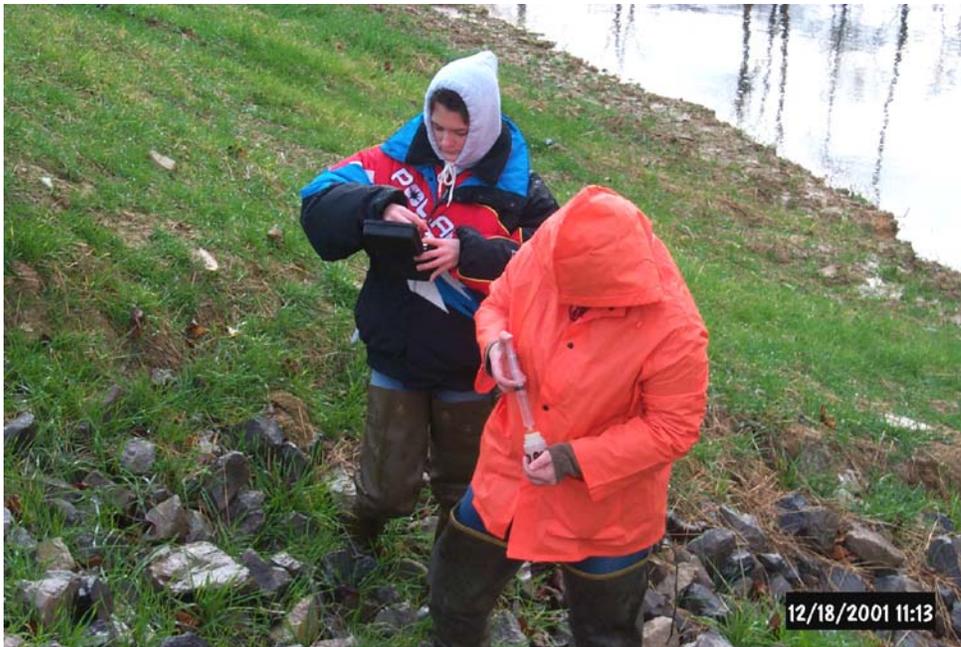
Shaun Busler, BioMost, Inc (left) with volunteer Terry Frombach (right) “burp” the system and balance flows from a Vertical Flow Pond while PA DEP interns look on from behind.

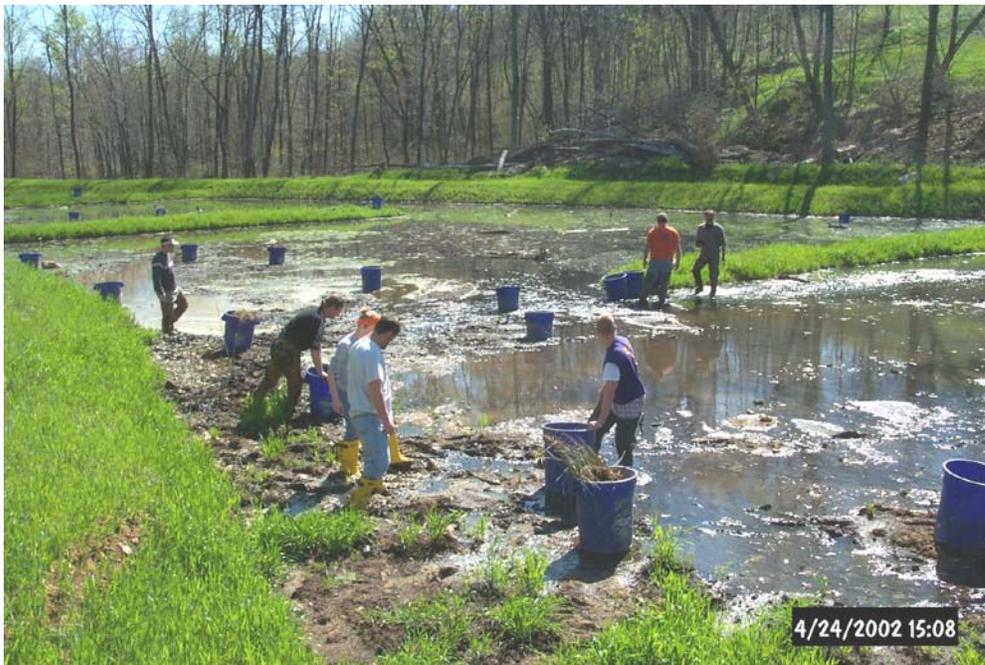
Employees of Aquascape Wetland & Environmental Services harvesting wetland plants to transplant them into the treatment wetland.

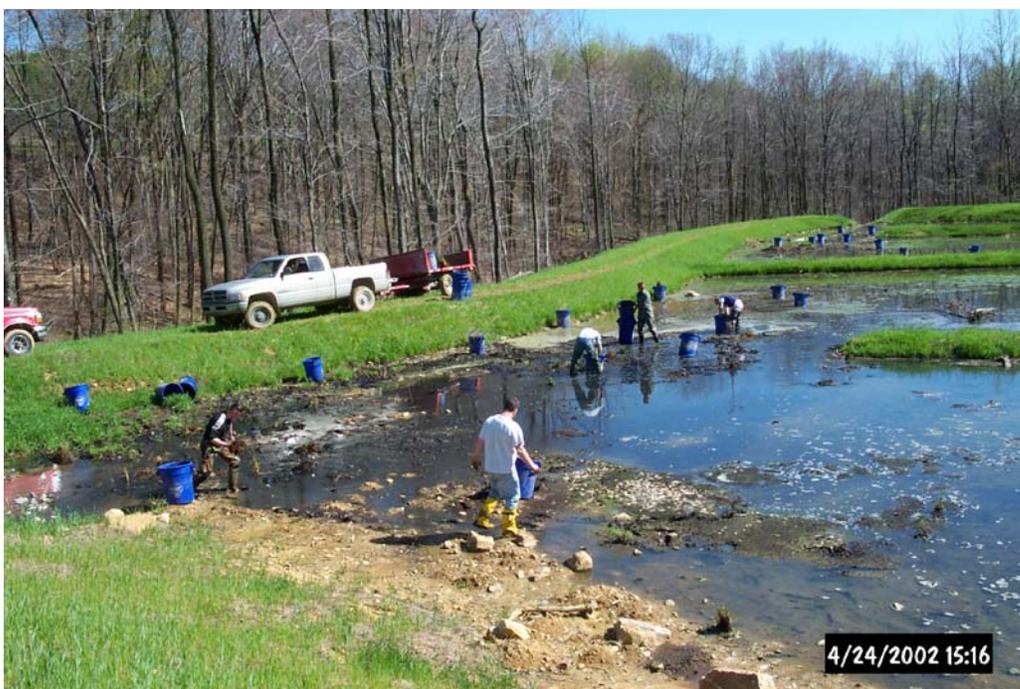
Dr. Brian Okey's Students from Indiana University of Pennsylvania volunteer with Aquascape, BioMost Inc., and Stream Restoration Inc. to plant the naturally-functioning treatment wetland. The students were given a tour of the site with a brief explanation of passive treatment systems and wetland plants prior to the planting.

In addition to improvements in water quality, about a half-acre of naturally-functioning wetlands has been created using more than 12 hydrophytic species which provide wildlife habitat in addition to water treatment. In similar wetlands constructed as part of a passive treatment system, additional hydrophytic species have been observed to volunteer and create an even more diverse ecosystem.

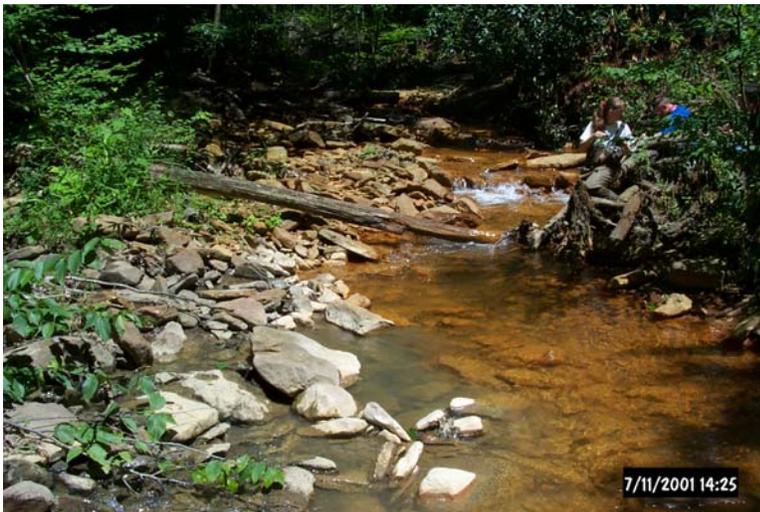
Figure 3: UN1A entering degraded Laurel Run.

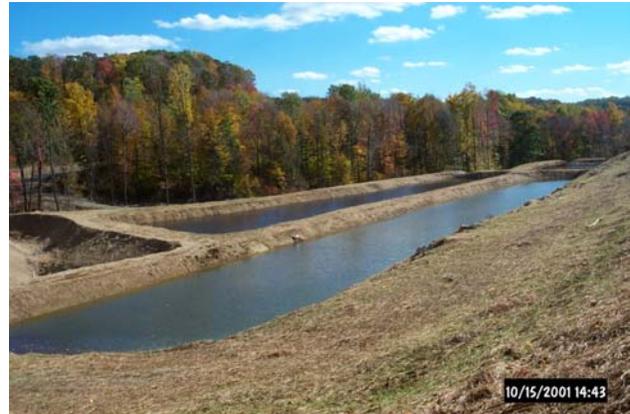
Figure 4: View of flush pond and Vertical Flow Ponds looking south.

In September 2001, a passive treatment system was placed online through a public-private partnership effort involving Stream Restoration Inc., Amerikohl Mining, Inc., PA Game Commission, private landowners, and the Pennsylvania Department of Environmental Protection. This system consists of two Vertical Flow Ponds built in parallel, a flush pond, and a ½-acre wetland. The vertical flow ponds were built entirely of environmentally-friendly materials (limestone and mushroom compost) and utilized an innovative piping system to flush metal particulates from the ponds (Figure 2, 4, 5).

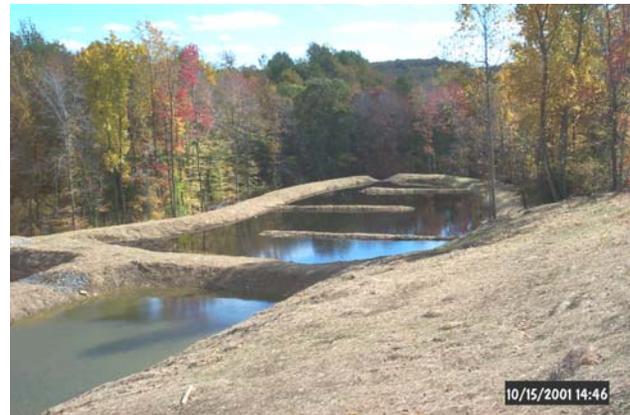
Figure 5: Vertical Flow Pond effluent entering unplanted wetland area to the south. Effluent of wetland enters Laurel Run.
