JB1 Passive Treatment System Phase 1 Technical Report

**BioMost, Inc.
Stream Restoration Incorporated**

RACCOON CREEK WATERSHED RESTORATION - JB1 (PHASE 1)

TECHNICAL REPORT

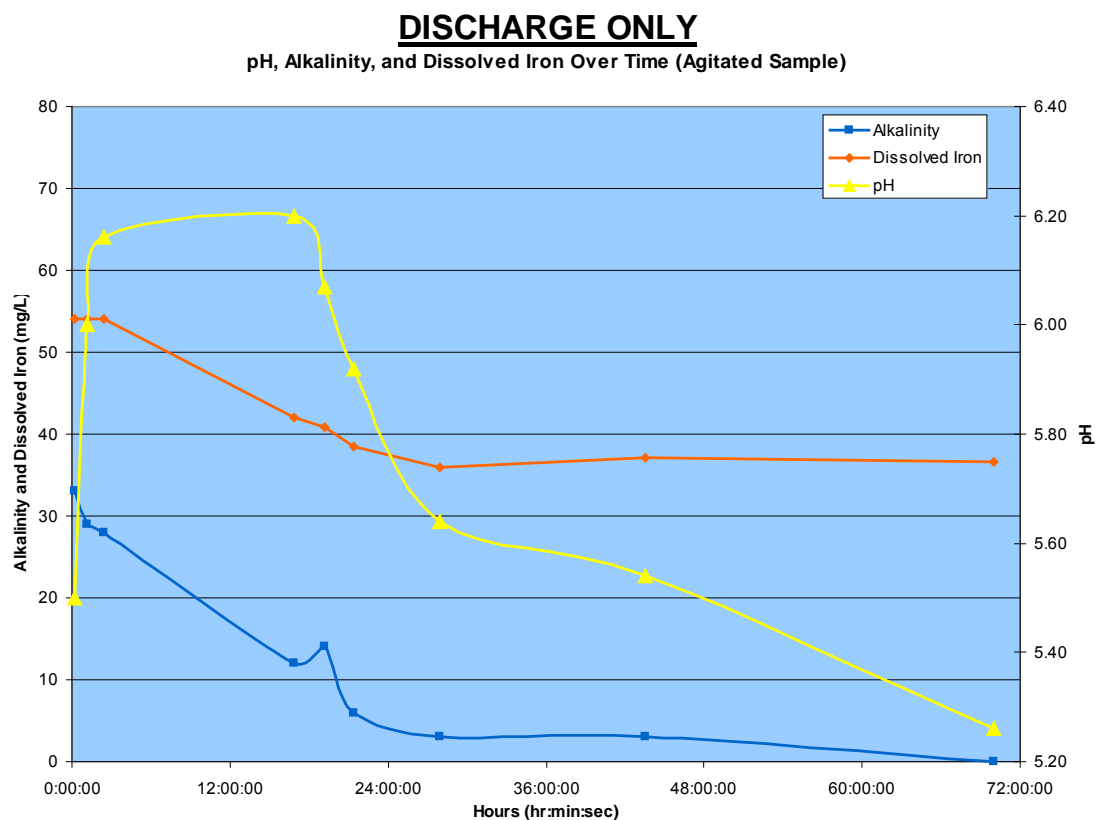
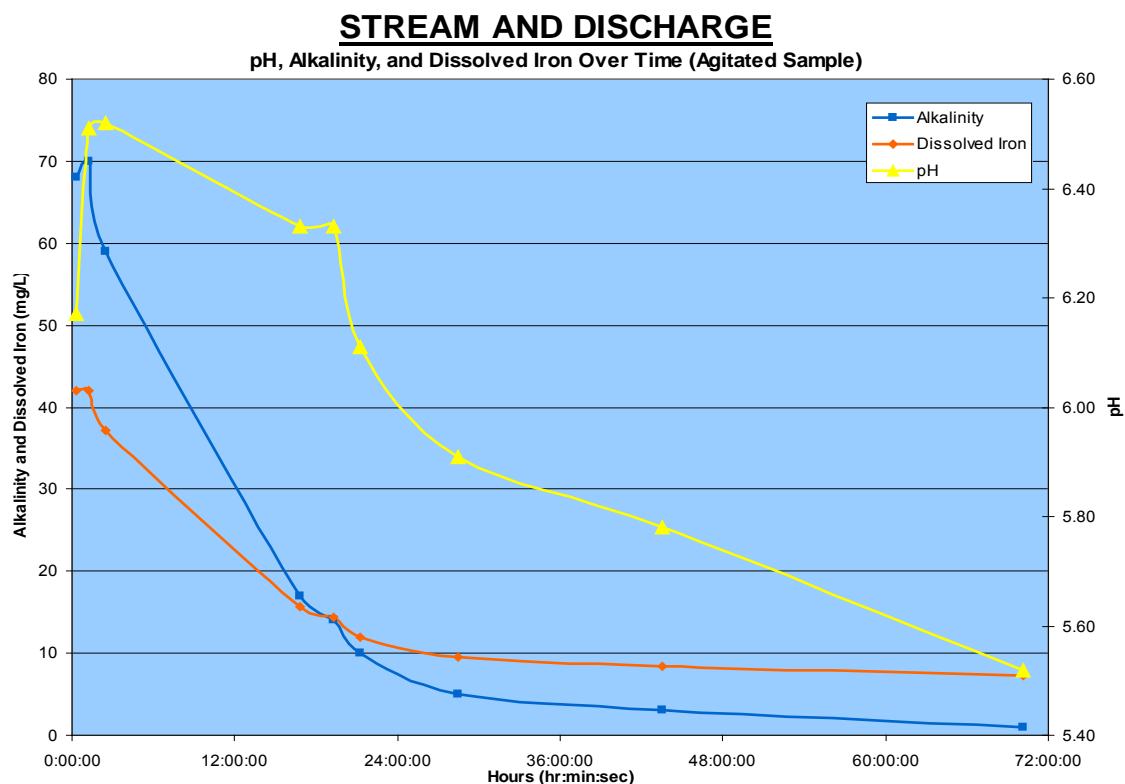
Figure 2: Agitated Samples With and Without Stream Contribution

Figure 2 provides a comparison of the pH, alkalinity, and dissolved iron of the agitated discharge verses the agitated discharge (3 parts) and stream (1 part) mixture. Of particular note is that while the final alkalinity values and pH of the two are similar, the final iron concentrations of the discharge mixed with the stream are much lower. The initial difference in iron content is due to stream dilution; however, the greater change realized for the mixture is most likely due to the higher pH, dissolved oxygen levels, and alkalinity loading provided by the stream, and, with degassing of carbon dioxide during agitation. [Ferrous iron oxidation rates are faster at higher pH and alkalinity maintains (buffers) the pH as acidity is generated from hydrolysis of the ferric iron.] (See photos.)

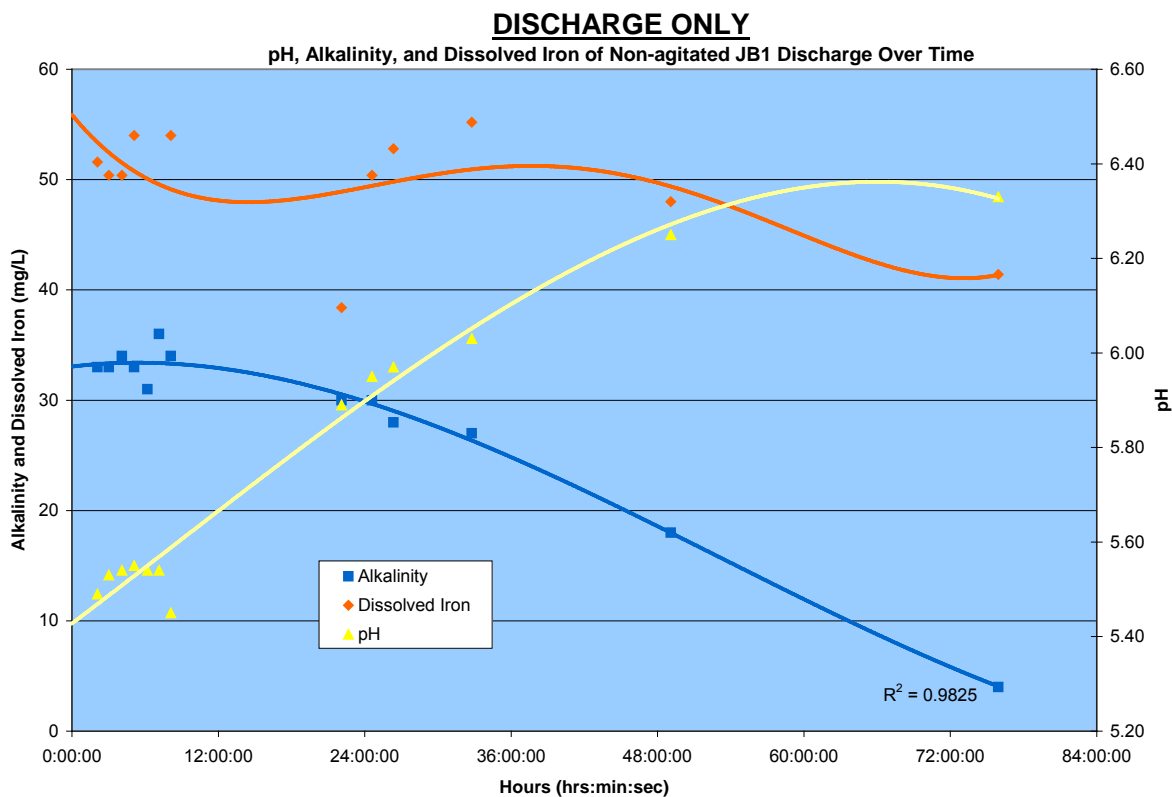
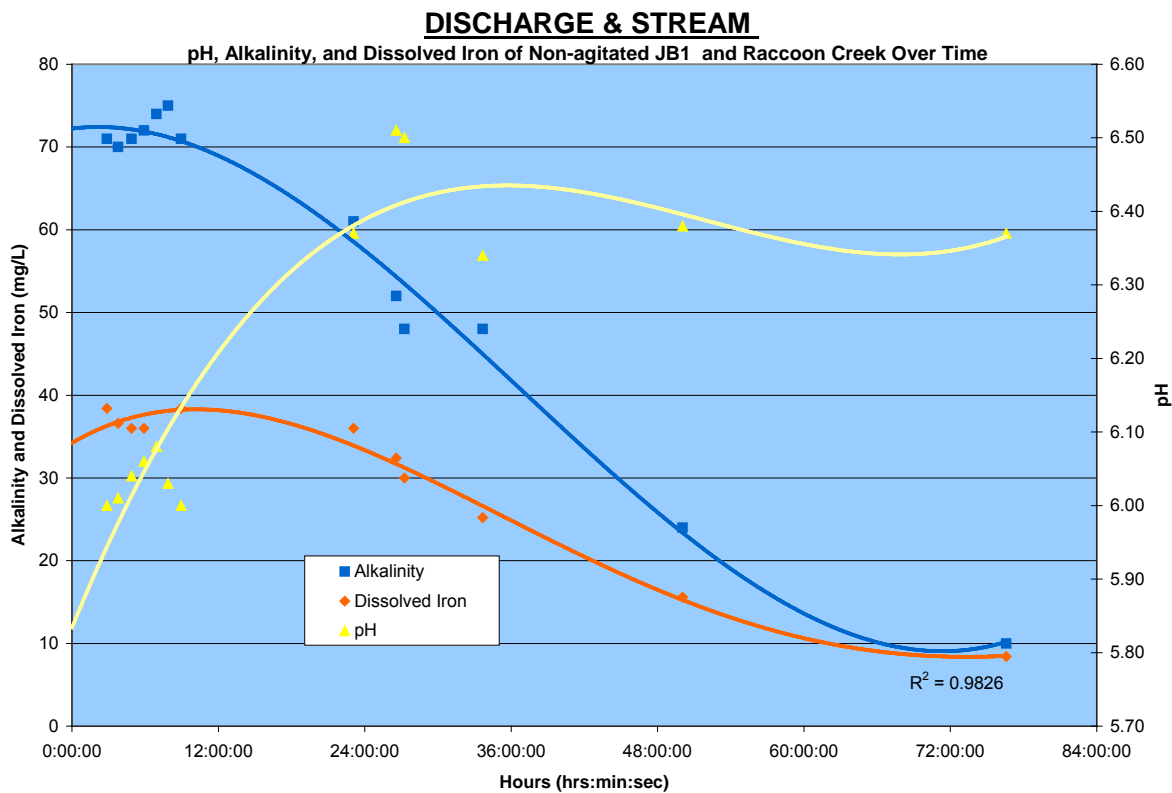
Figure 3: Nonagitated Samples With and Without Stream Contribution

Figure 3 provides a comparison of the pH, alkalinity, and dissolved iron of the non-agitated discharge versus the non-agitated discharge (3 parts) and stream (1 part) mixture. The test indicates that even without agitation, adding a minimal amount of alkaline stream water increased the rate of iron removal. As the system had to be redesigned relating to potential wetland impacts and as the change in elevation at the site is minimal, the non-agitated tests appear to be more applicable for Phase 1 as constructed. Note that specific features, other than the initial “drop” realized at the JB1 discharge outlet pipes, were not able to be included in the redesigned system. (Gravel bars placed in the channels may have helped, in some instances, to aerate the water.) (See photos.)

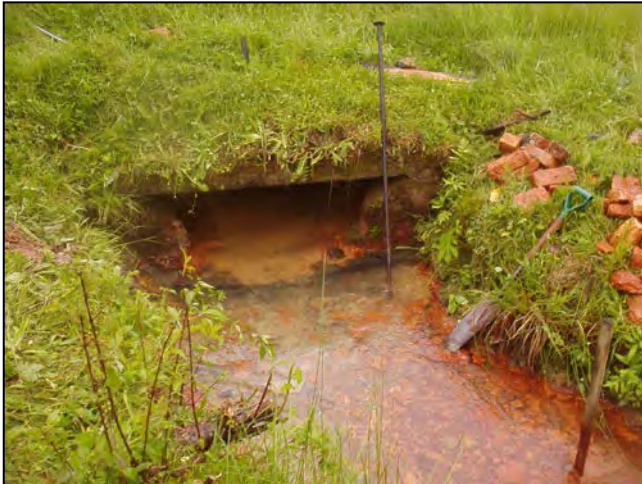
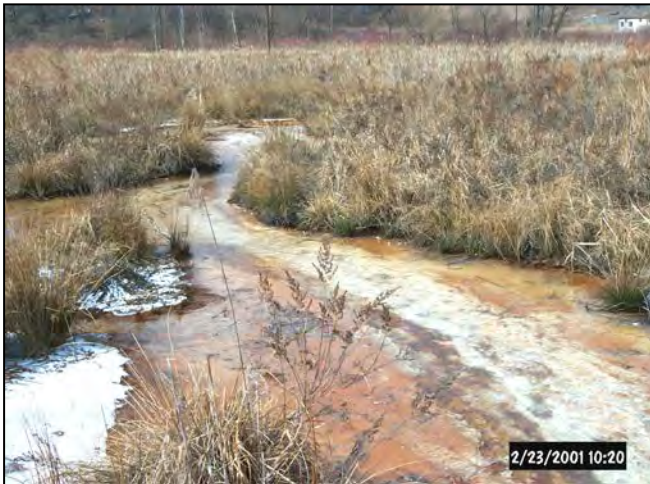
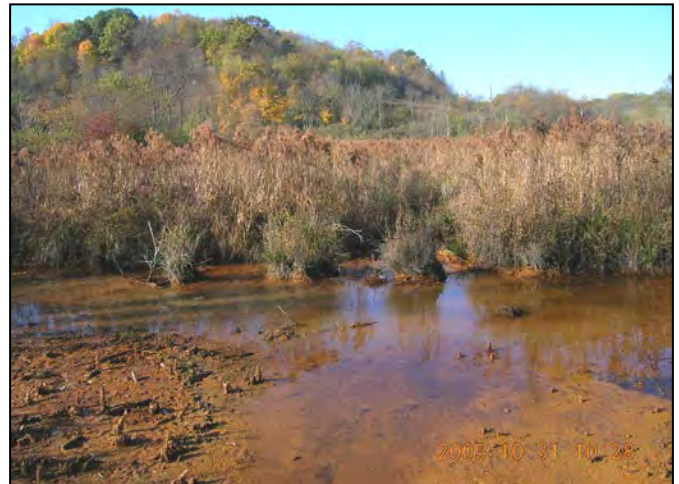
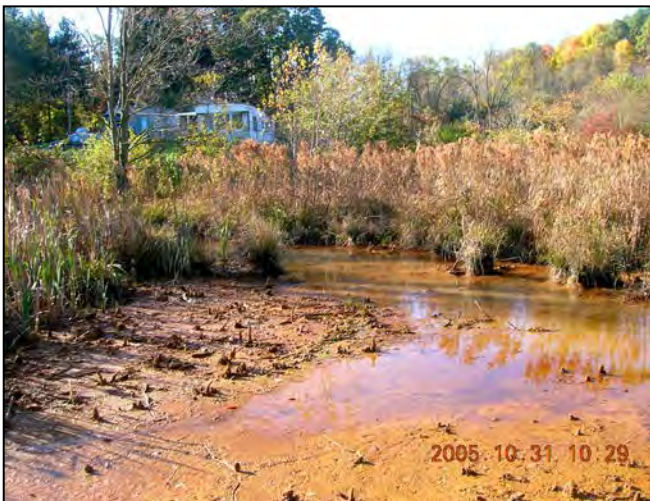
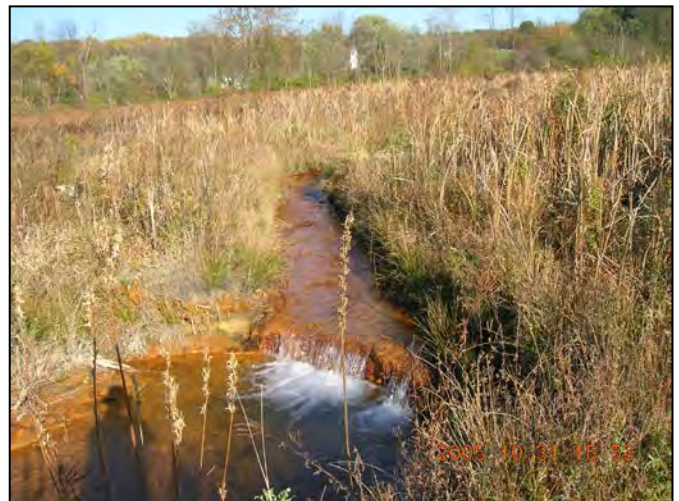
The acidic, metal-laden, JB1 discharge (Upper Left) located in Smith Township, Washington County, which at times flows over 2000 gpm, emanates from an abandoned slope entry of the Pittsburgh and Eastern Coal Company #2 and #3 mines. The AMD flows through a large degraded wetland prior to entering Raccoon Creek. An "aerial" photo (Upper Right) as well as the remaining photographs on this page depicts the extent of the impact of the JB1 discharge to the wetland. Note the proximity of a home to the discharge (Upper Right and Lower Left).

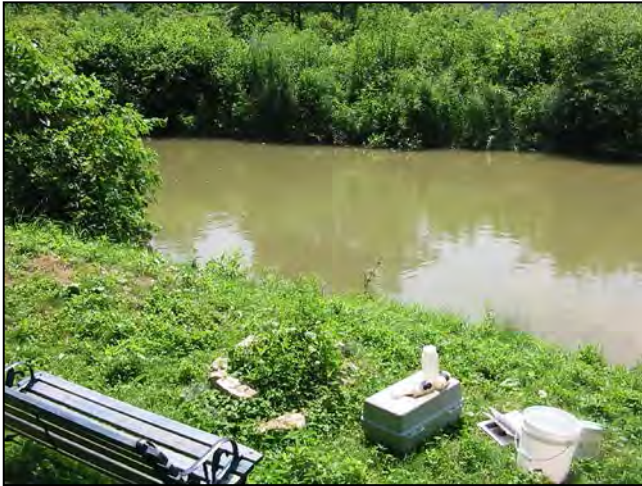
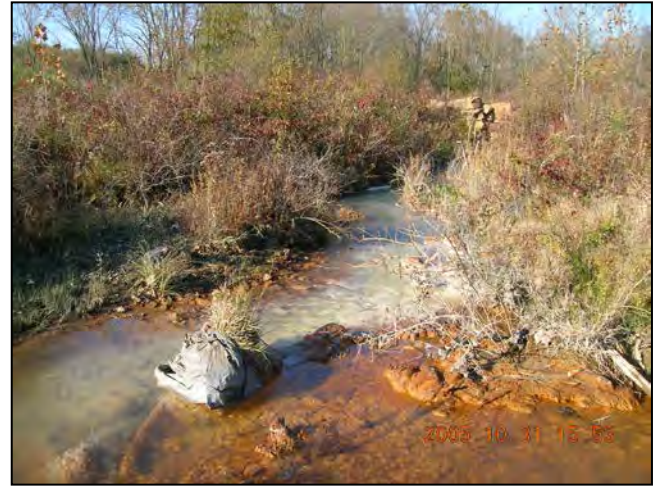
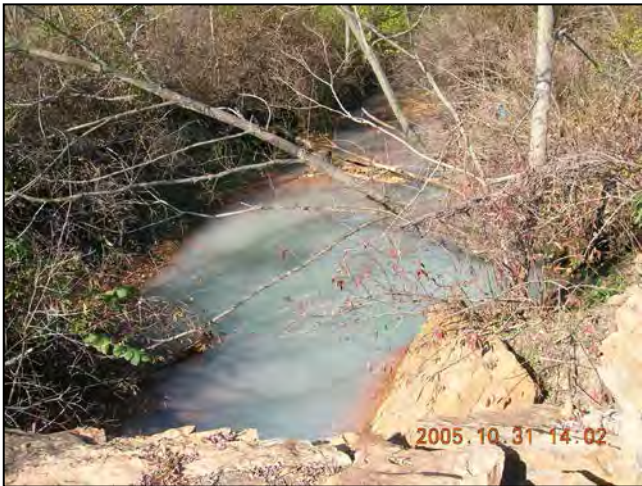
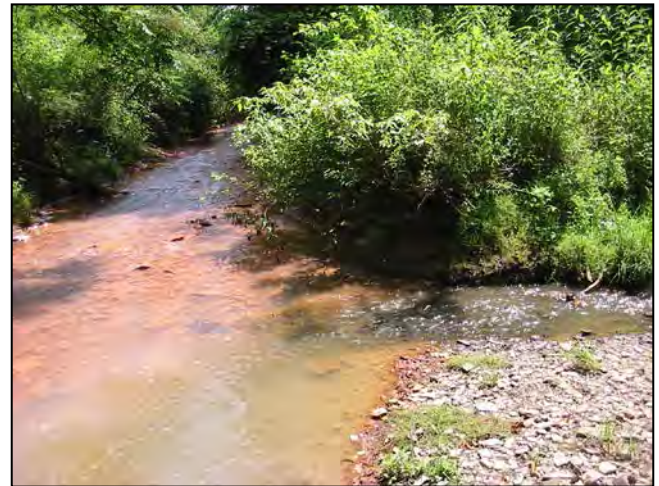
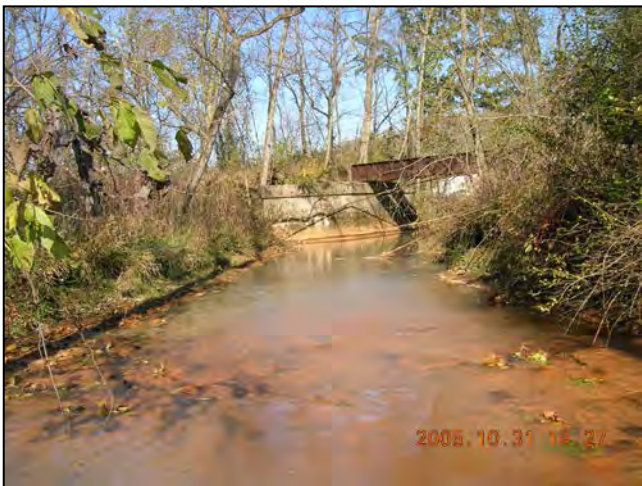
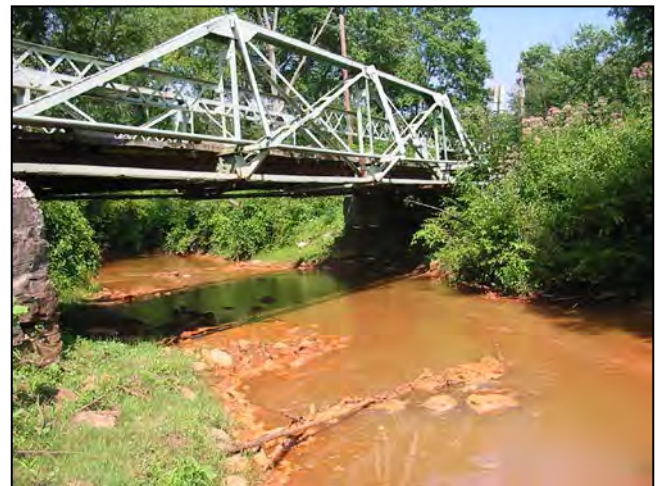
Upstream of the JB1 discharge, Raccoon Creek (Upper Left) is a good quality stream. A portion of Raccoon Creek splits from the main branch as a side channel and intercepts the JB1 discharge (Upper Right and Center Left). After mixing with JB1, the side channel then re-enters Raccoon Creek (Center Right). The severe impact of JB1 to Raccoon Creek can easily be seen at downstream sampling points SR8 (Lower Left) and Keys Road (Lower Right).

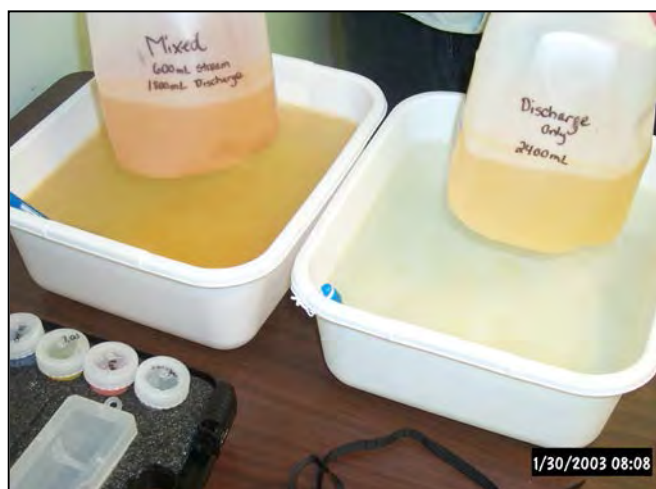
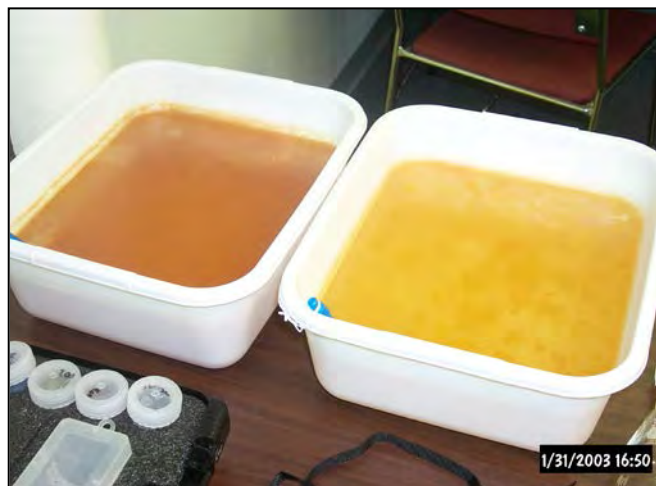
Prior to submitting the grant proposal, a bench-scale experiment utilizing plastic tubs to mimic a settling pond or wetland was conducted, where the discharge without addition of alkaline stream water (Right Tub) was compared to a mixture of 1 part Raccoon Creek to 3 parts of JB1 discharge (Left Tub). The photos depict the experiment from beginning to end. As can be seen from the photos, the mixture resulted in faster iron precipitation than the discharge alone. The initial conceptual design of the passive treatment system was to install a stream intake in order to mix the JB1 discharge with the highly-alkaline and well-oxygenated Raccoon Creek in a treatment wetland.

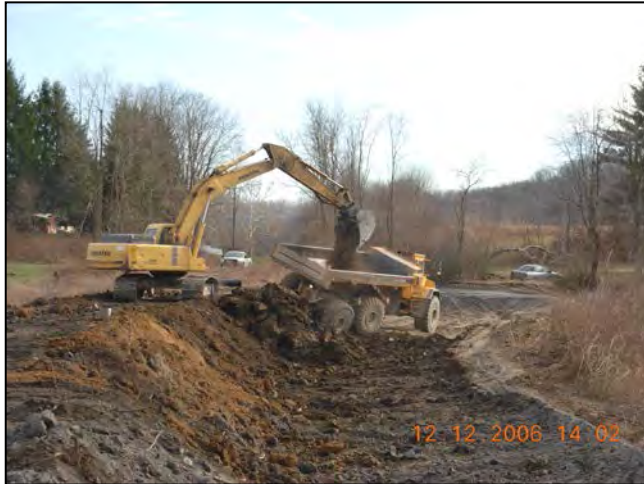
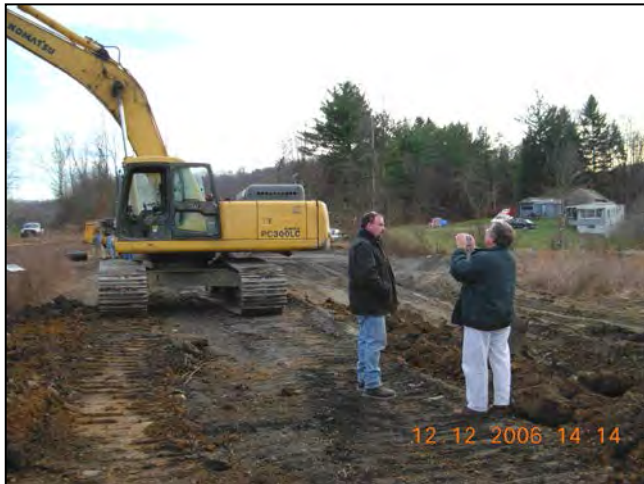
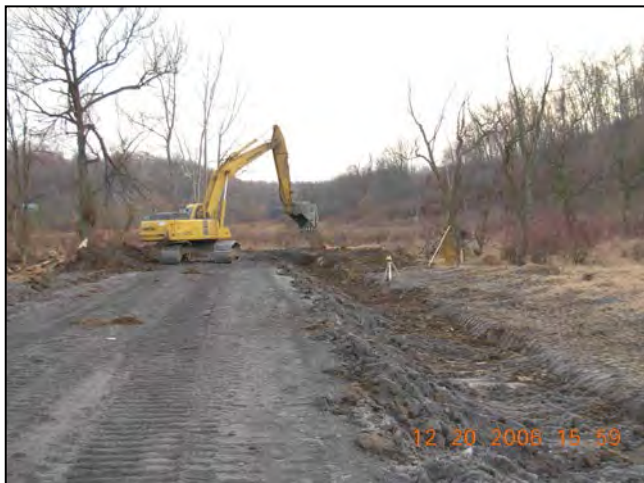
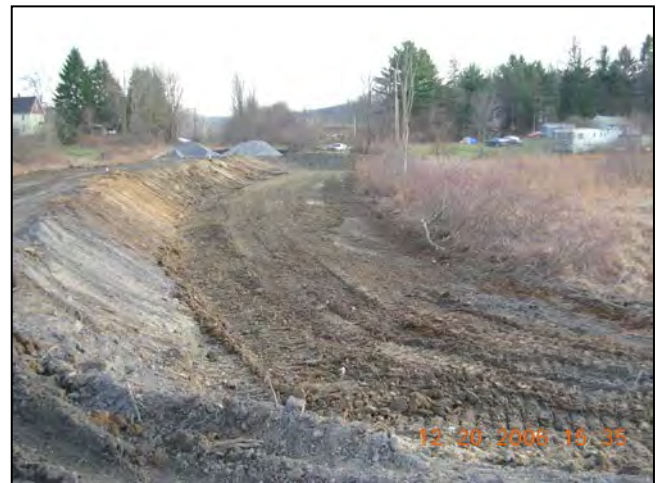
In order to complete the design and permitting for the passive treatment system, water monitoring and site investigations were conducted. An Environmental Assessment (Upper Left and Right) was completed with Jeff Reidenbaugh (Aquascape). Piezometers were installed by McKay & Gould Drilling (Center Left) and monitored by BioMost, Inc. and Bruce Leavitt (Center Right). A flume was installed (Lower Left and Right) at the JB1 discharge to monitor flow rates prior to completion of the design.

A V-notch weir was installed and used by the PA DEP for JB1 flow measurements. As the weir needed to be replaced, in May 2006, an H-Flume was temporarily installed to measure the flow rate of JB1. A datalogger was used to provide measurements at 30-minute intervals between June 2006 and Oct. 2006, primarily as part of the aforementioned “ELF” feasibility study. The following graph depicts the continuous flow rate measurements obtained from the datalogger. The flow rates physically measured [engineer’s rule with conversion to gpm from the Discharge Table for 2.0’ H Flume (Wachter, 04/06/00)] during sampling events or site inspections are identified in the monitoring reports and used for the site evaluation. During construction of the passive system, the flume was removed. Currently, research is being conducted by Bruce Leavitt, PE, PG to evaluate measurement of the JB1 flow rate from a single port into each of the JB1 discharge distribution pipes.

In order to characterize the groundwater conditions as well as the geology of the site, ten boreholes (94-1 through 94-10) were drilled and logged. Of the ten boreholes, four (94-1, 94-8, 94-9, 94-10) were developed into piezometers. Drilling was completed by McKay and Gould Drilling, Inc. (Darlington, PA) and BioMost, Inc. on 12/19/05. Water levels were measured and water samples collected. See the Geologic Drill Hole Logs/Piezometer As-Builts (Drill Logs) and Water Quality Database in the Appendix. The information gained enabled interpretation of the local attitude of the Pittsburgh coalbed, location of mine workings, and a “glimpse” as to the local hydrology and mine pool characteristics.

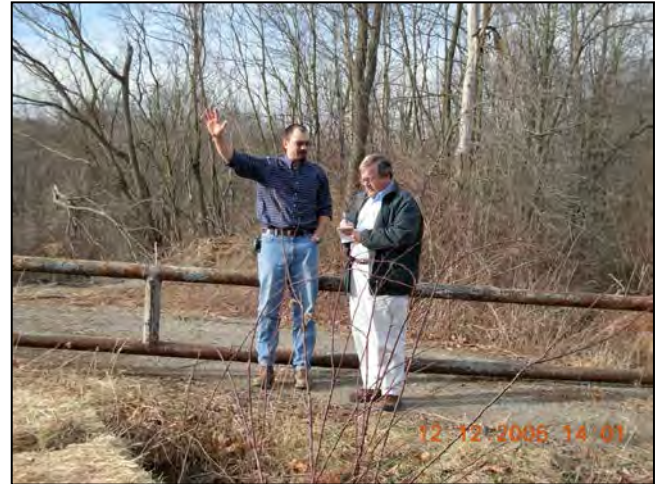
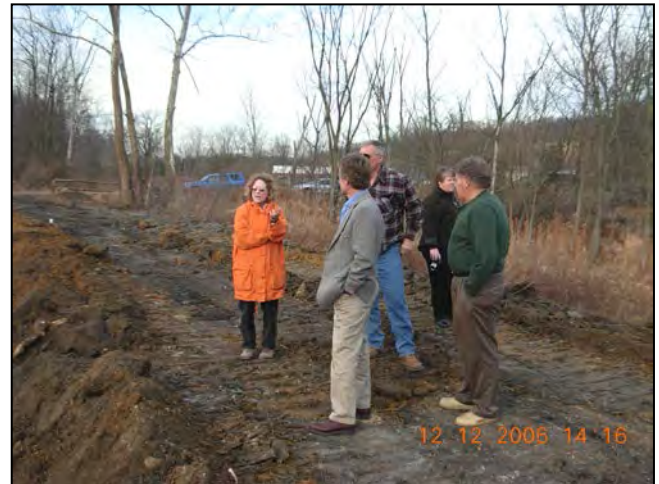
An innovative approach was taken to enhance the naturally-occurring, AMD-impacted, wetland. These enhancements began in December 2006 with stabilization of an existing, abandoned, railroad grade/access road. On 12/12/06, former PA DEP Secretary Dave Hess toured the JB1 site and other restoration projects in the Raccoon Creek Watershed. Video blogs of Tim Danehy of BioMost, Inc (Upper Right) and equipment operator Wayne Fuchs (Center Left) of Quality Aggregates were included in the *PA Environment Digest*. Members of the Raccoon Creek Watershed Association and Stream Restoration Incorporated (Center Right) were also on hand to conduct the tour.

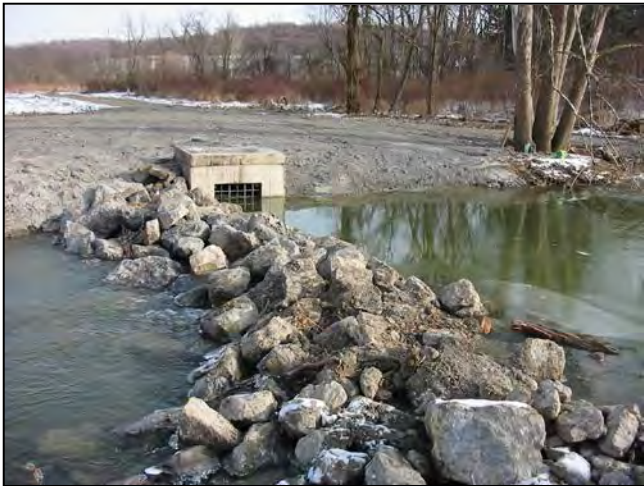
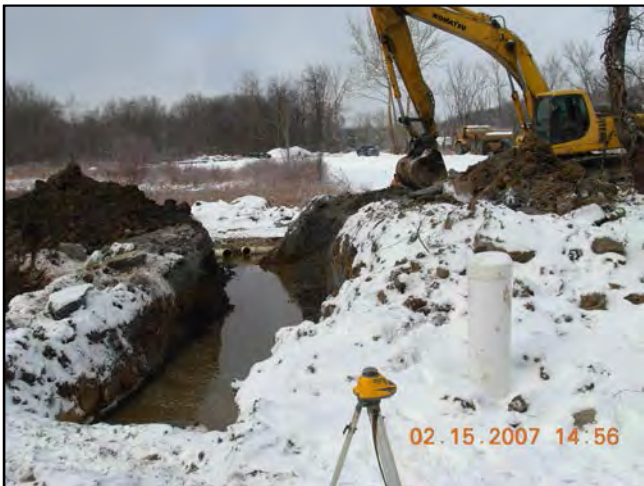
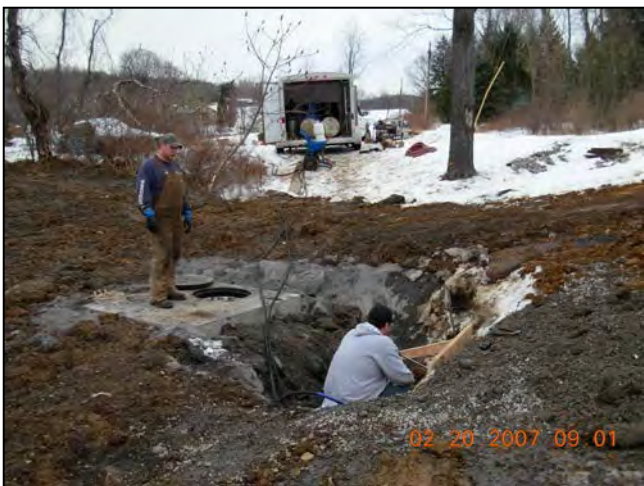
Two separate distribution systems were installed to evenly disperse the JB1 discharge and a small portion of Raccoon Creek around the outer perimeter of the wetland. Each distribution line has twenty-one outlet risers (Center Right and Lower Right) to spread the flow in order to more completely utilize the pre-existing, AMD-impacted, wetland. The lower outlet riser closer to the wetland is for the Raccoon Creek distribution line while the higher outlet riser closer to the berm is for the JB1 discharge distribution line.

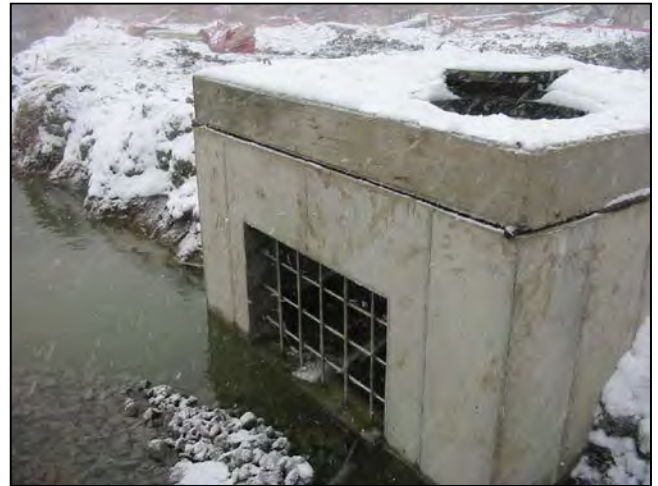
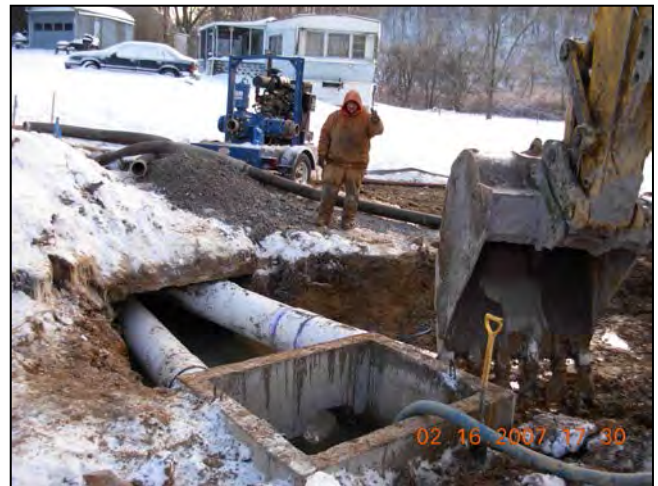
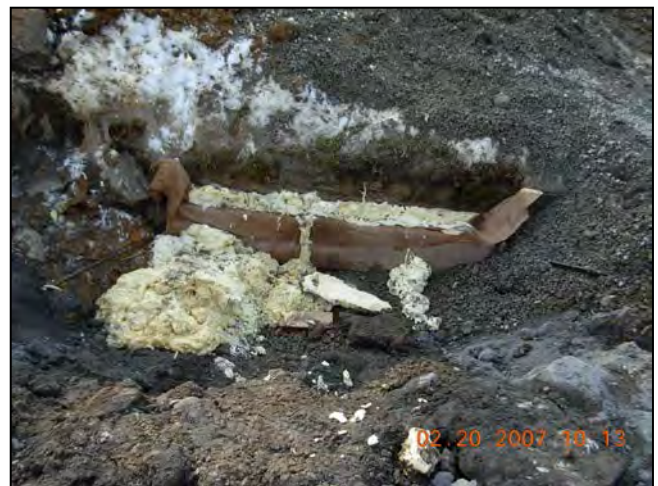
An intake structure and rock vane (Upper Left and Right) were installed in the same location as a previously existing beaver dam (local fishing and swimming “hole”). A distribution line from the intake was installed along the perimeter of the existing wetland in order to mix a small portion of the high alkalinity, well-oxygenated, Raccoon Creek with the JB1 discharge. To capture and distribute the JB1 discharge, two, 18”, perforated pipes were placed in an excavated channel (Center Left), inserted into the old mine entry, and connected to a concrete, flow-splitter box (Center Right). The flow-splitter box was then connected to the distribution line. The mine entry was then sealed with a polyurethane grout by contractor Sub-Technical, Inc. (Lower Left and Right).

The second component is a stream intake and distribution system. An existing, breached, beaver dam (See attached photo.) which had been previously stabilized by others for fishing/swimming was replaced in Raccoon Creek with a rock cross-vane to maintain a water level at ~1001.5 feet. (The elevation at the top of the existing streambank was ~1002.6 feet and the water level above the breached beaver dam was ~1000.2 feet on 12/07/05.) Upstream of the cross-vane, a 12-inch, Schedule 40, PVC pipe with ½-inch perforations spaced every 4 inches was installed to convey the stream flow to a prefabricated concrete stream intake structure. A pipeline was then installed along the perimeter of the wetland in parallel with the discharge piping. Twenty-one adjustable outlet risers were installed at the same locations as the discharge risers to encourage mixing of the AMD and the stream water prior to entering the wetland.

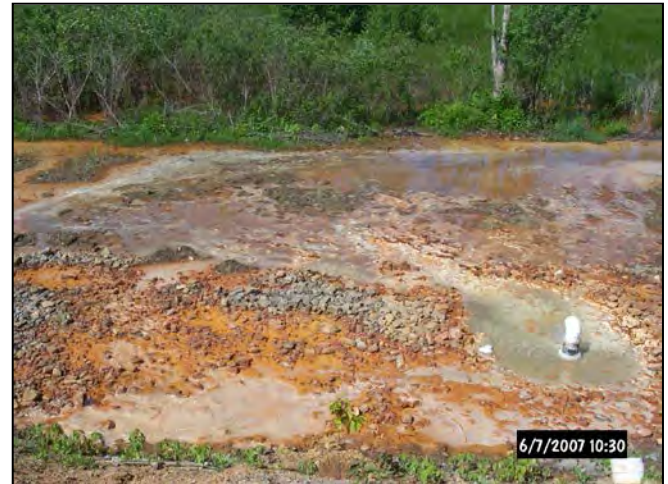
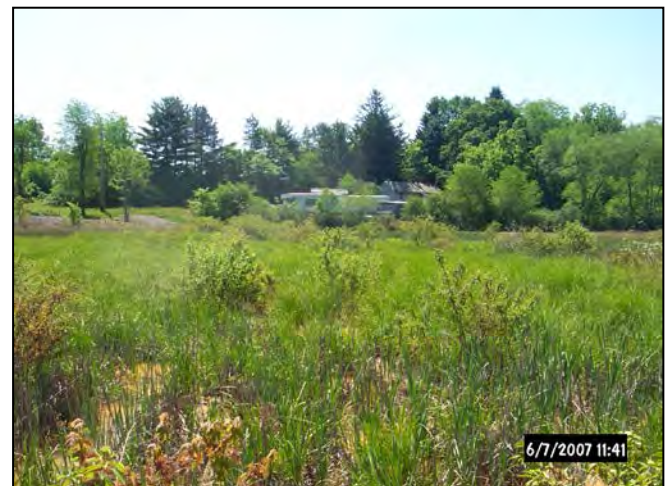
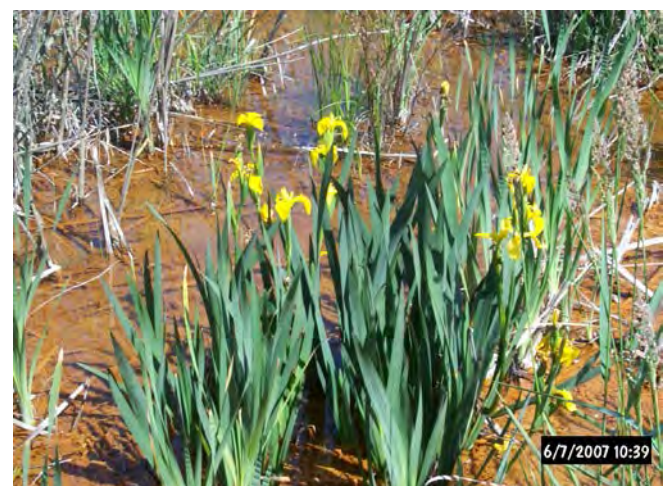
As the JB1 discharge and stream water from Raccoon Creek mix, chemical reactions begin to occur resulting in the precipitation of aluminum (white precipitates) and iron (red and orange precipitates). These reactions continue within the wetland. Gravel bars (Lower Left) were placed within existing channels in the wetland to disrupt preferential flow paths and encourage better distribution and mixing of the discharge with the stream water. Wetland plantings were conducted to increase species diversity, to enhance wildlife habitat, and to further water treatment.

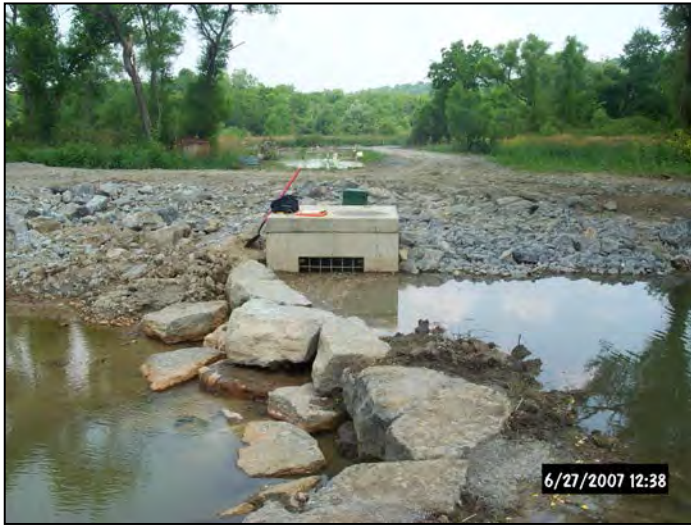
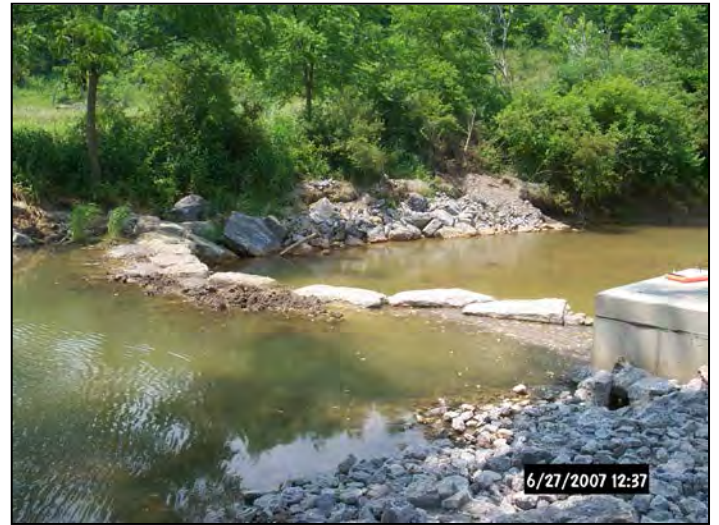
The pre-existing beaver dam (fishing and swimming “hole”) was removed and replaced with the cross vane shown here.

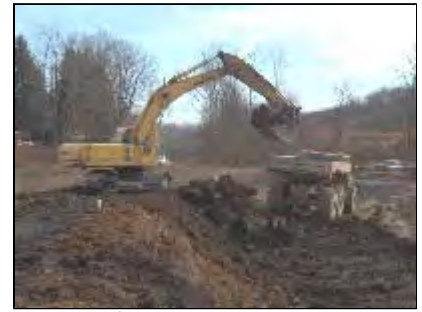
JB#1 Under Construction

Phase I of the JB#1 Project is located in the headwaters of the Raccoon Creek Watershed in Washington County and is designed to treat a 1,100 gallon per minute mine discharge.

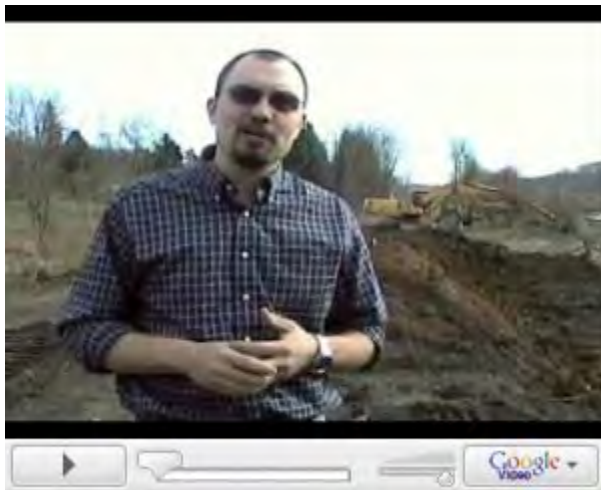
Phase I of the JB#1 Project is located in the headwaters of the Raccoon Creek Watershed in Washington County and is designed to treat a 1,100 gallon per minute mine discharge.

The unique design of this project will mix clean water from Raccoon Creek with the contaminated mine water to increase the effectiveness of a pond and wetland treatment system to reduce the iron content of the water by about 45 tons a year.

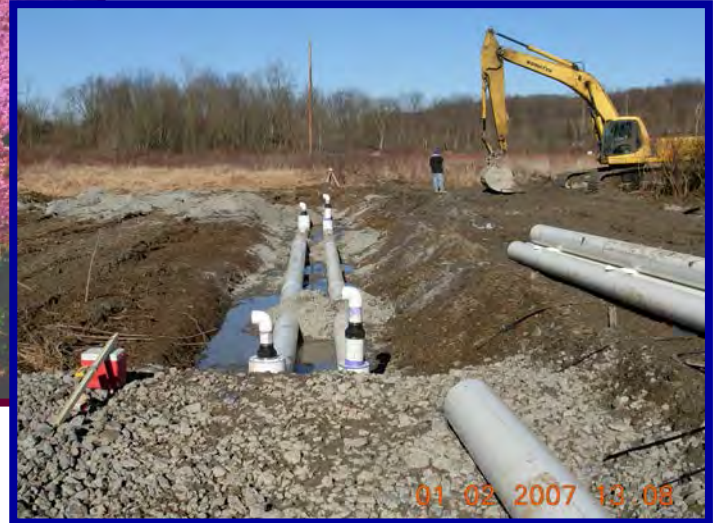
Right: Quality Aggregates Inc. installing an innovative manifold distribution system to utilize available wetland area to treat JB1.
