SCHUYLKILL CONSERVATION DISTRICT

**REMEDIATION OF THE TRACY AIRHOLE AMD DISCHARGE PROJECT**

FINAL REPORT

DOCUMENT # 4100028356

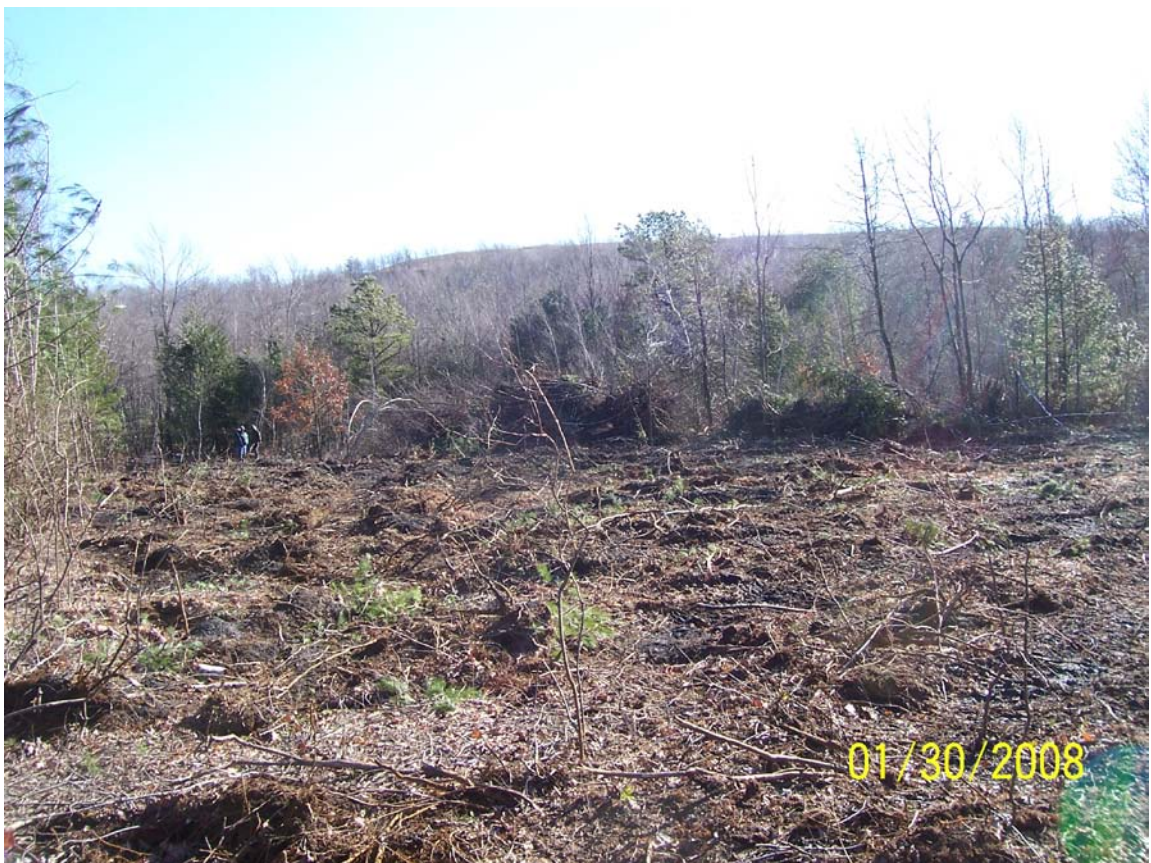
Picture1. Clearing and grubbing of the overflow settling basin site.

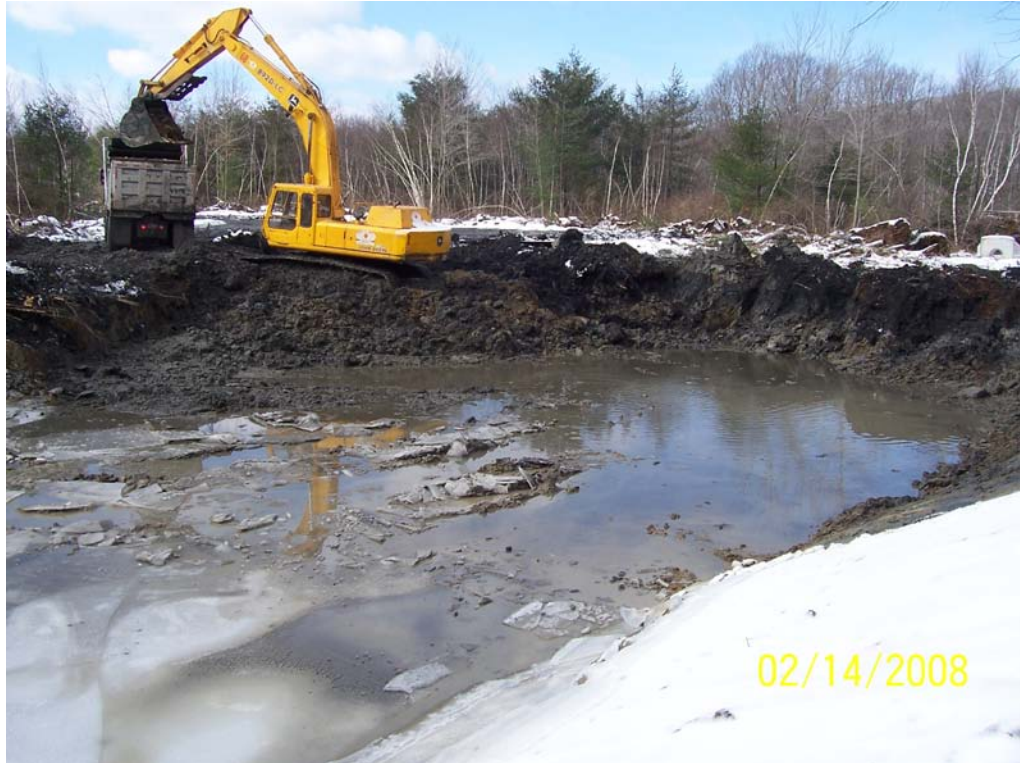
Picture 2. Excavation of the overflow settling basin

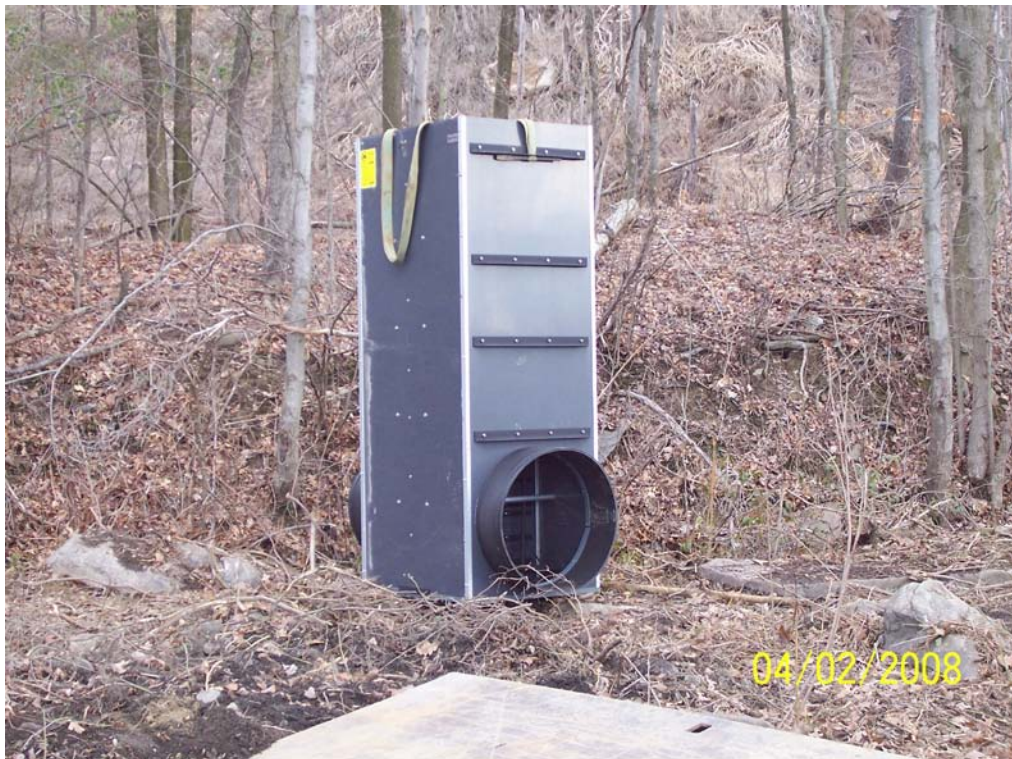
Picture 4. Inline water control level control structure to be placed in discharge channel.

The treatment system utilizes an ability to be operated passively or actively using aeration. An Inline Water Level Control Structure (IWLCS) placed in the discharge channel diverts water through an 18" pipe to the primary settling basin's level spreader. During periods of high flows, water is diverted through and around the IWLCS down the existing channel to a second IWLCS that diverts water into the overflow settling basin.

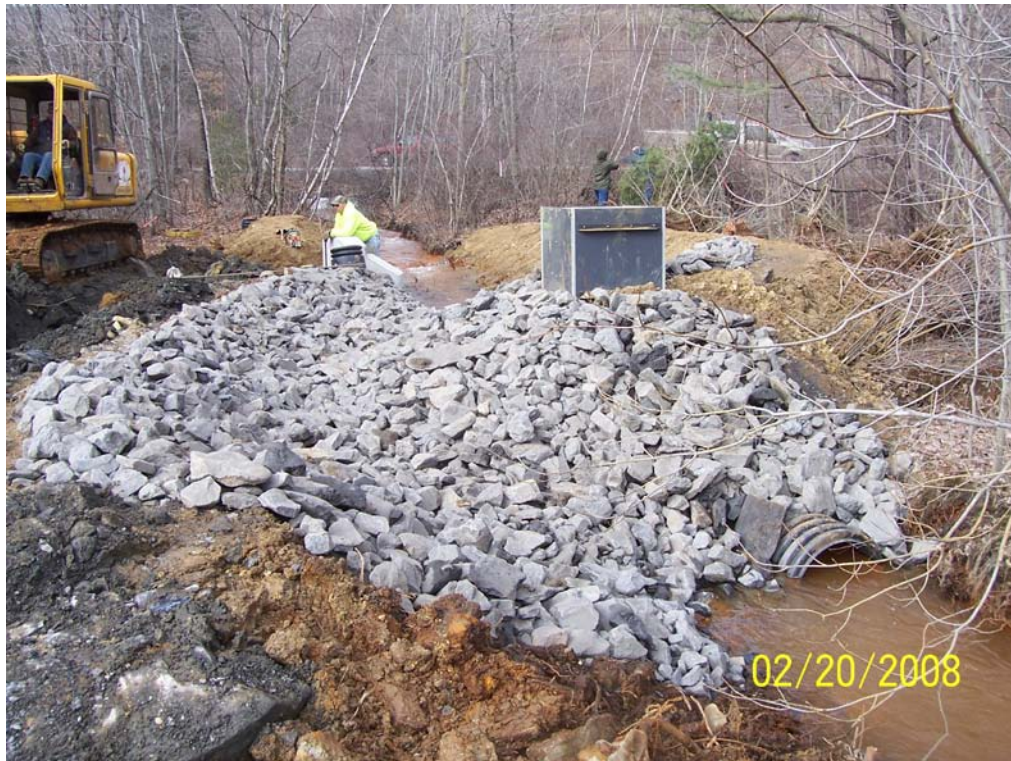
Picture 5. Placement of water level control structure in discharge channel.

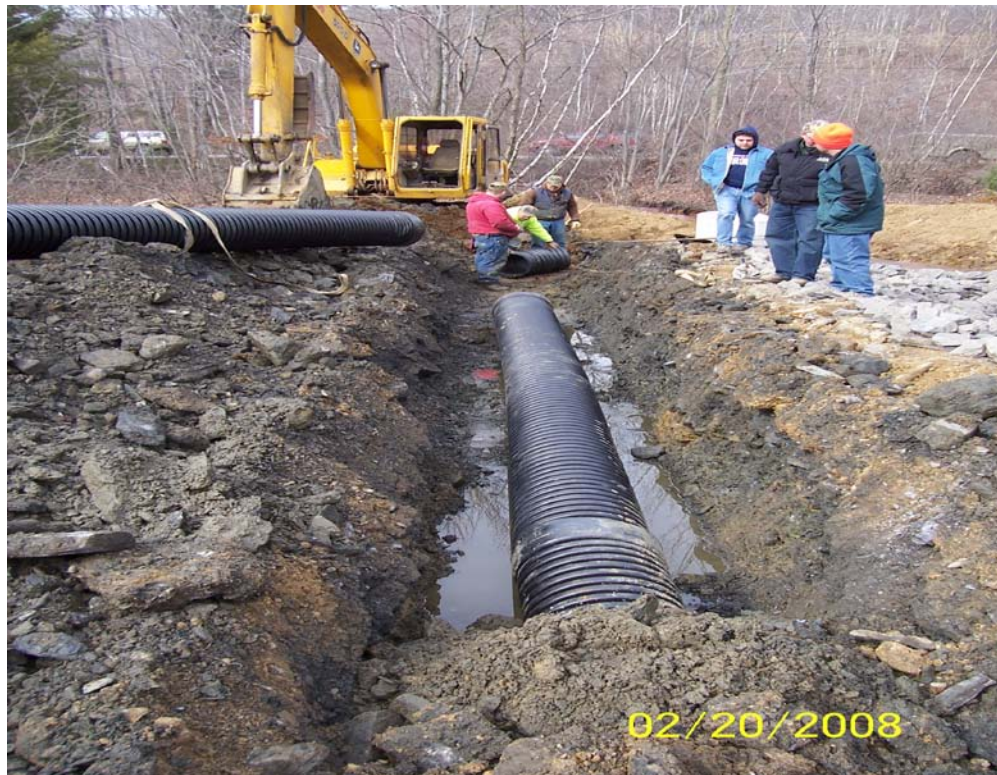
Picture 6. Placement of overflow settling basin intake pipe.

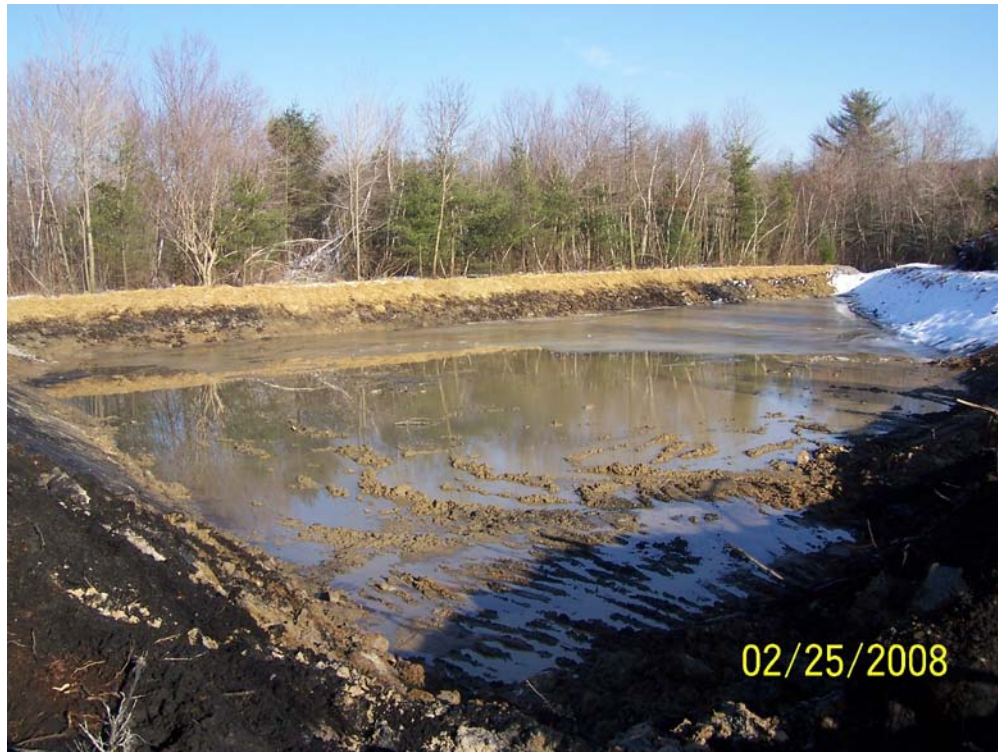
Picture 7. Completed overflow settling basin before being filled with water.

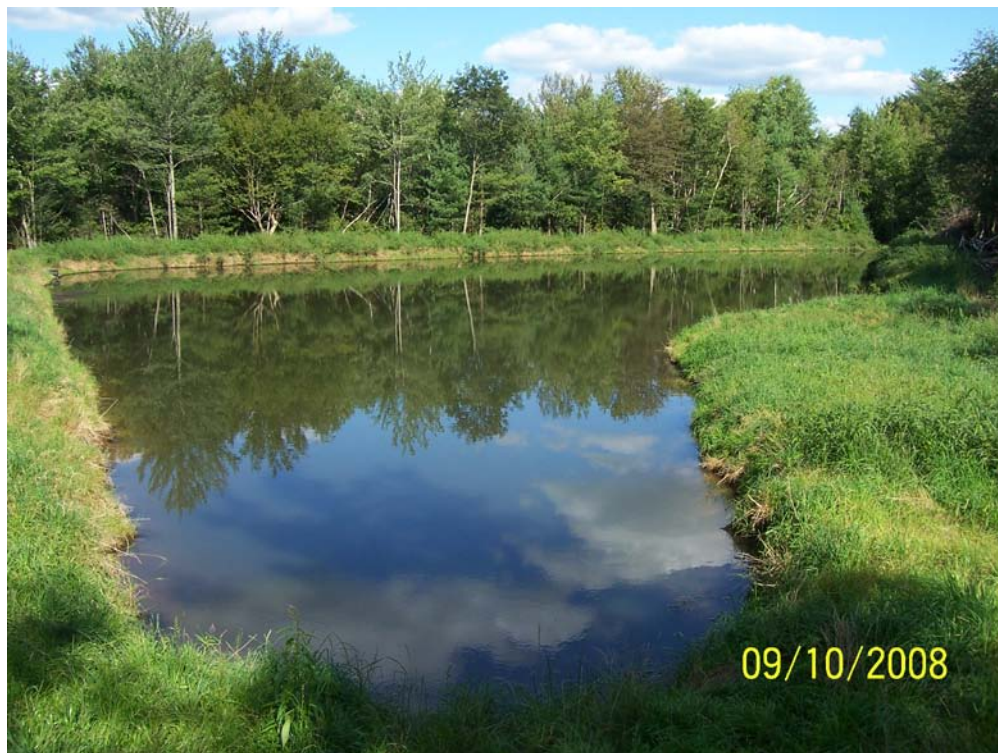
Picture 8. Overflow settling basin receiving water from the primary settling basin.

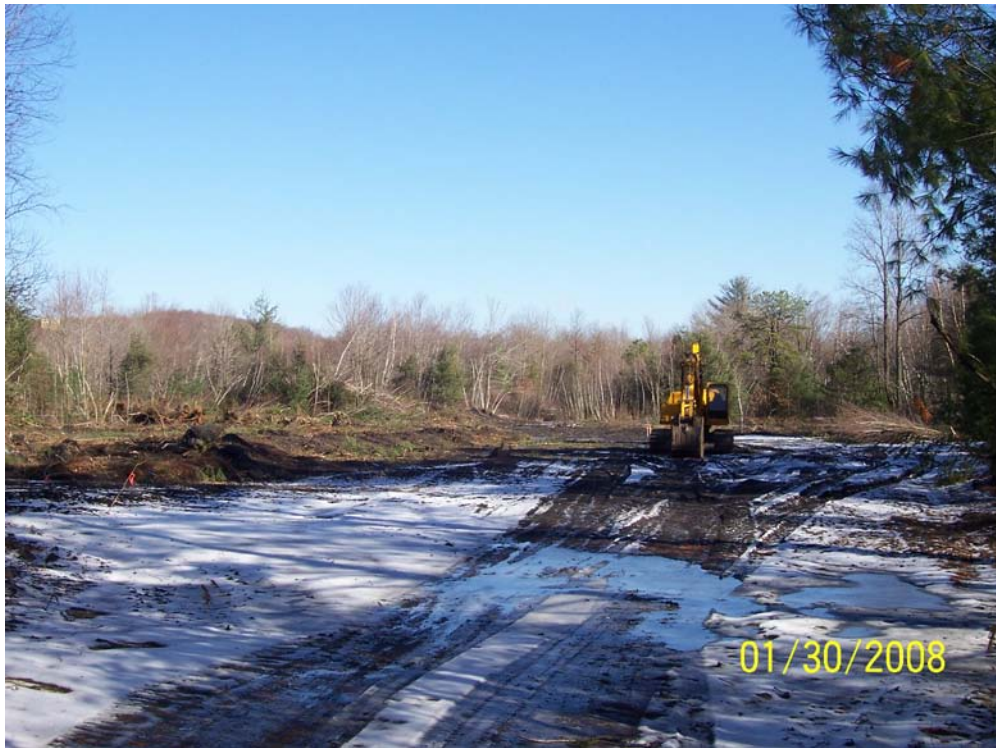
Picture 9. Clearing and grubbing of the polishing wetland site.

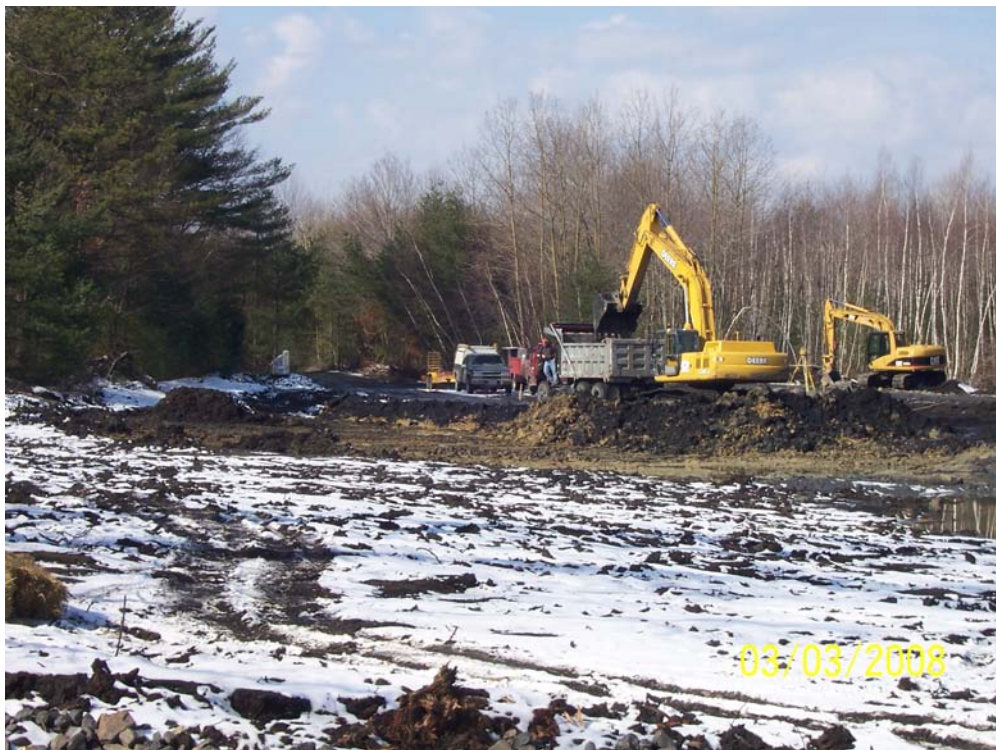
Picture 10. Excavation of the polishing wetland.

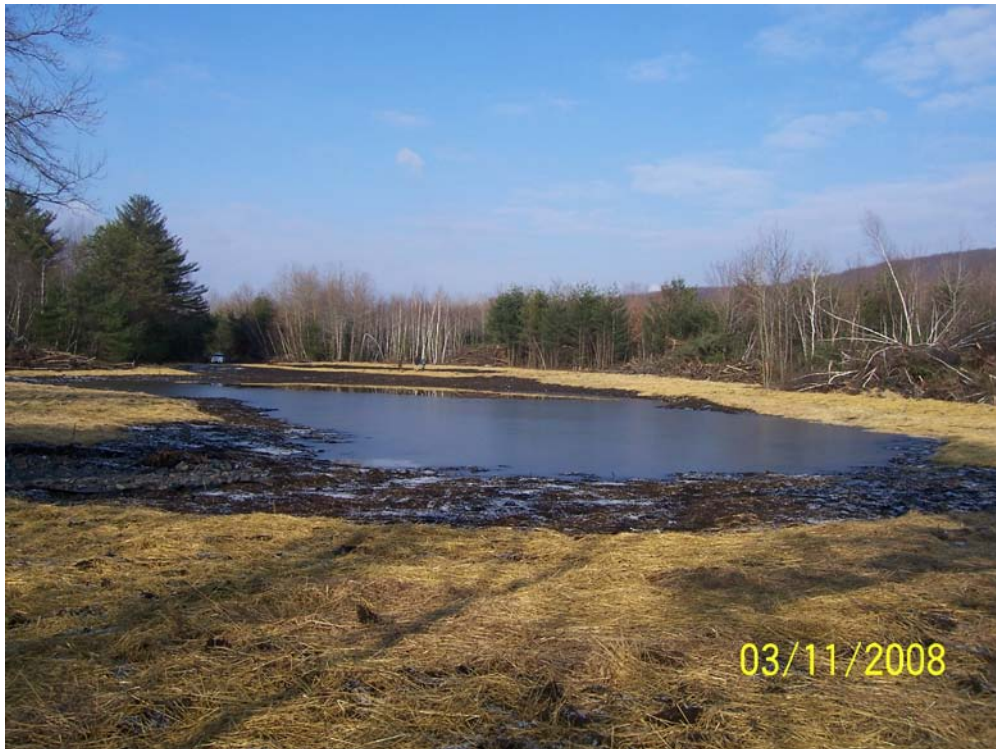
Picture 11. Completed polishing wetland, before being filled with water

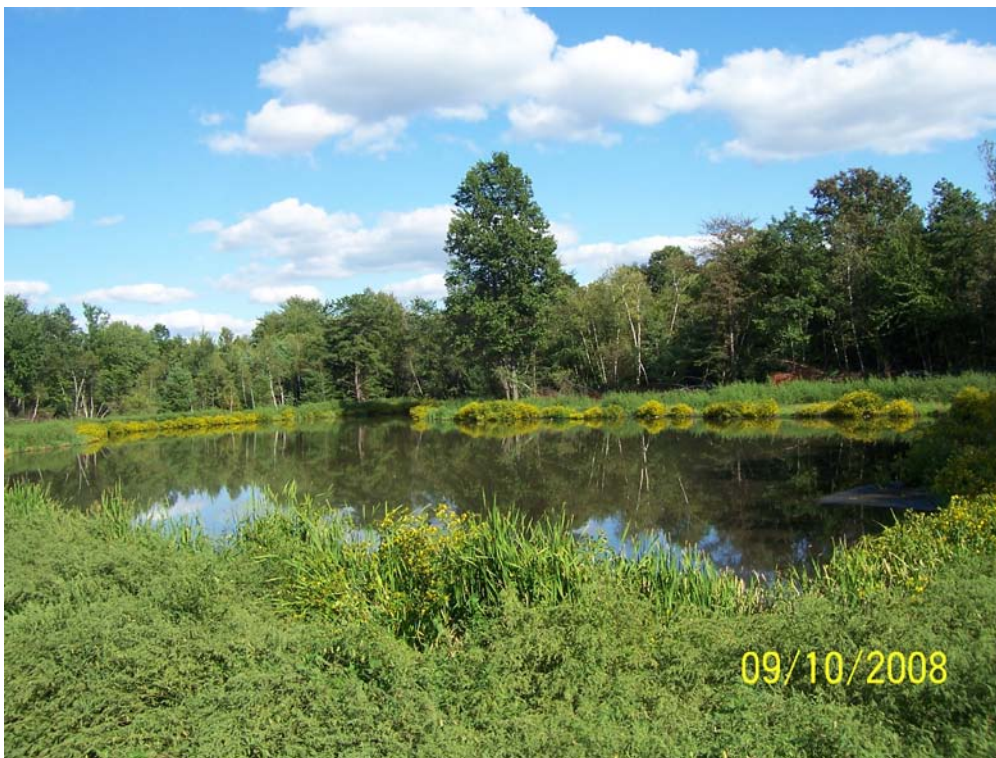
Picture 12. Polishing Wetland receiving water from the primary settling basin.

After water has left the primary settling basin, it flows through an undisturbed wooded area where it creates a shallow wetland. Originally all water leaving the primary settling basin was to flow through the wooded area into a constructed polishing wetland; however, this did not occur due to variations in land topography about one third of the flow is diverted further into the wooded area where it flows into the overflow basin. Although not originally designed, the splitting of flow between the constructed polishing wetland appears to be beneficial to the treatment system's overall treatment effectiveness. The remaining two thirds of flow continues as intended to the polishing wetland. Treated water leaving the overflow basin and polishing wetland enters Good Spring Creek.

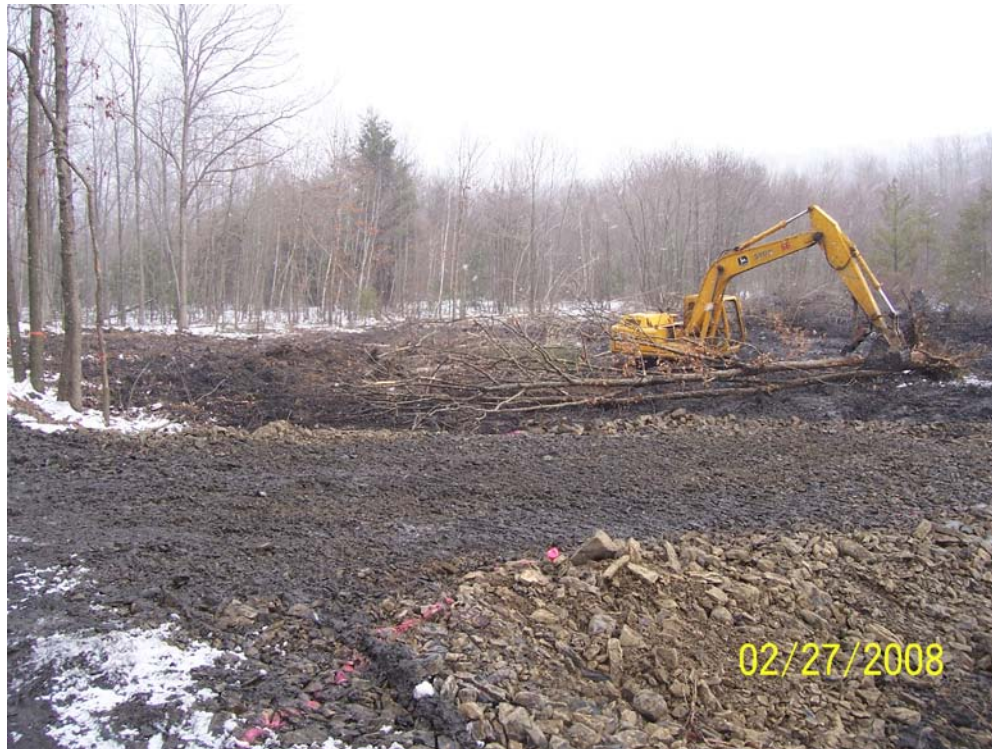
Picture 13. Clearing and grubbing of the primary settling basin site.

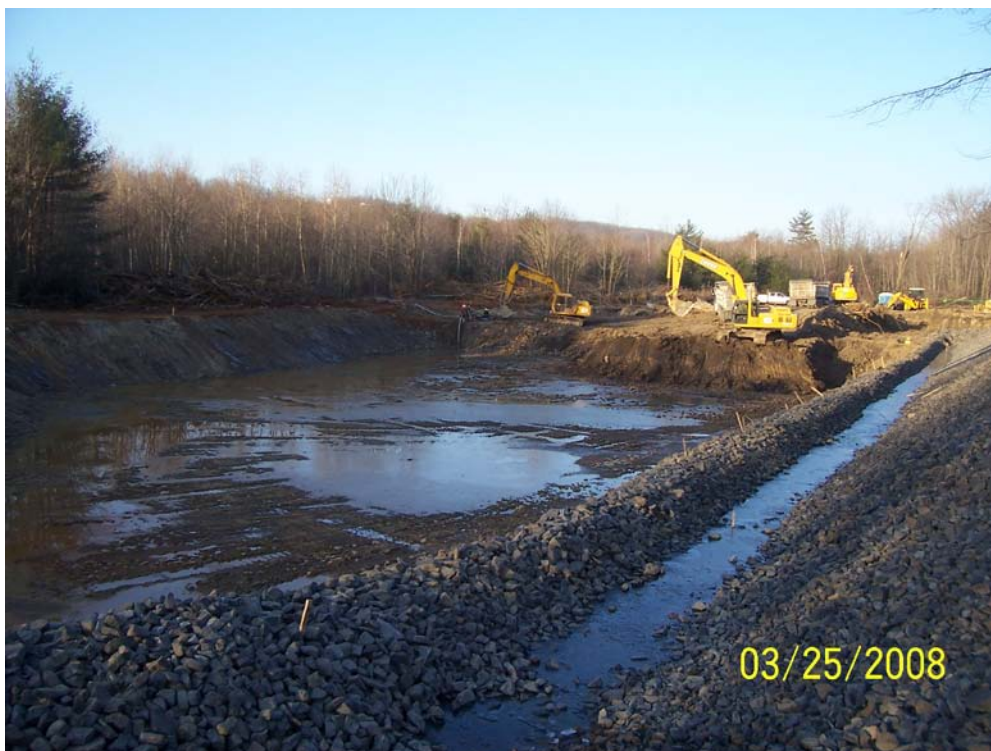
Picture 14. Excavation of the primary settling basin.

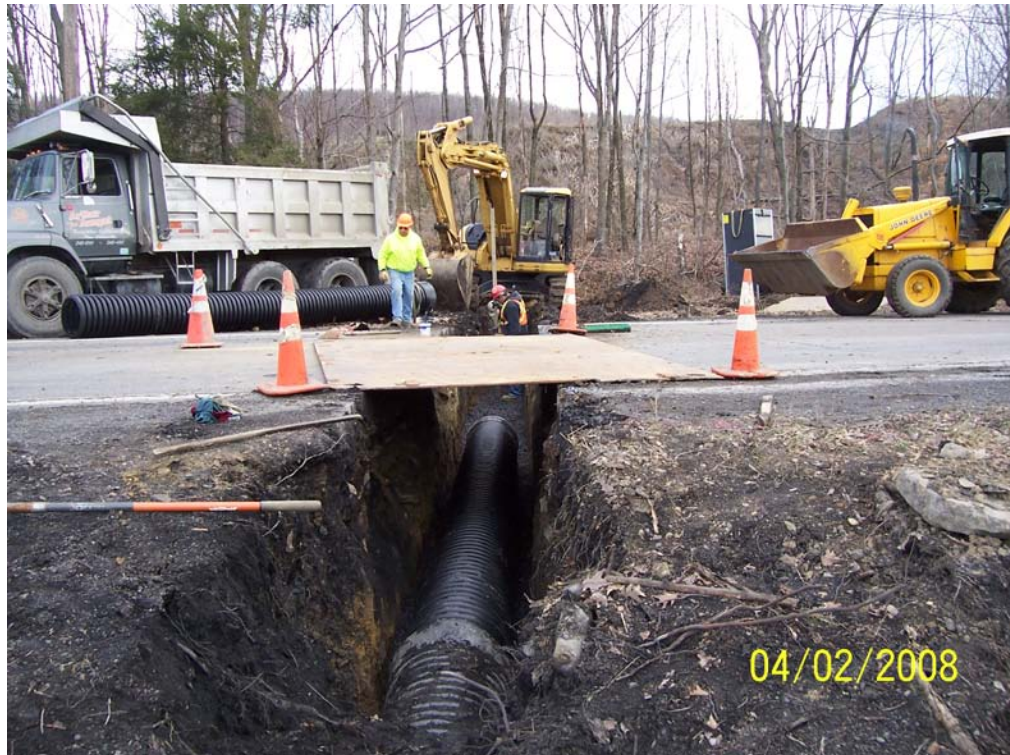
Picture 15. Placement of primary settling basin intake pipe under highway.

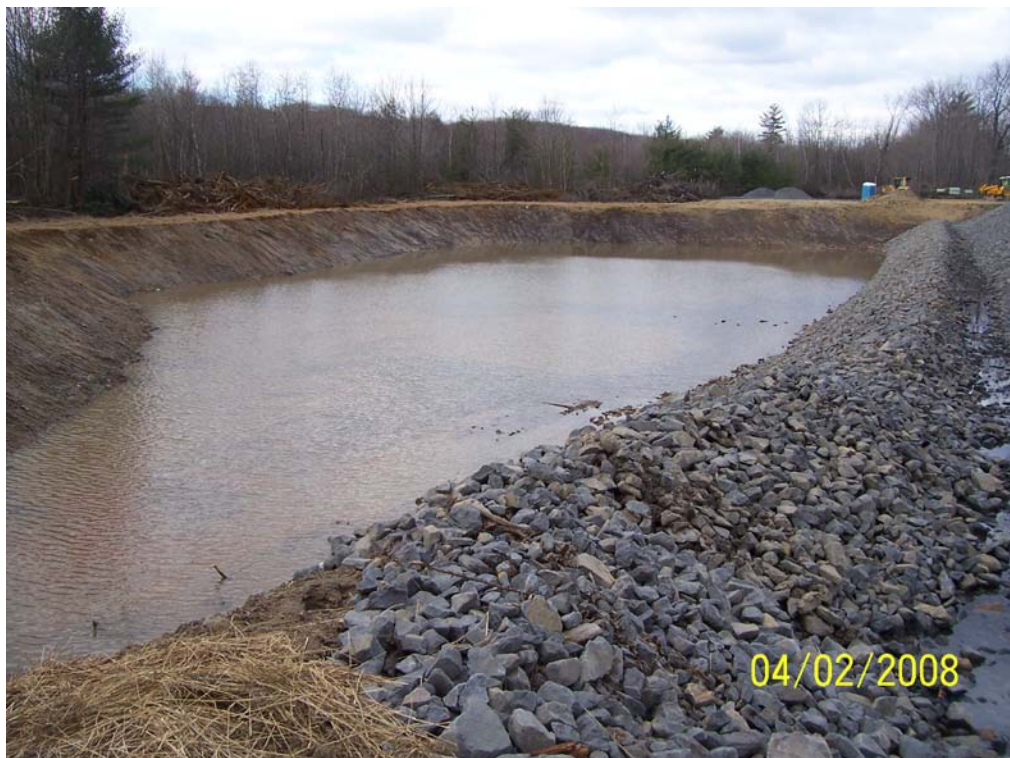
Picture 16. Completed primary settling basin before being filled with water.

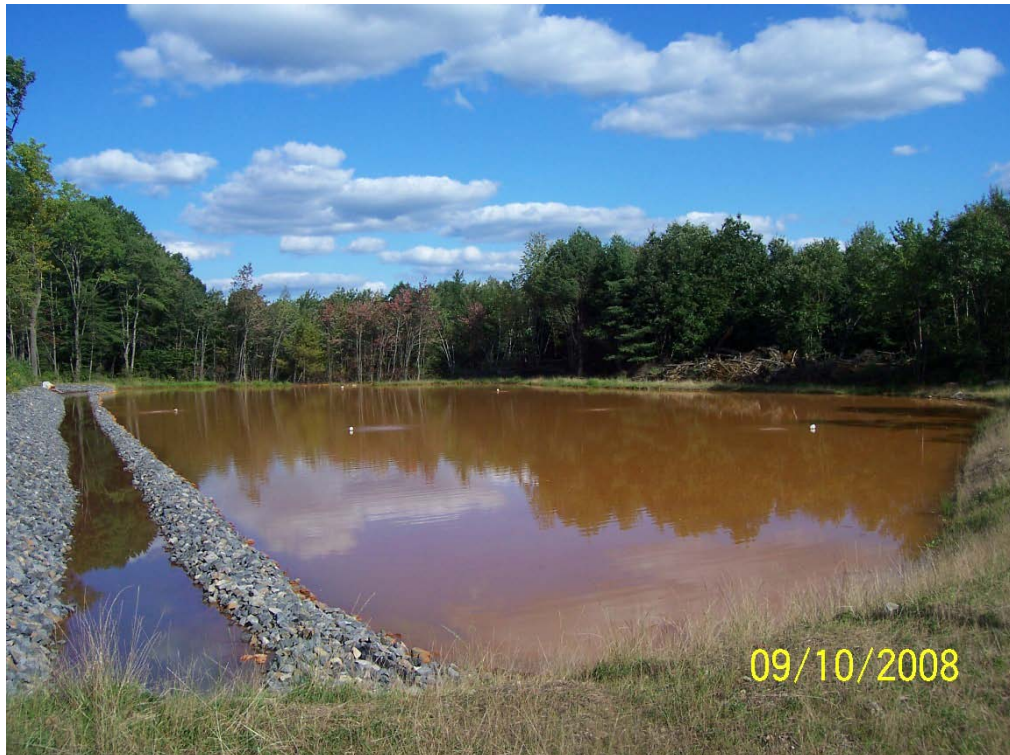
Picture 17. Primary settling basin receiving discharge water and operating aeration system.

Water is conveyed through the 18" pipe to the level spreader that distributes water across the entire basin's front. This level spreader was designed to passively increase carbon dioxide (CO<sub>2</sub>), and oxygen (O<sub>2</sub>) transfer between the atmosphere and water to increase iron oxidation and slow water velocities to maximize settling. An aeration system was placed in the primary settling basin to actively increase diffusion of CO<sub>2</sub> and O<sub>2</sub> between the atmosphere and water to maximize iron oxidation.

appears to be a greater reduction of iron in the primary settling basin when the aeration system is in operation (8/19/08) when compared with data collected when the aeration system was not operated (5/8/08 and 10/16/08). Collection of additional samples is required to determine if statistical differences in treatment system efficiency exist when operated with and without the aeration system.
