**FINAL REPORT:
McCASLIN ROAD MINE DRAINAGE TREATMENT PROJECT**

Environmental Stewardship/Watershed Protection Project
Growing Greener Project Document No. 4100034884
Project No. GD050276

Watershed: Montour Run (Allegheny County)
Grantee: Montour Run Watershed Association (MRWA)

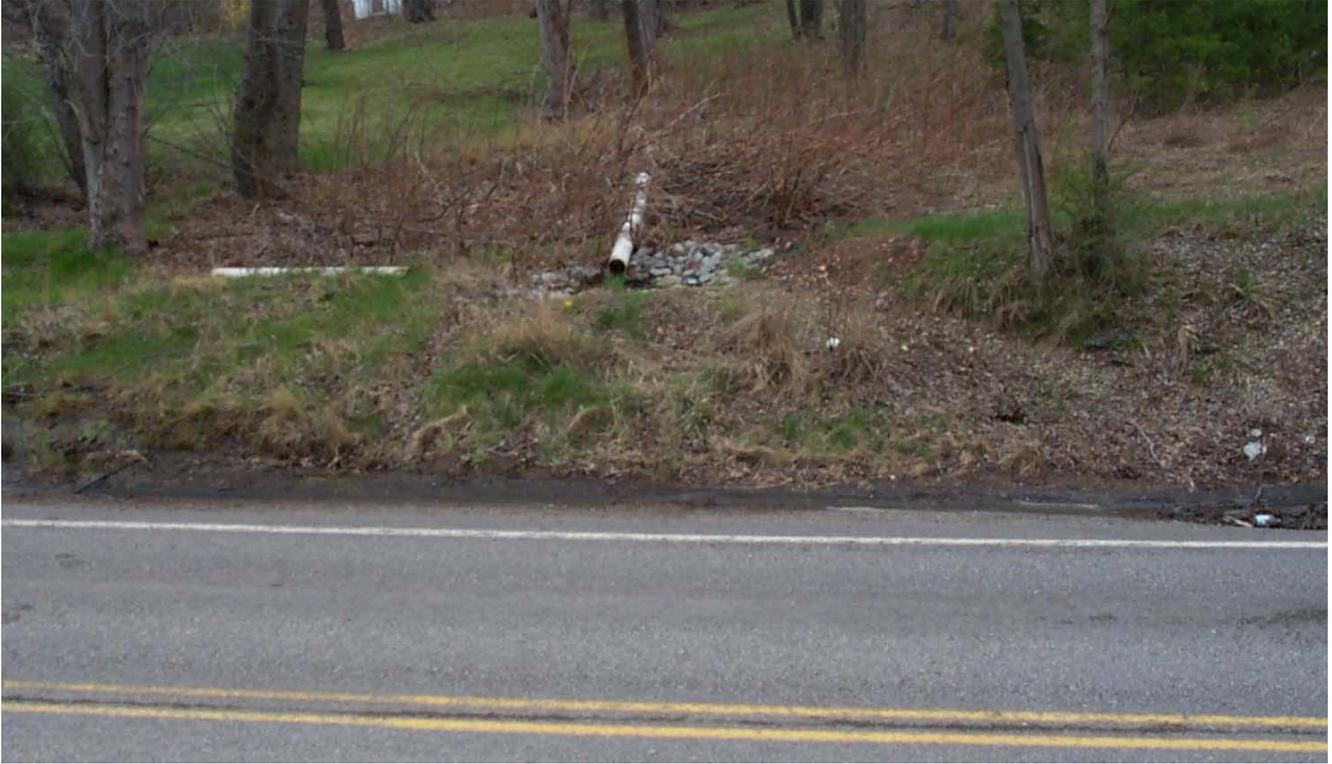
MP5 discharge prior to treatment issuing from existing 6" PVC pipe flowing into storm water facilities along Clinton Road (SR-3089).

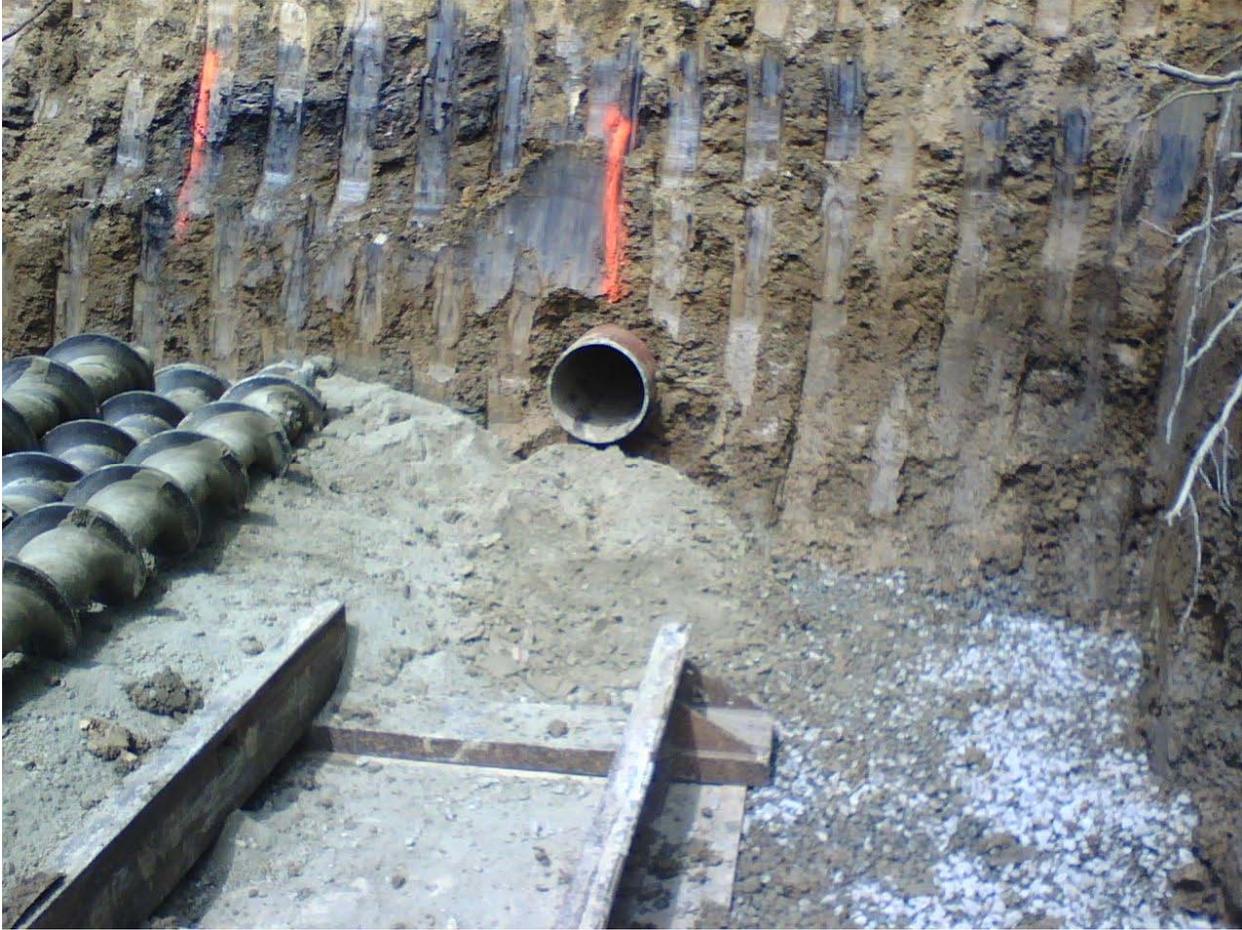
80' long 12" diameter steel casing installed beneath Clinton Road to conduct the AMD discharge to the treatment facility. A six-inch SCH40 PVC pipe was inserted into the steel casing.

- Six-inch PVC pipe encased in 12" steel pipe conveying the AMD discharge under the road, in lieu of the originally planned 8-inch steel casing.
- A limestone neutralization bed [Automatic Flushing Vertical Flow Pond (AFVFP)], relocated to the north side of the entrance road (Public Works Drive) from its original concept location behind the Public Works salt sheds. This bed is an automatically flushing vertical flow pond using 800 tons of AASHTO #1 limestone. Untreated mine drainage enters the AFVFP via a 10'-long perforated 6" SCH40 PVC pipe bedded in ~23 tons of R-4 riprap (inlet manifold). An underdrain consisting of a total of 90' of 8" Perforated SDR35 PVC installed in 4 separate single-line sections drains the limestone bed into a concrete siphon vault. The vault houses a Fluid Dynamic Siphons, Inc. Model 648 Automatic Dosing Siphon with optional 648/634 trigger mechanism.

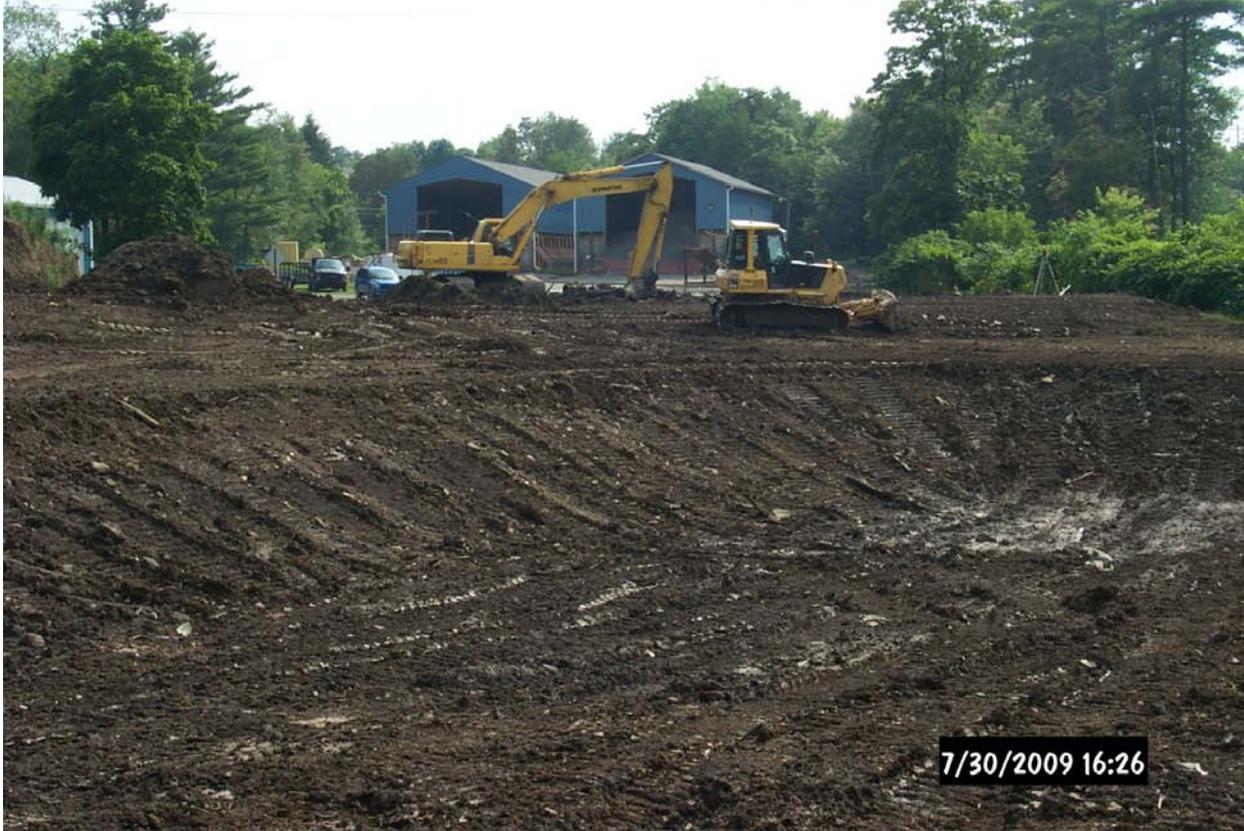
Construction of the settling pond/wetland downstream of the AFVFP.

- An 8,200 square-foot (SF) settling pond/wetland (SPWL) (5,900 SF pond + 2,300 SF wetland) downstream of the AFVFP.
- The SPWL drains via a rock-line outfall channel to an unnamed tributary to the West Fork of Enlow Run.

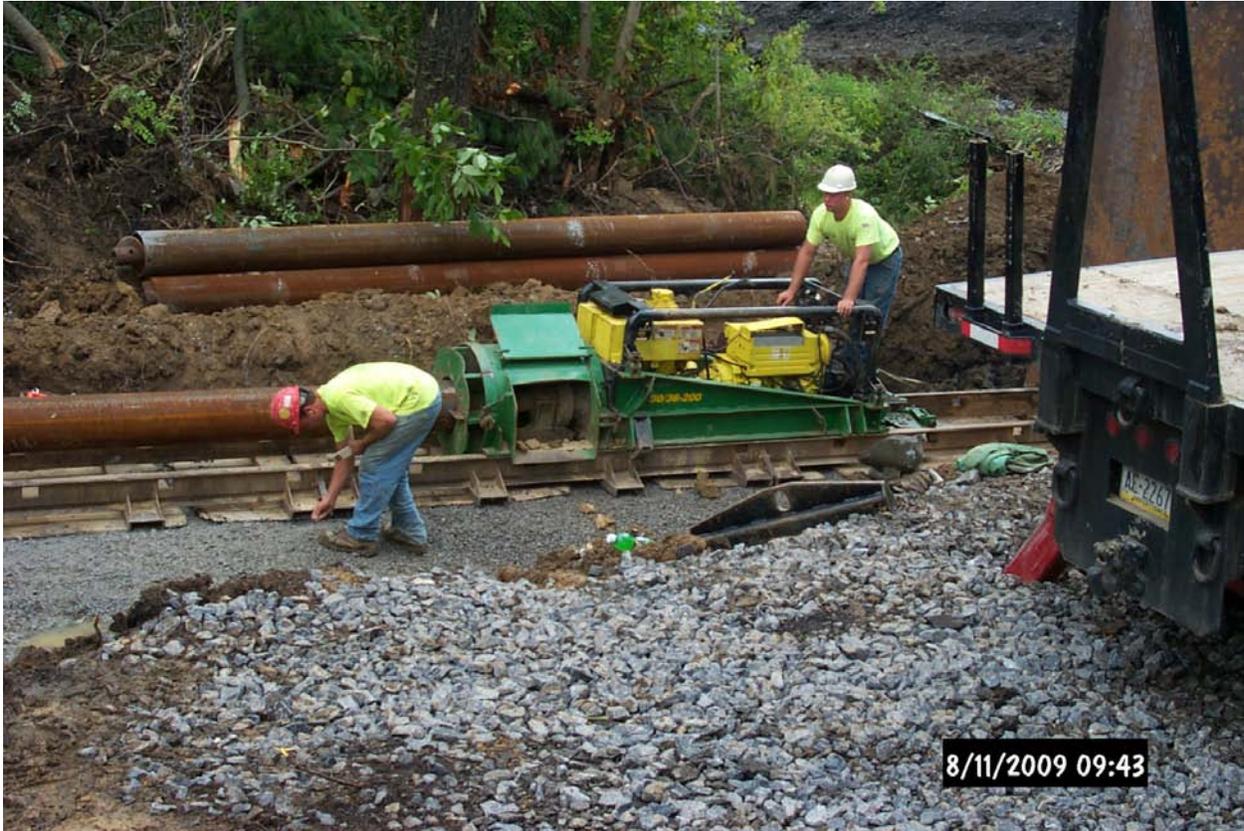
Centerline Boring, Inc. of Zelienople, PA installing 12" diameter steel casing. The horizontal bore crossed under an 8" water line owned by Findlay Township Municipal Authority, Clinton Road (SR3089), and a 4" steel Dominion Peoples gas line

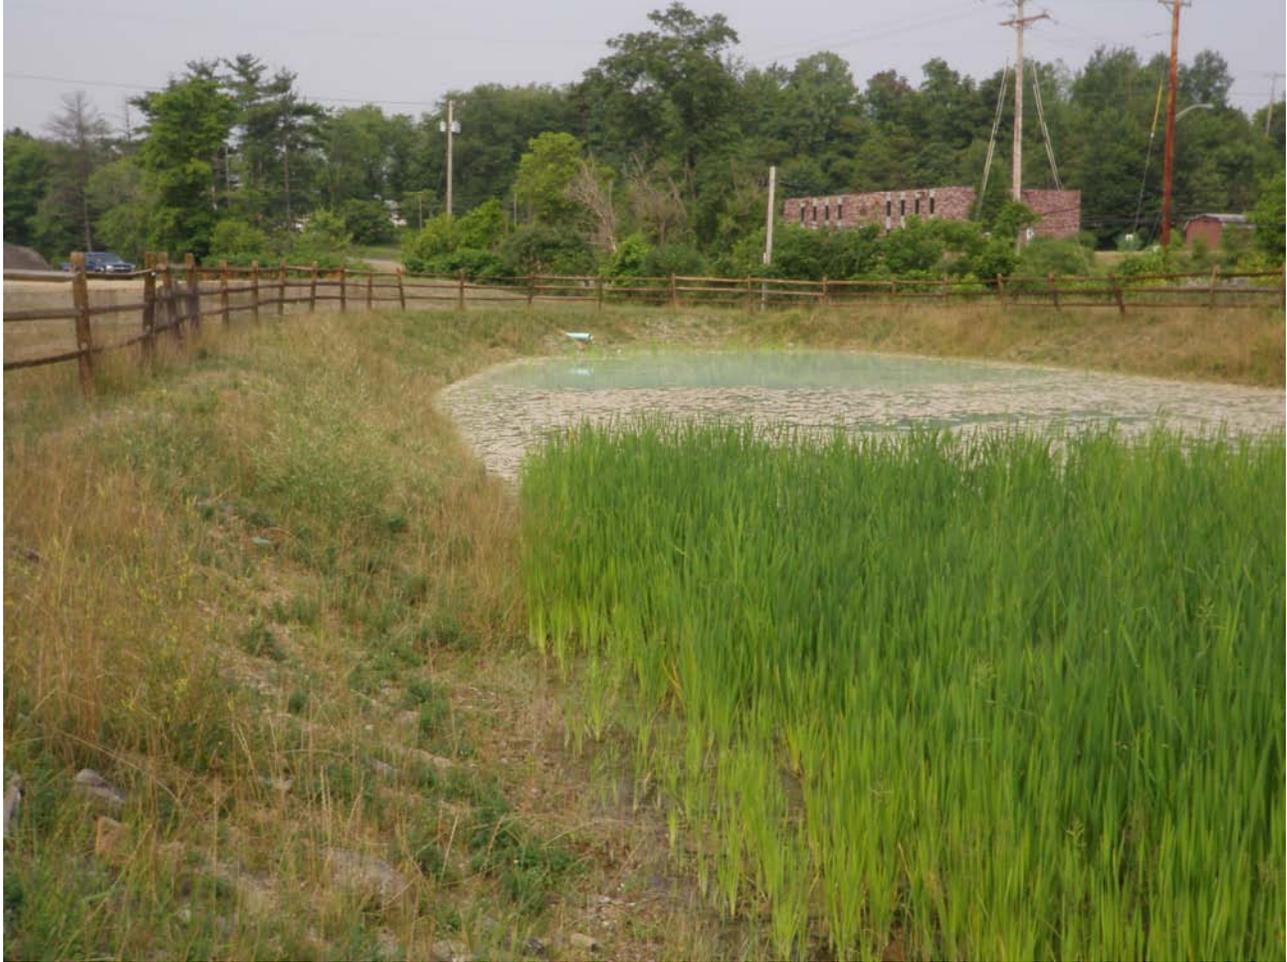
View of Settling Pond (back ground) and Wetland (foreground) with safety fence.
