Shamokin Creek Site 48 Treatment System SRI O&M TAG Project #5 Request #2 OSM PTS ID: PA-36

Requesting Organization: Shamokin Creek Watershed Association & Northumberland CCD

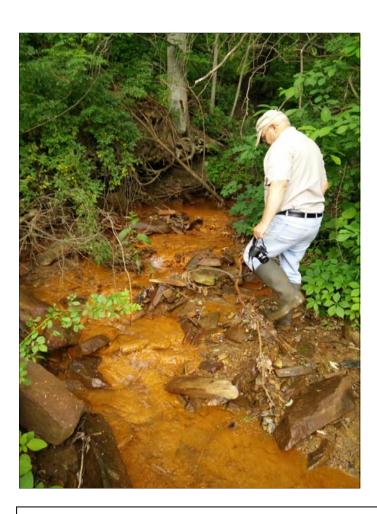
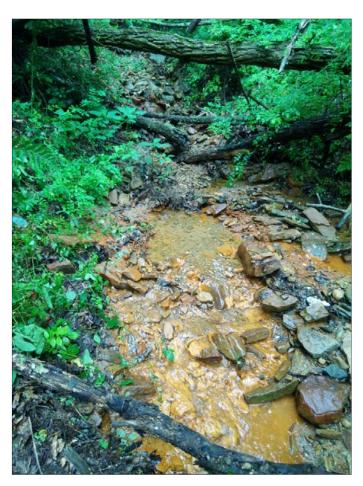
Meeting with Jim Koharski from SCRA during a site visit (left) to locate the mine discharge. The discharge (right) was located approximately 650 feet upstream from the current PTS intake. Above the elevation of the discharge, the only flow that occurs is from storm water during precipitation events.

The site was revisited on 6/18/15 with Jim Koharski of SCRA who had previously cleared a path to access the discharge point. Water sampling was conducted at the discharge and flow was measured to assess the amount of water taken into the system. Based on available data, a conceptual plan and cost estimate (see attached) has been developed, which includes an underground collection system and ~600 foot pipe that will convey the discharge directly into the system. As the discharge is the primary source of AMD and flow to this section of the stream, once the suggested design improvements in the

plan are implemented, the need for a stream intake should be eliminated and only AMD should be entering the treatment system. In addition, high flow events should decrease, which should have an added benefit of less erosion and sedimentation in the stream.
