Kalp Mine Drainage Remediation Project

The Anna and Steve Gdosky Indian Creek Restoration Project

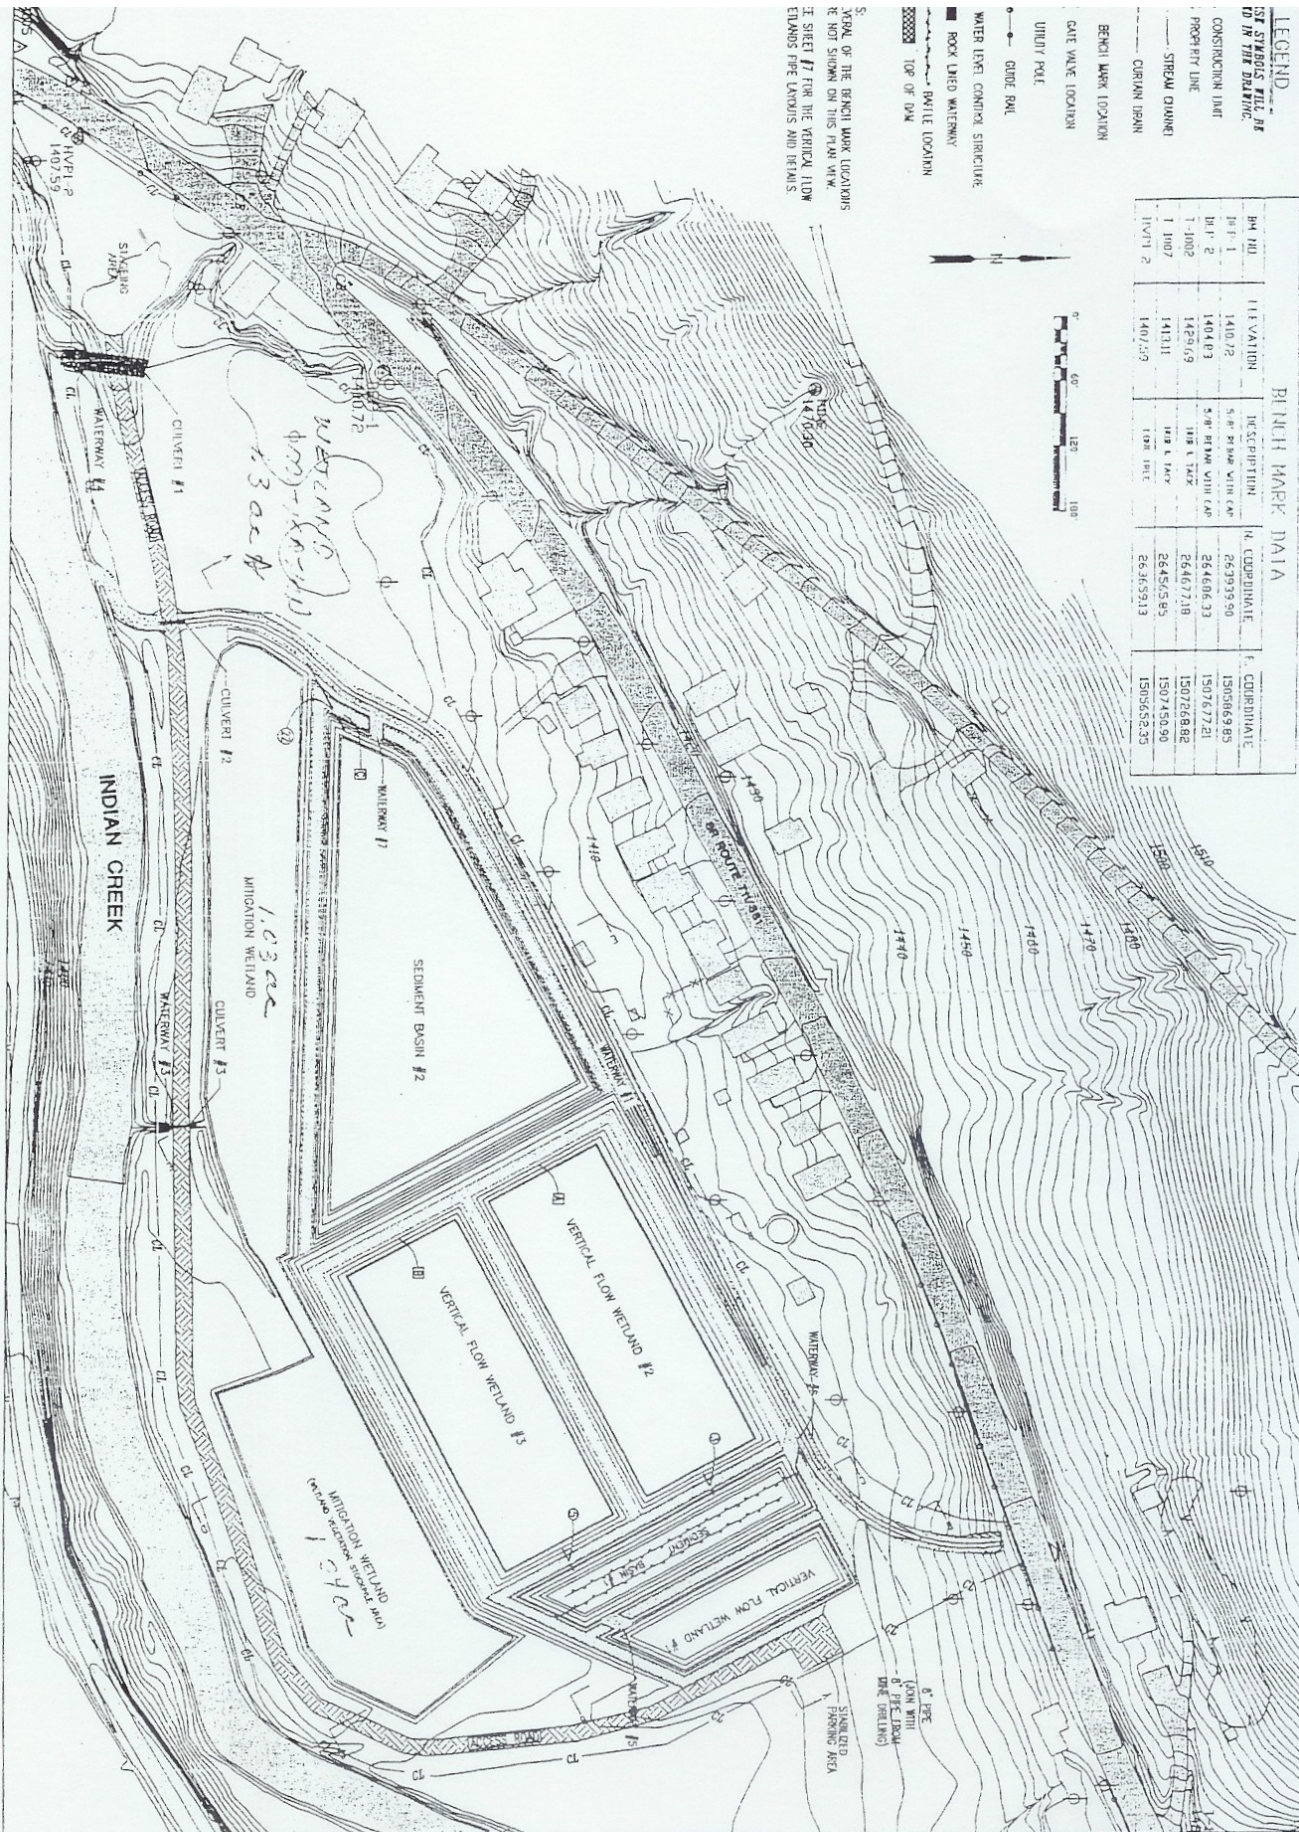
Phase II consisted of the construction of a permanent passive treatment system. The system utilizes a design developed by the federal Natural Resources Conservation Service (NRCS), and consists of three alkalinity producing vertical flow wetlands, two settling basins, and a mitigation wetland. The discharge enters the treatment system in the up-flow wetland where it comes into the system underneath a limestone bed adding alkalinity raising the pH level of the water. Increasing the pH allows metals to precipitate out of solution. The water is transported to the first settling basin where the water is slowed down utilizing baffles to increase the detention time so more metals can fall out of solution. The water is then sent to one of the two vertical flow wetlands where additional treatment occurs as the water interacts with compost increasing the alkalinity causing additional metals to precipitate out. From the vertical flow wetlands the water is transferred to the final settling basin and then discharged into Indian Creek.

5' SCALE OF THE BENCH MARK LOCATIONS
IF NOT SHOWN ON THIS PLAN VIEW
IF SHEET #7 FOR THE VERTICAL FLOW
WETLANDS PIPE LAYOUTS AND DETAILS
